Pelican PU-P16S1 Abandonment Summary

Darren Bewick
Senior Completions & Interventions Engineer

Introduction to PU-P16S1

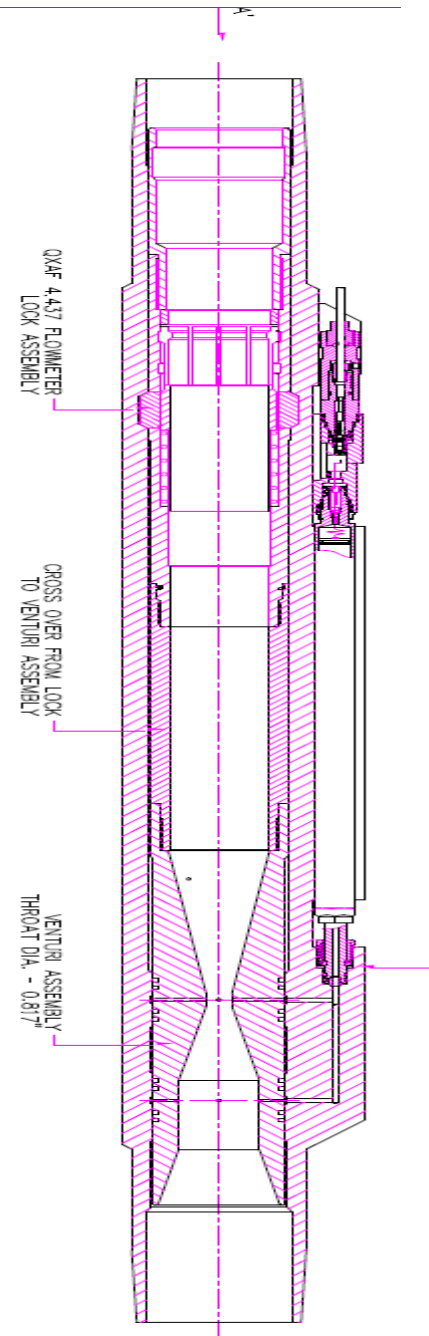
Lower Tubing Restriction

- Tubing restriction preventing access to reservoir
 - Flowmeter Gauge / Mandrel set at 9,511ft.
 - **0.817" ID through Venturi, (About the size of a 20p piece).**
 - Lock is not anti rotational so whole assembly would spin whilst milling however some resistance would be given by the dogs in the profile and the two sets of o-rings on the venturi mandrel.
 - Run on QXAF Uniset Lock Mandrel, body **OD 4.477"**.
 - Tubing Restriction **3.6" ID**.

NOTE: -MATERIAL 17-4 PH CONDITION H1150+1150 HARDNESS 29-33 Rc
MIN YIELD 105,000 PSI TO NACE MR-01 75(LATEST REV).

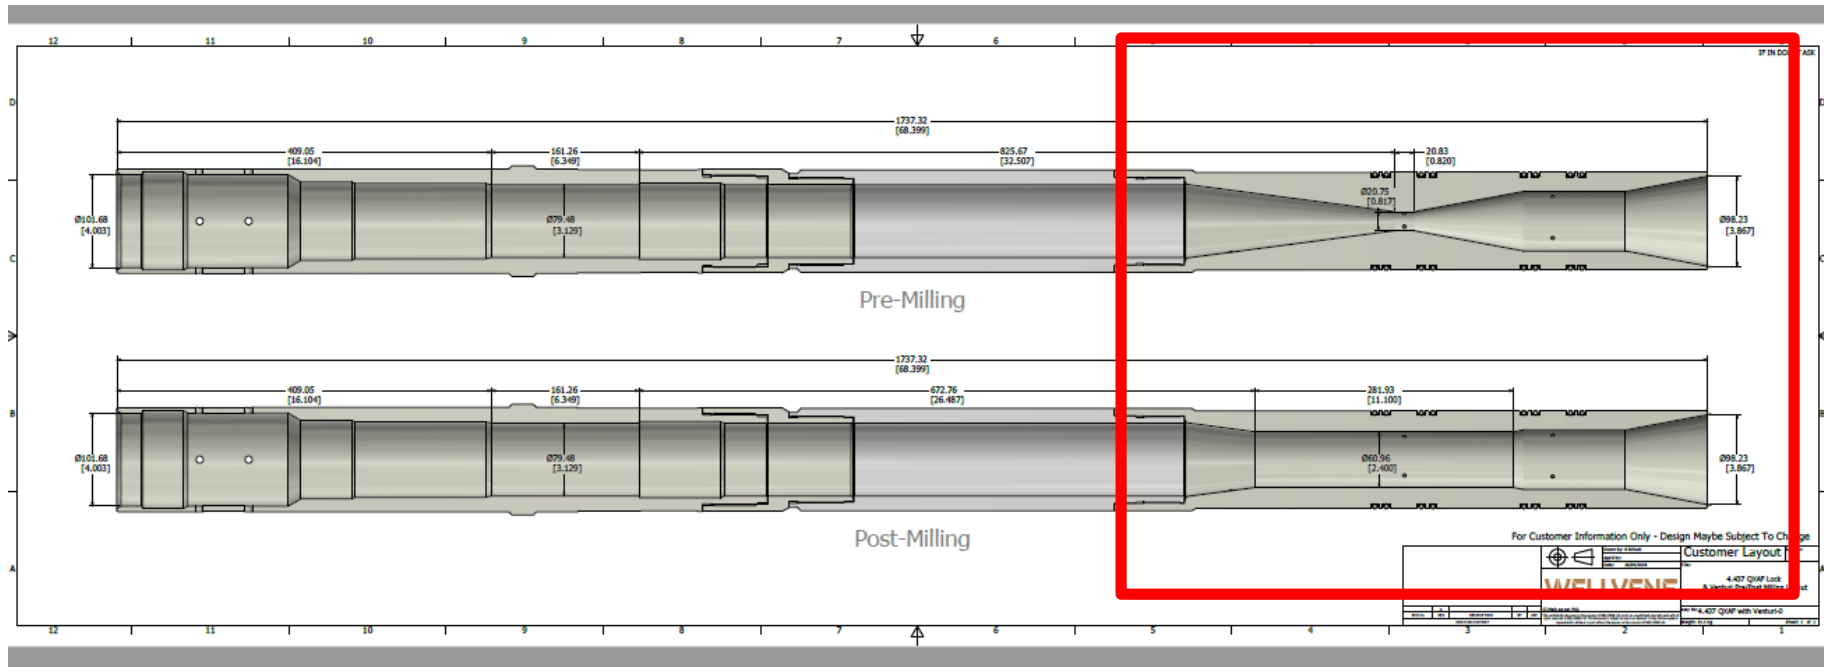
Lower Tubing Restriction- Tractor Milling Trials

- 4.437" QXAF Lock c/w venturi mandrel did not exist so a duplicate for the Tractor Milling trials had to be manufactured.
- Test Fixture had to be manufactured.
- Anti rotation sleeve designed and manufactured from lessons learned during onshore tractor milling trials.

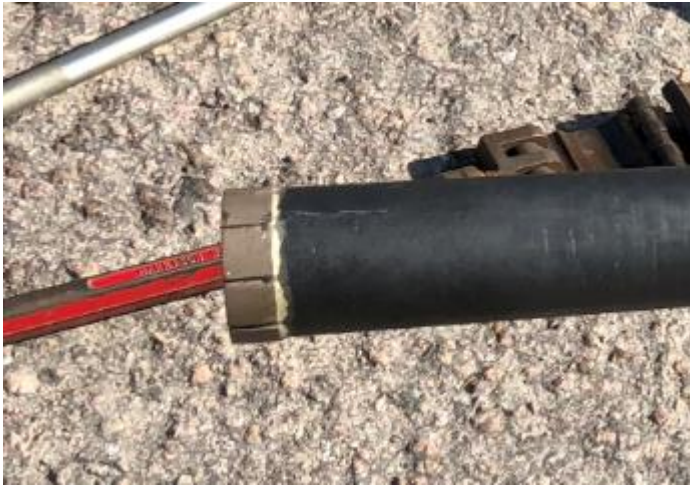
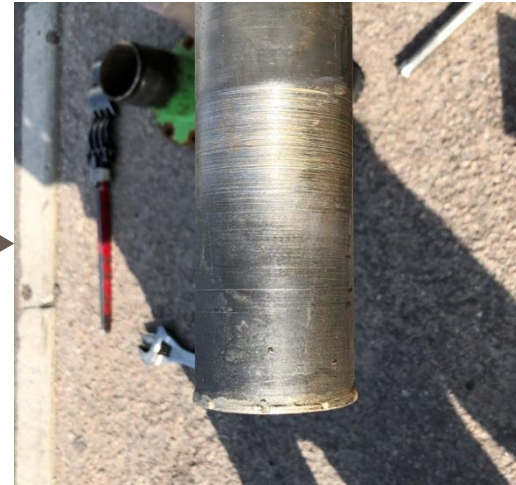
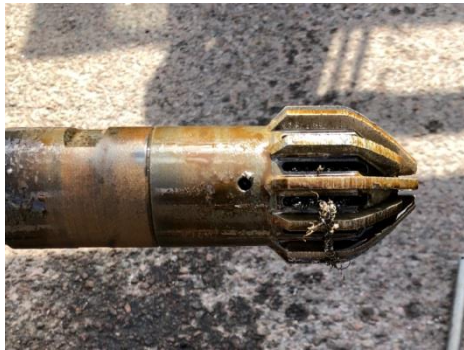
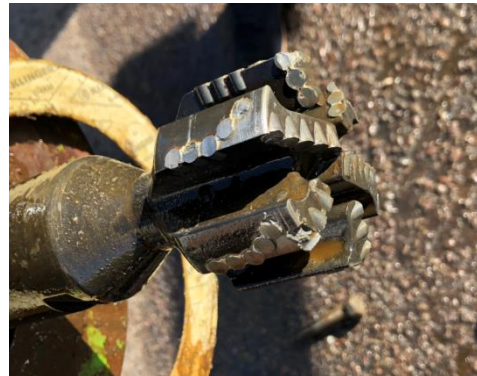
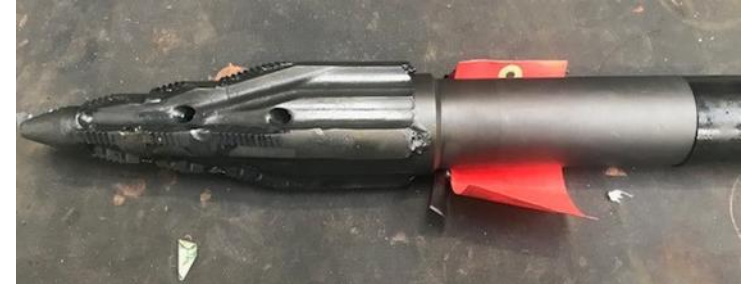
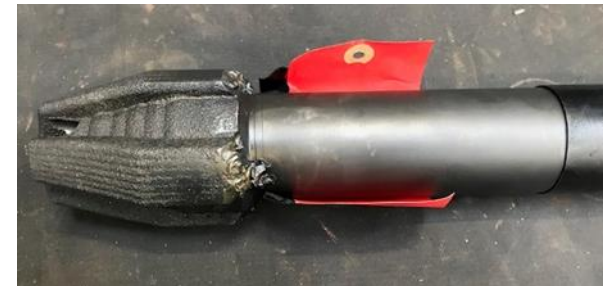
Lower Tubing Restriction- Mill bits tried during trials

- CT could not be used for milling as assembly rotated.
- Cementing up assembly ruled out due to need to keep hole to allow bull heading if no access was achieved.

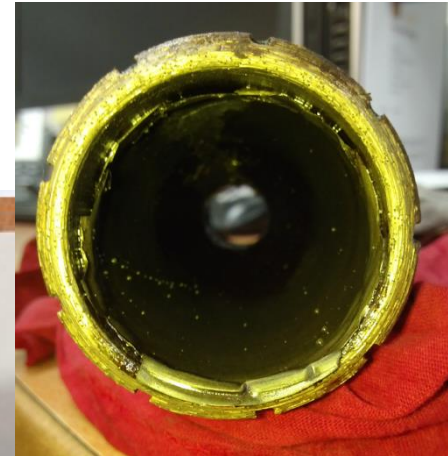
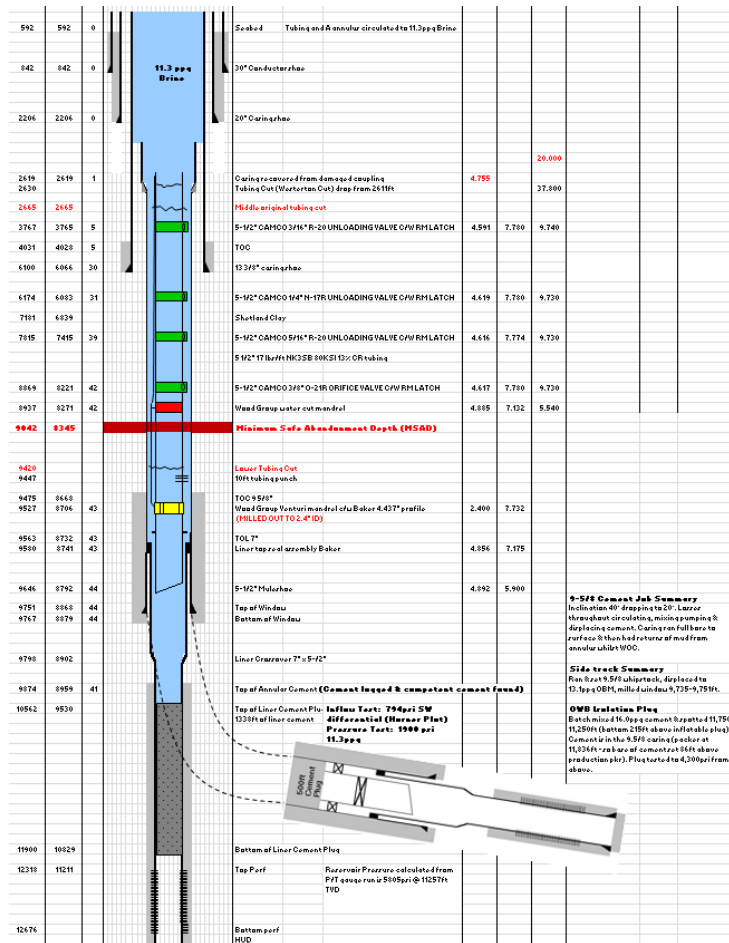
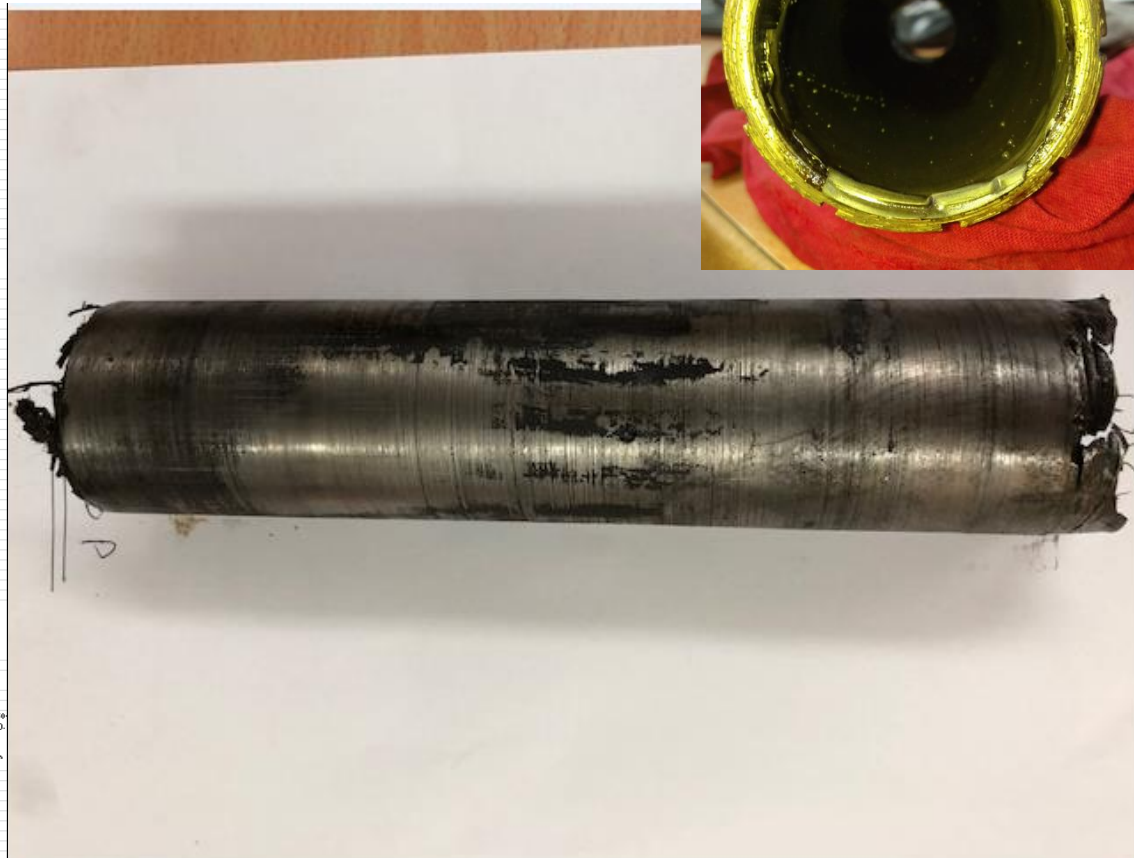
Lower Tubing Restriction- Offshore Tractor Milling

- Nine runs in total (Inc setting anti rotation sleeve)
- Three miss runs
- Three milling runs giving a total effective milling time of 64 hours

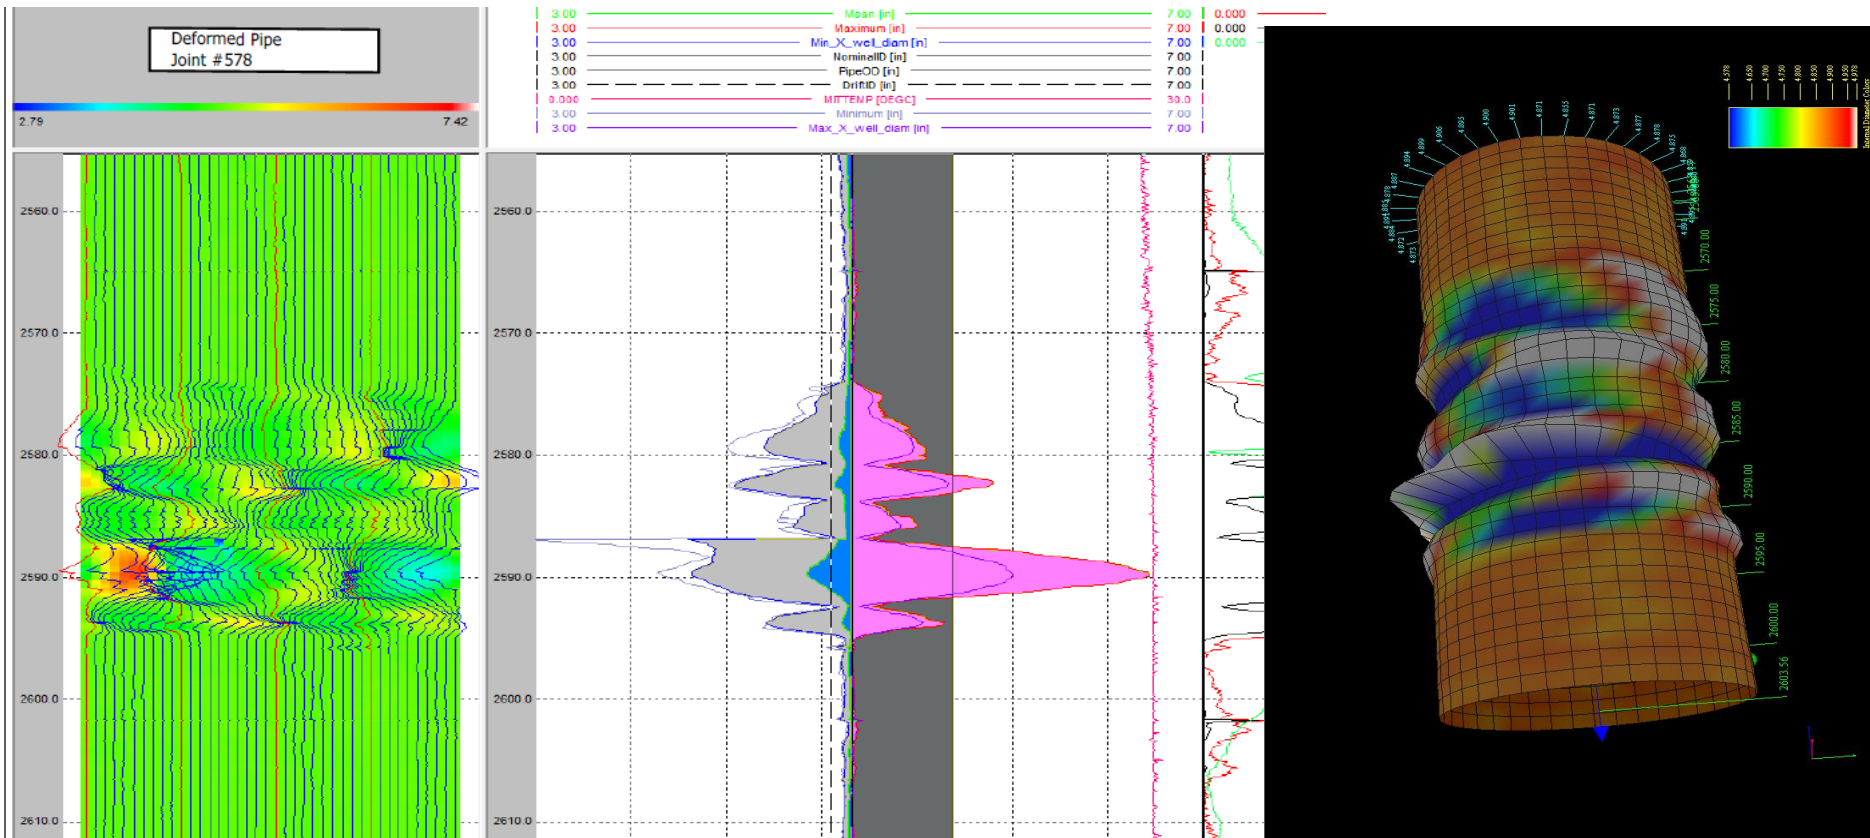
Tubing restriction calliper results

- Two additional tubing cuts (5 in total) required to fish damaged tubing section.
- One with a blade cutter (above coupling) and one with a power cutter (mid damage)

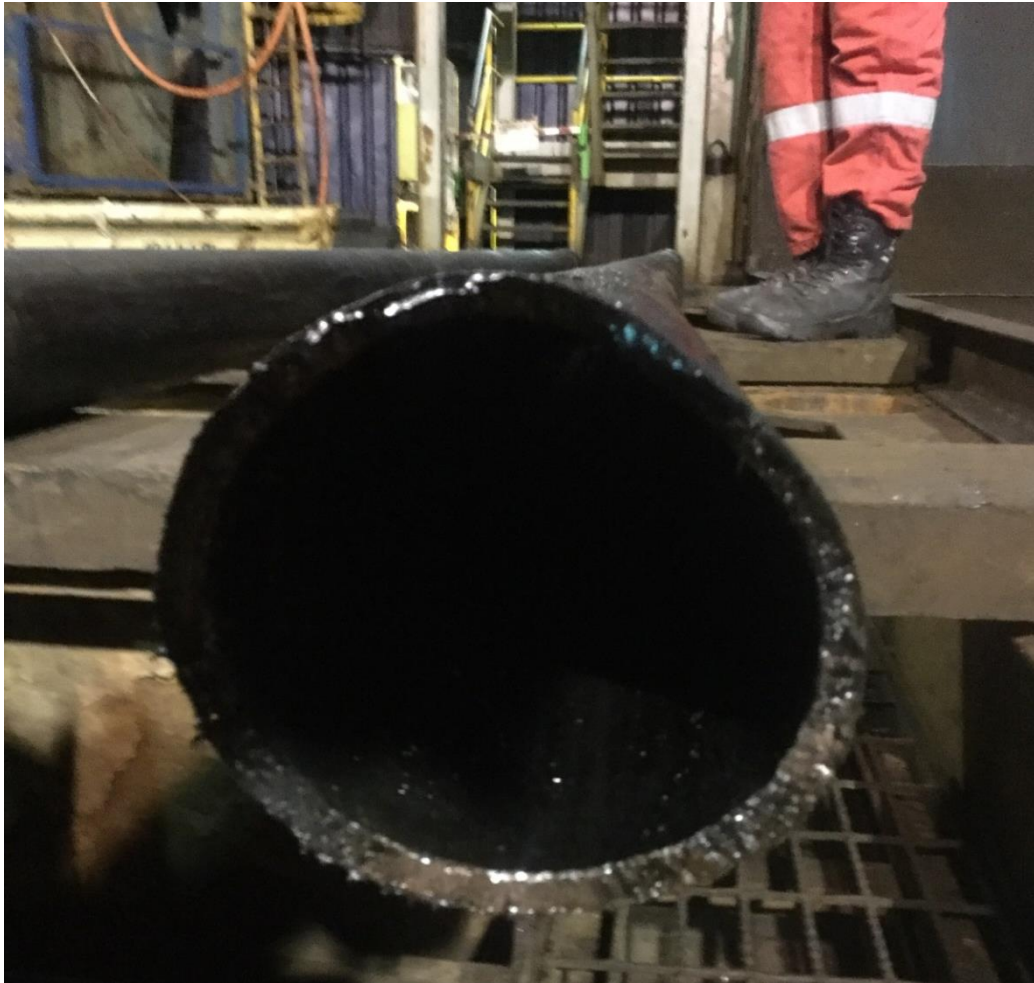
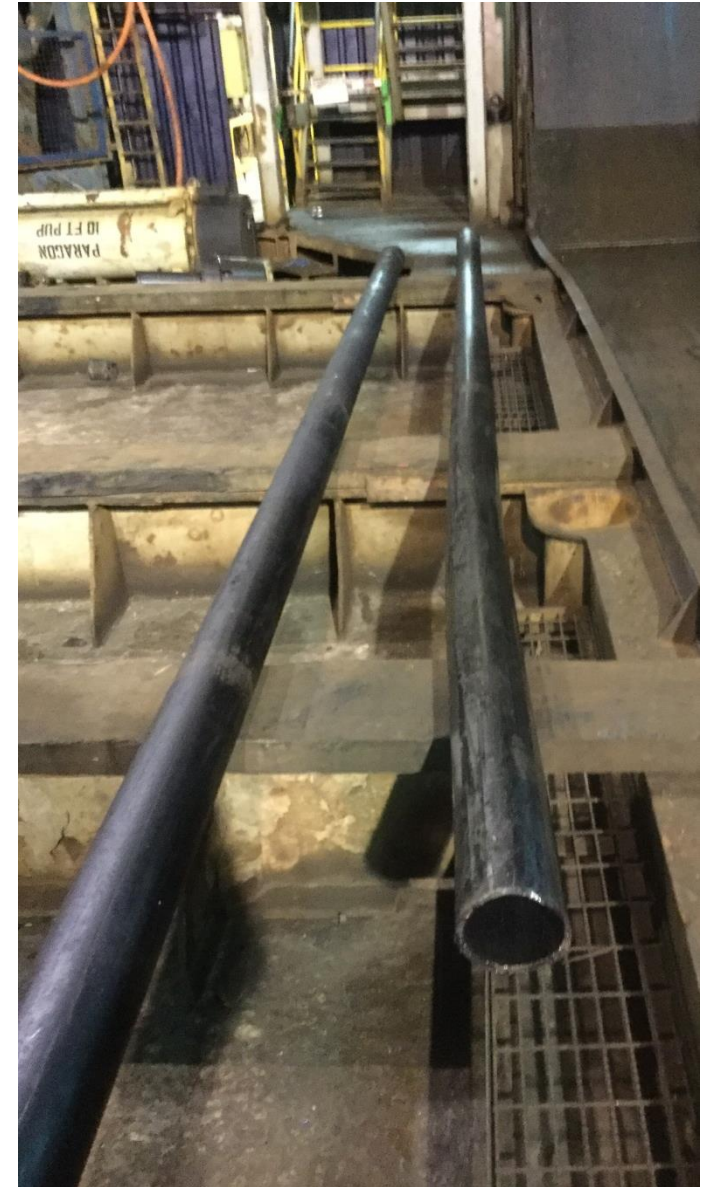
Completion Tubing Fish #1 Recovered 2538-2601 ft

- Bent and Ovalled
- 55 ft Gauge Line recovered on separate run

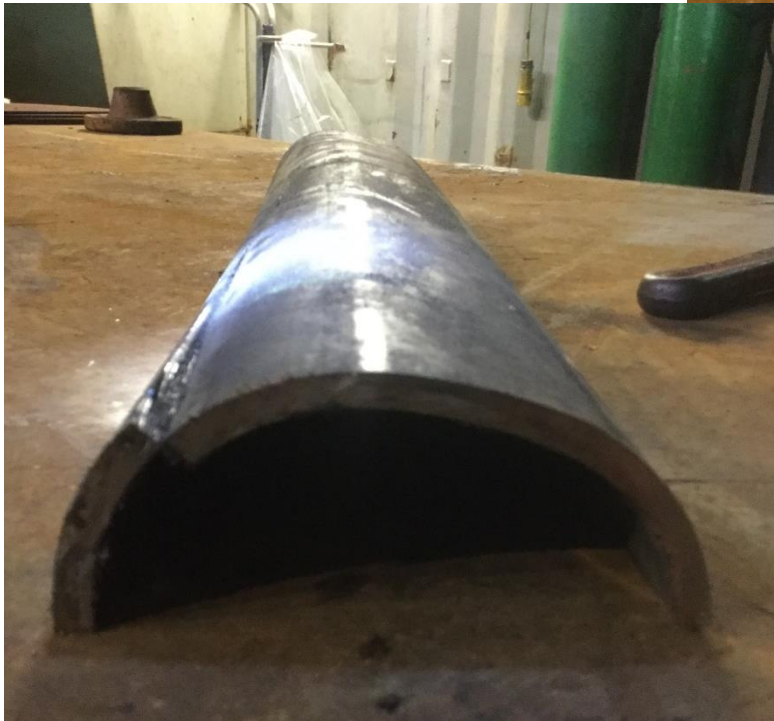
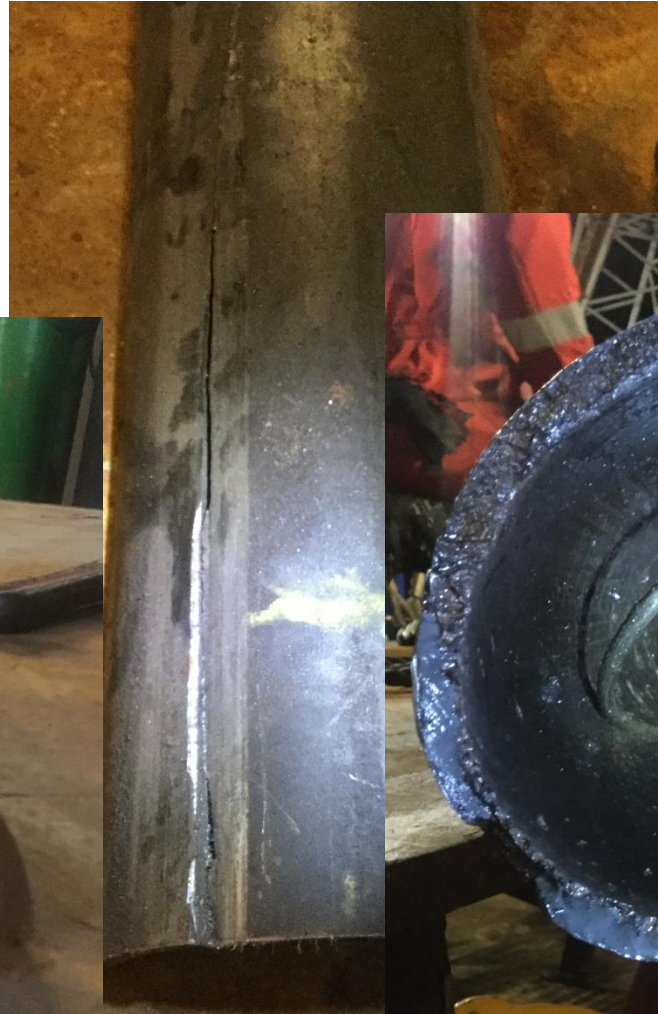
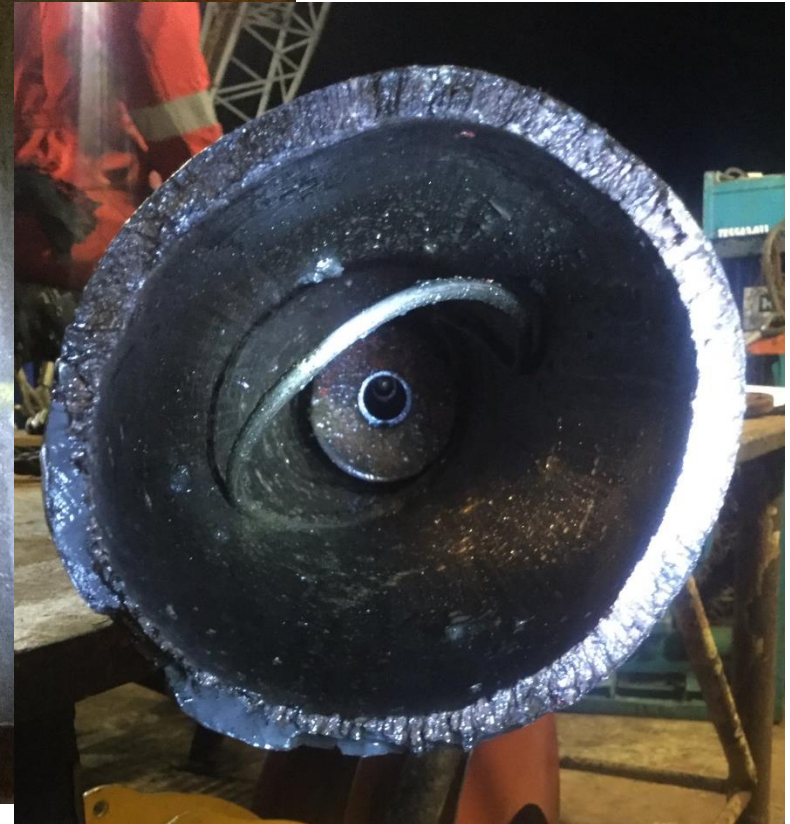
Completion Tubing Fish #2 Recovered 2601-2611 ft

- Ovalled and Split (3 ft from lower end). 5 ft Gauge Line recovered

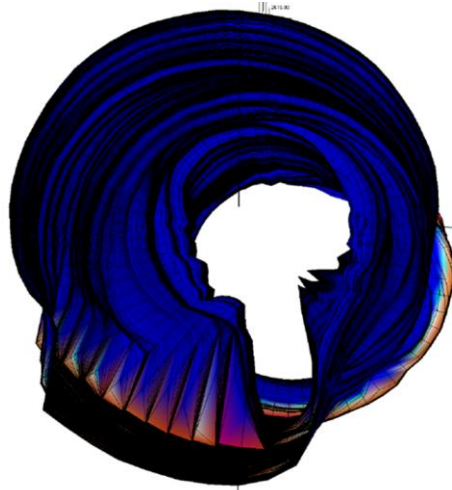
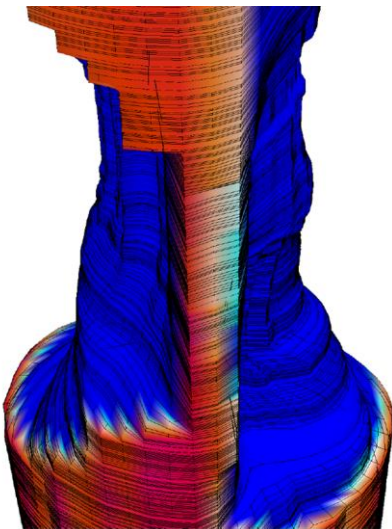
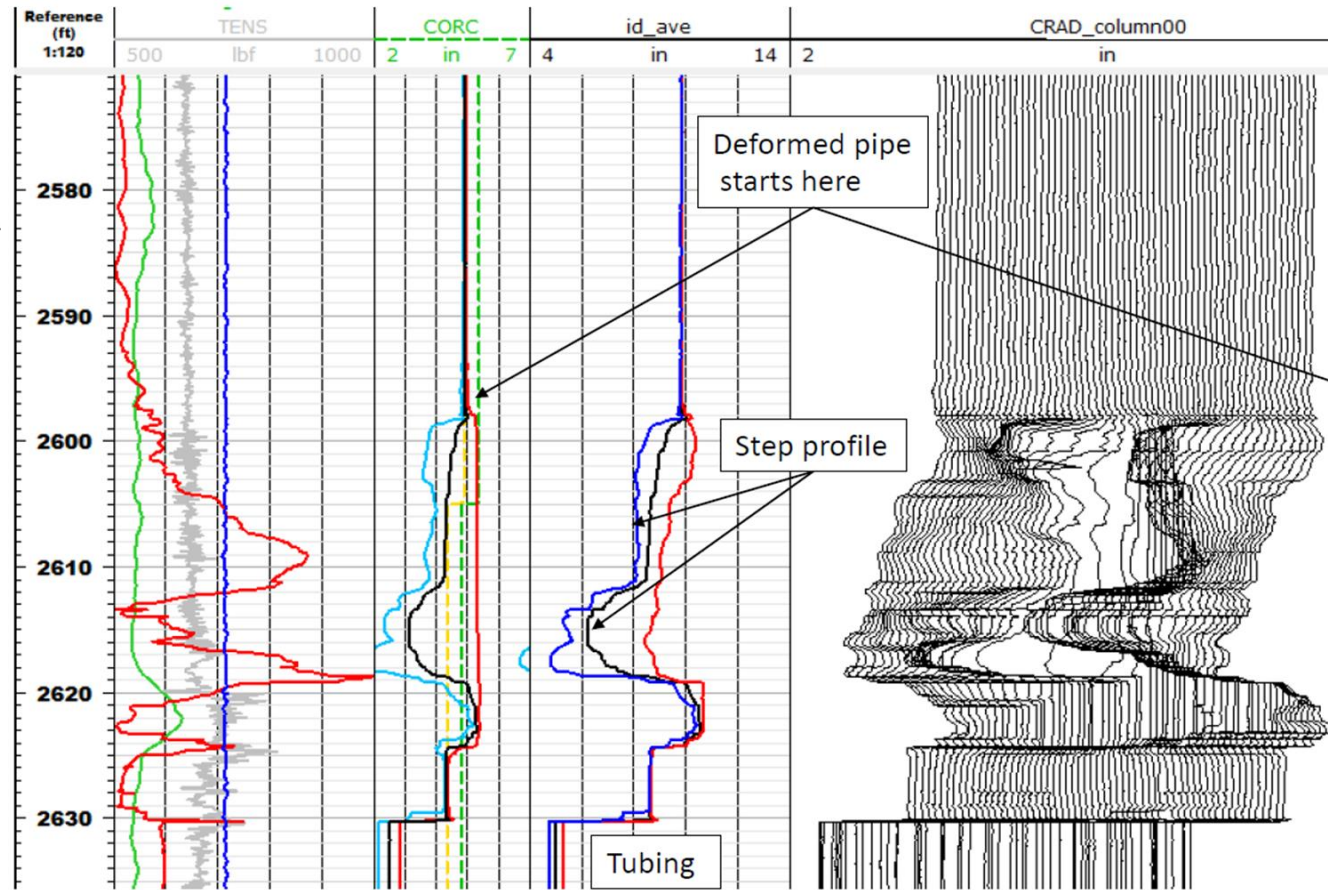
10-3/4" casing collapse 5.26" id

- 3 sizes of casing swages tried from 8-1/8" down to 6-3/8"
- Only 8ft of 20ft damaged section opened up
