Completion and Production Challenges in Offshore Heavy Oil – Lessons Learnt from Peregrino

Luiz Fernando Pastre – Completion Engineer

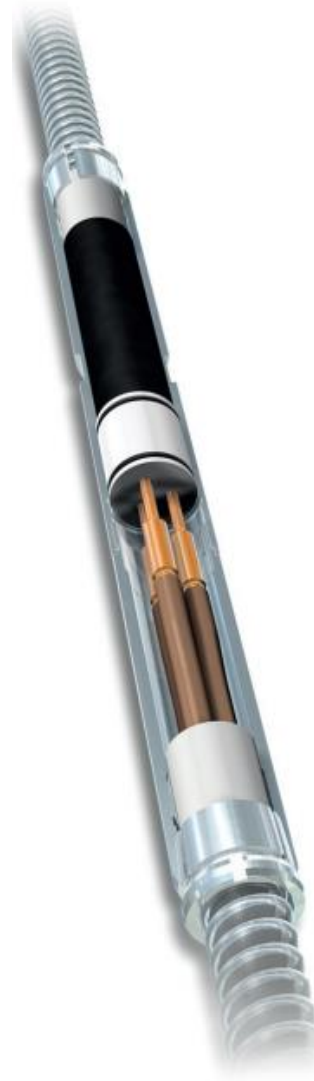
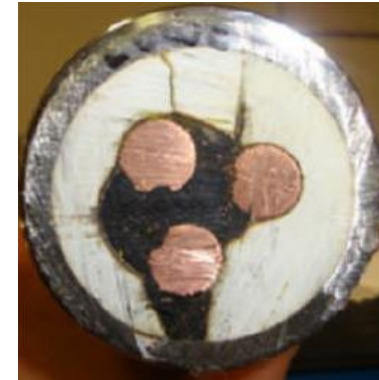
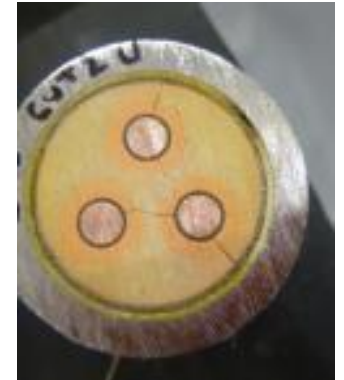
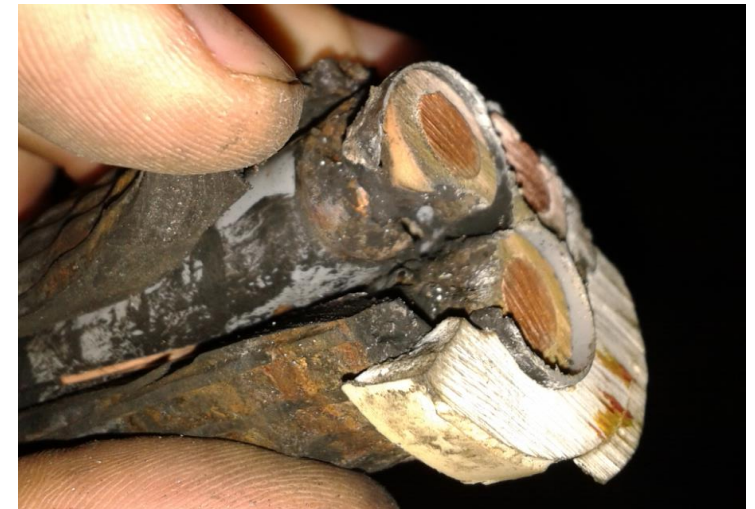
ESP Failure Modes | Packer Penetrator

- Epoxy with cracks leading to phase-phase and/or phase ground failures.
- Fluid contamination inside packer penetrator.
- Signs of overheating noticed during teardown.
- Packer penetrator upgraded to HPHT design.
 - Pressure rating: 10k psi absolute and 5k psi differential.
 - Temperature rating increased to 180 deg C.
 - Insulation materials improved.
- 38 HPHT packer penetrator installed in Peregrino without any failure.

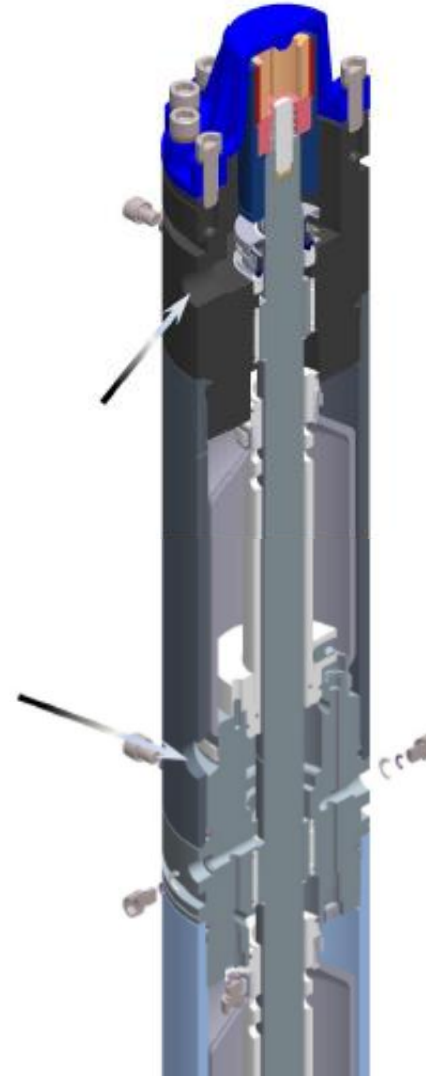
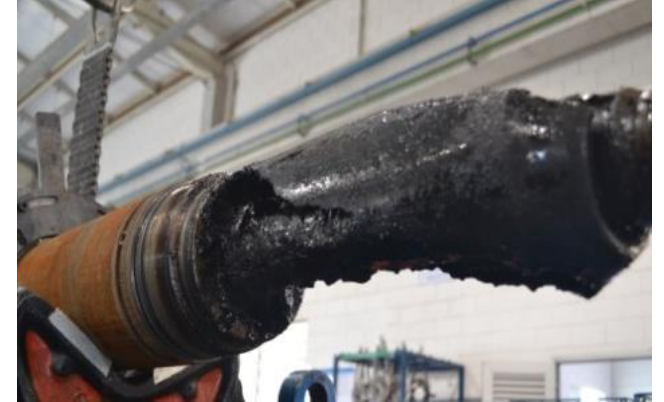
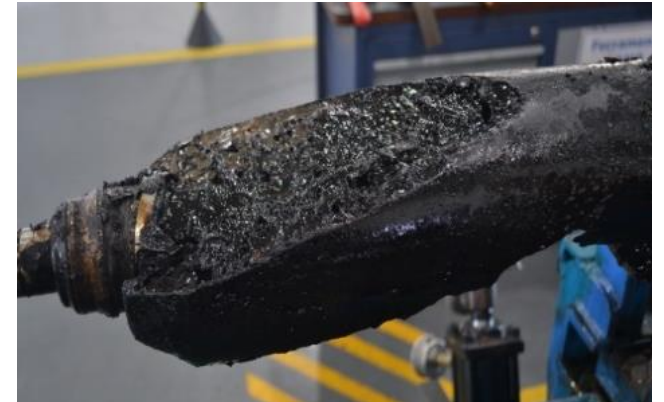
ESP Failure Modes | Asphaltene Precipitation

- Created by chemical instability between dielectric oil and heavy crude.
 - Bag expansion capacity reduced.
 - Check valves plugged.
 - Mechanical shaft seal operation compromised.

- Asphaltene resistant seal design
 - Particle expulsion holes in top chambers.
 - Communication holes in housing.
 - High pressure check valves.
 - Anti-asphaltene additives added to seal section oil.
