ESP Mechanical Shaft Seal Run-Life Extender Performance Enhancements

Hassan Mansir, Andras Bencze
COREteQ Systems Limited

EuALF 2021 EUROPEAN ARTIFICIAL LIFT FORUM

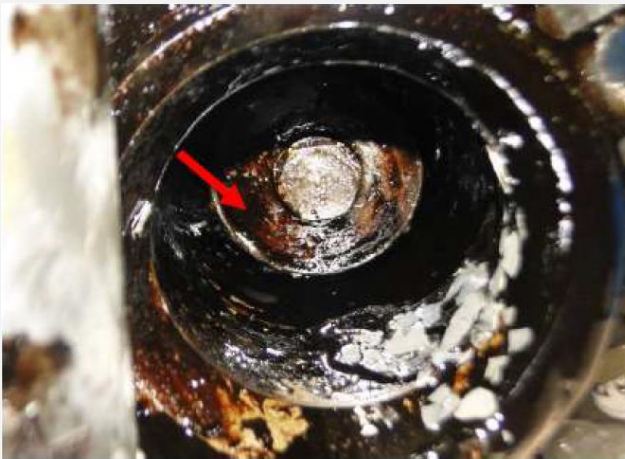
The guardian base showing no signs of sand.

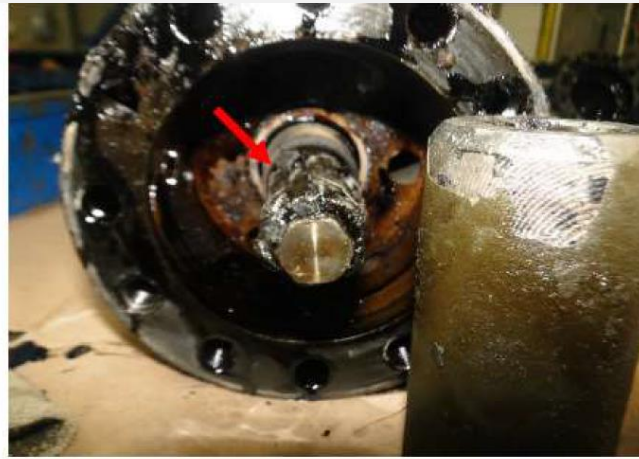
The guardian head was in fair condition.

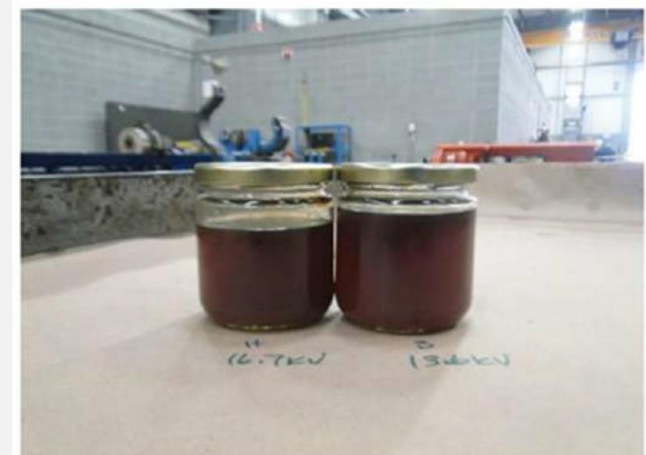
Oil samples collected from the motor:
Head = 16.7 kV, Base = 13.6 kV

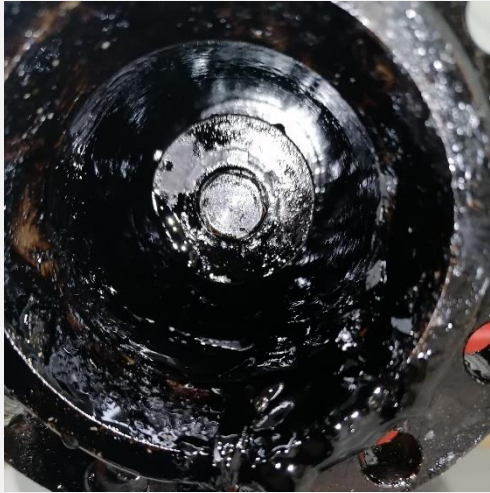
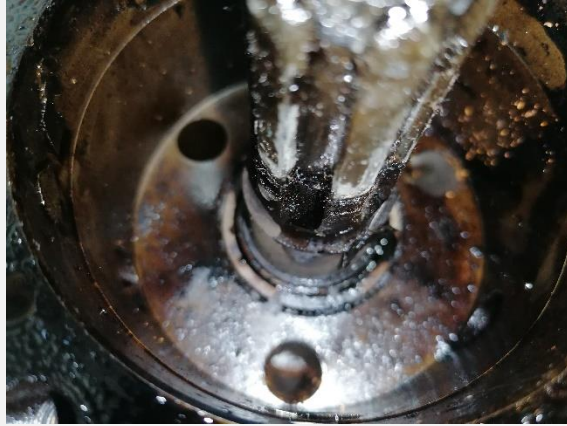
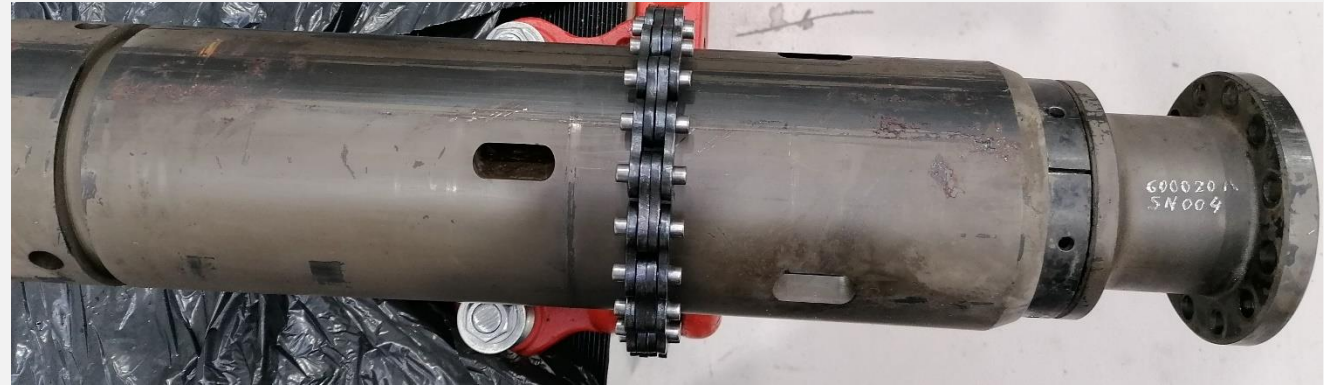
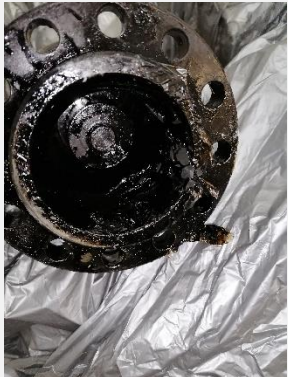
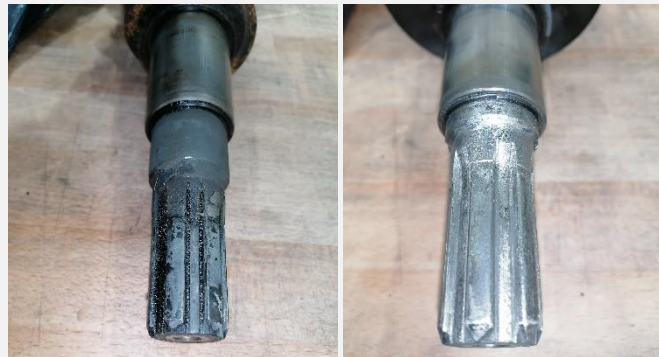
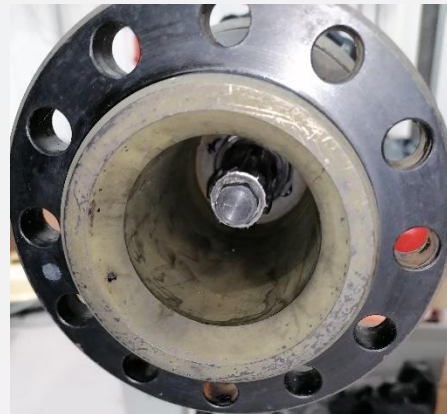
SURFACE CORROSION

- The returned unit was found to be in good condition
- Minor aesthetic issues (discolouration/corrosion) were found on the carbon steel parts.
- Thin scale like layer found on the shaft exposed to the well bore fluid
- Bearings with some polishing but within tolerance
- The unit was shipped back to go into service

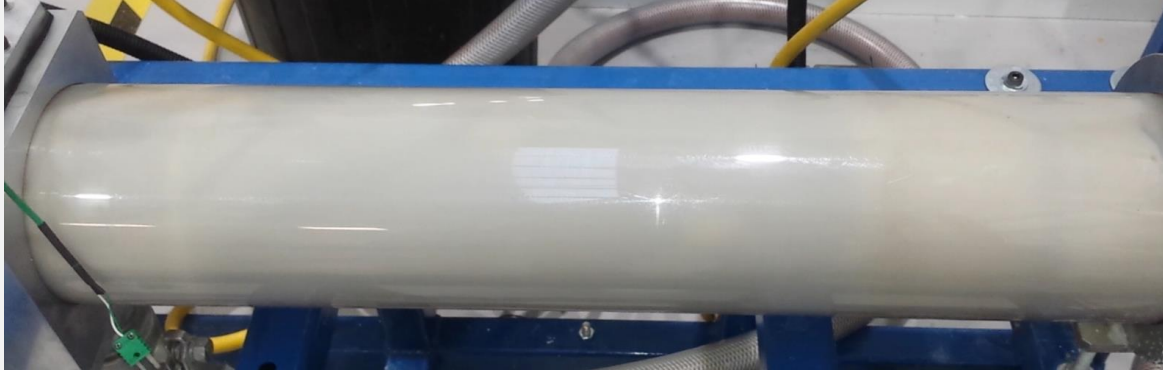
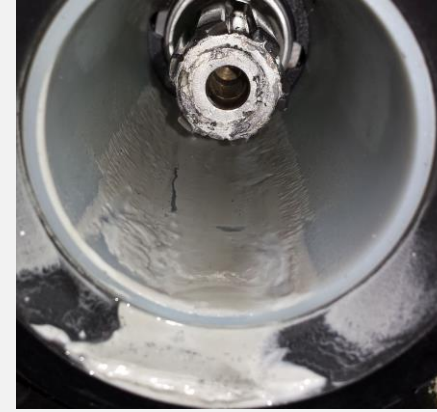
**ORIGINAL DESIGN – 8 HRS
~0.2% of total solids**

- Total accumulated time: 8 hrs
- Significant amount of macerated solids (sludge)
- Speed: 3000 rpm

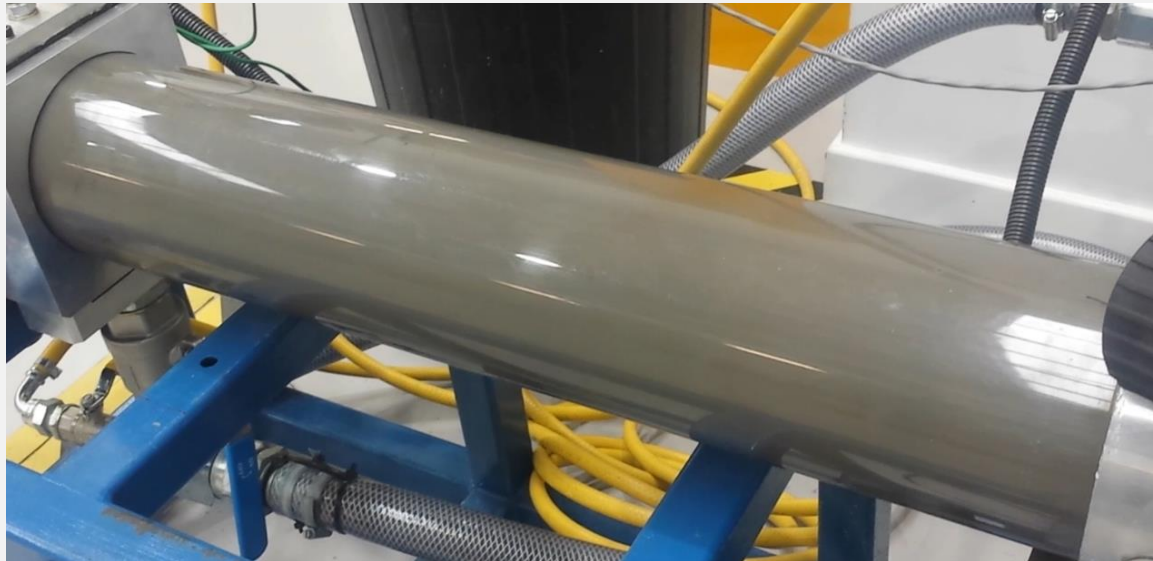
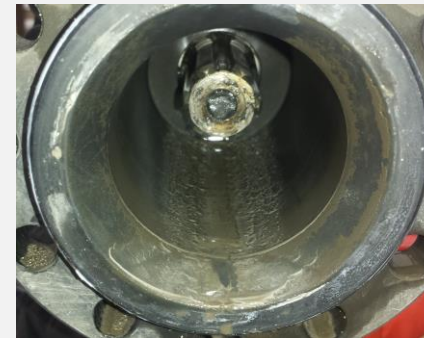
**UPGRADED DESIGN – 16 HRS
Traces of solids**

- Total accumulated time: 16 hrs
- Speed: 3000 rpm
- Less maceration observed (more un-broken glass beads)
