# A case study in the use of a mechanical clamp on a non-typical joint

4 March 2021

Minor seepage detected in a gas pipeline around a monolithic isolation joint.

30" (773.7mm OD) Carbon Steel API 5L X65, 28.6mm wall thickness

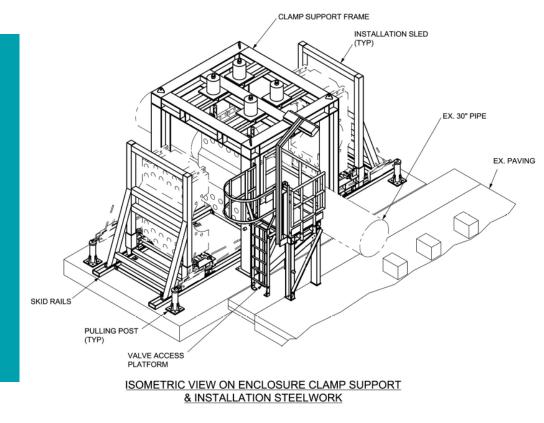
Installed Weight – 16,075 KG

No load to be transferred to Monolithic Isolation Joint

The design and condition of the Monolithic Isolation Joint makes it impossible to define an acceptable load. Particularly axial and moments

No solid base to support from

Selected support design

- Spring Support Variable Type
- Load cells
  - Monitor installation load transfer
  - Monitor settlement

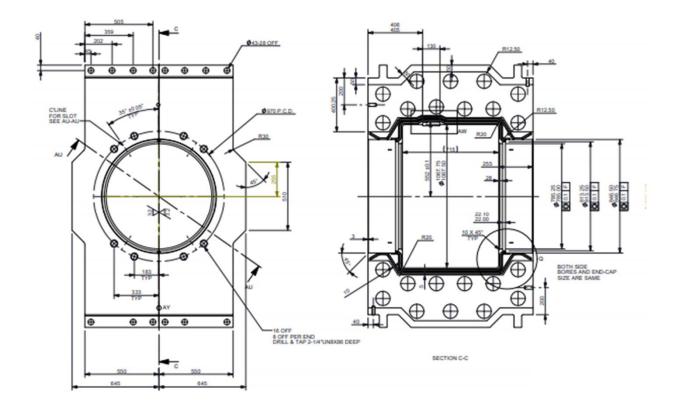
- Non standard seals due to electrical isolation requirement
  - Larger aperture
  - Different grade Viton mc616 non- carbon

- Tufnol 10G/40 rings to provide separation
- Isolation test
  - 2000V, 50Hz for minimum 1 minute no flash over or breakdown
- Resistance test
  - 500V dc isolation tester, resistance shall exceed 50 Mohm
- Failed first FAT
- Capacitive effect

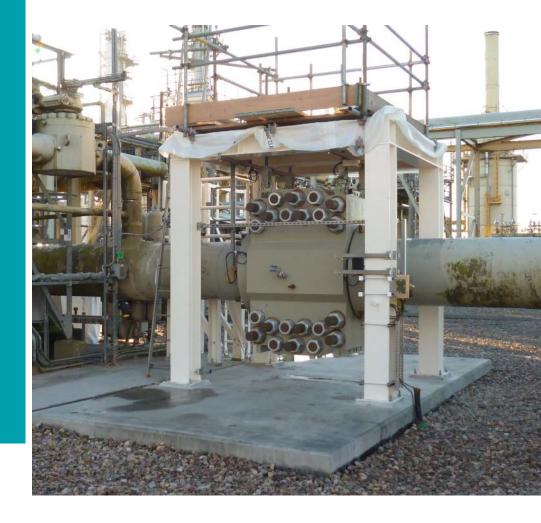
### Cause of Issue with IJ:

- Without destructive testing not possible to confirm
- Possibly subsidence
- Possible degradation of seals due to aging

#### Inspection:

- Monitoring Sealing
  - Cavity pressure
  - Inter-seal cavity pressure
  - External gas / sniff tests
- Settlement
  - Load Cells
  - Dimensional Survey
