# Application of novel downhole video technology leads to the diagnosis and successful remediation of injectivity performance issues in deep saline CO2 storage well

22 FEBRUARY 2022

AQUISTORE®

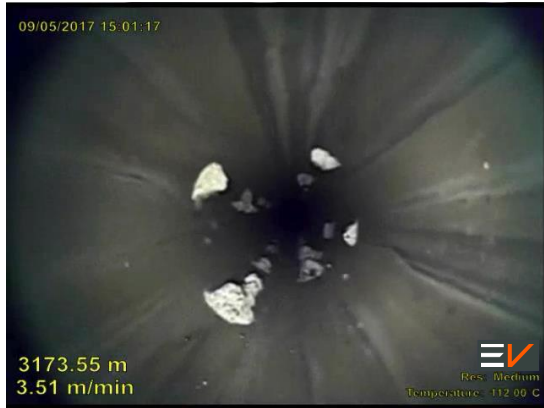
TYPE 1

ZONE 1 (BLACK ISLAND)

Localised precipitation at perforations  
Limited impact on wellbore ID  
Some travel along wellbore (50cm)

- **Creation of highly saline Ca-Mg-Cl brines** through repeated drying/wetting cycles in operation
- Type 1 structures at **perforations with localised low porosity and permeability**, resulting in loss of injectivity
- Type 2 structures at **perforations within overall low permeability zones**, causing loss of injectivity to zone below
- Simple **warm water wash** would remove salt build-up, but **risk of unintended consequences** from change in chemistry
- **Focus shifted** from intervention **to management**

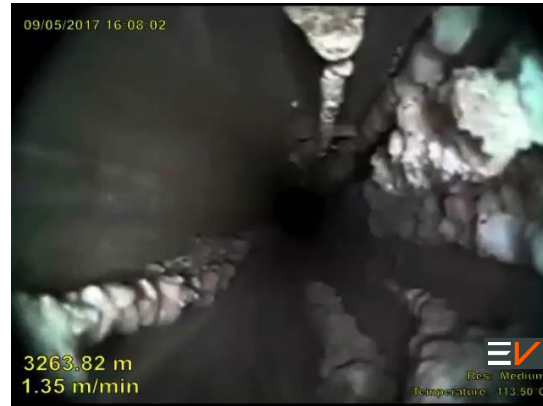
TYPE 2

ZONE 3 (DEADWOOD C)

Widespread precipitation  
Significant impact on wellbore ID  
Extensive travel along wellbore (50m)

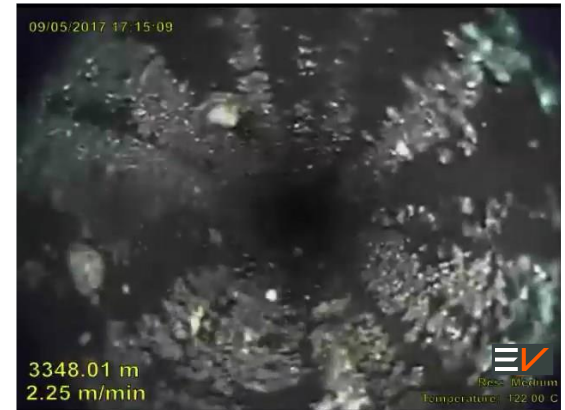
TYPE 3

WELL BOTTOM

Widespread precipitation  
Minimal impact on wellbore ID  
Limited to gas/liquid interface

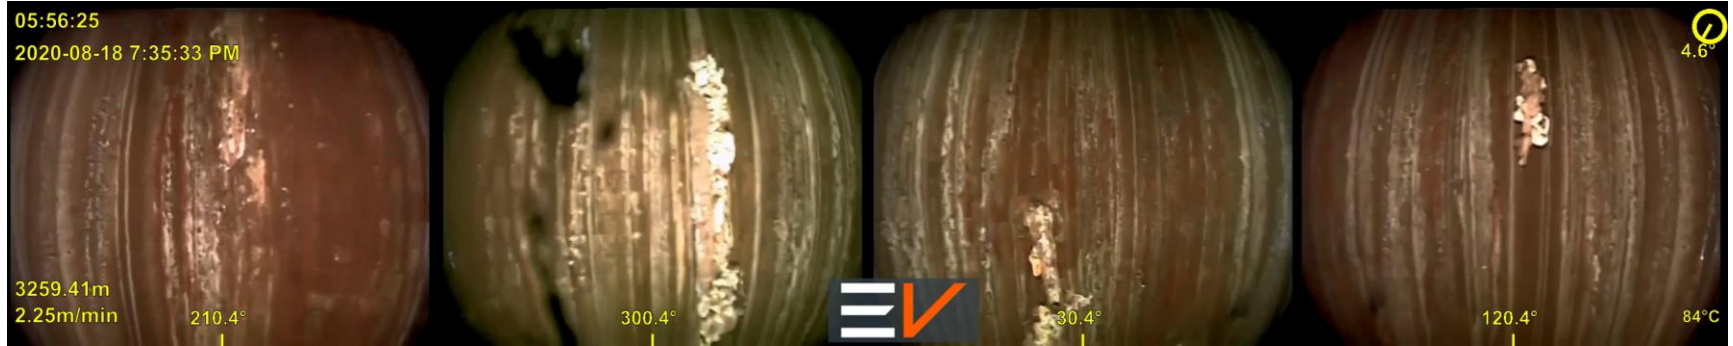
- Revealed more detailed images of solids structure
- Granular / porous texture confirmed at all zones
- 360° field of view allowed detailed imaging of every perforations in each zone

- No “Type 2” structures: Deadwood C wellbore clean
- Type 1 structures evident in all perforated zones
- Degree of precipitation variable across each zone

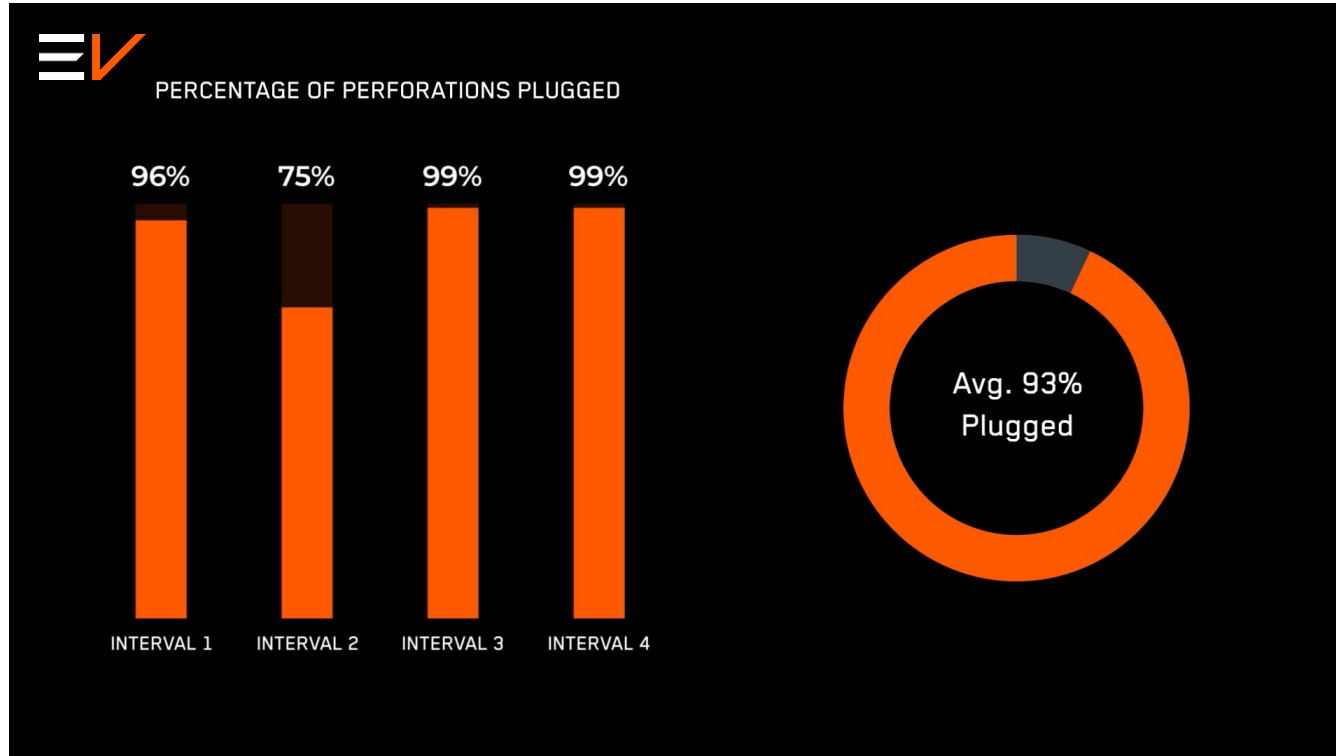
- Each perforation analysed for presence of solids
- Statistical database created for each perforation and zone
- Up to 99% of perforations in some zones affected
- Average of 93% of perforations affected by solids
