Learning from Experience: Completing a Subsea Dual ESP Well, second time round.

Solan Field, West of Shetland

Stewart McIntosh – Artificial Lift Solutions

Kevin Eddie – Harbour Energy

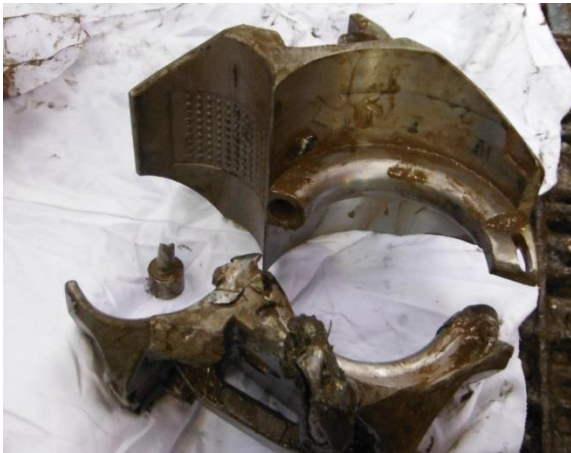
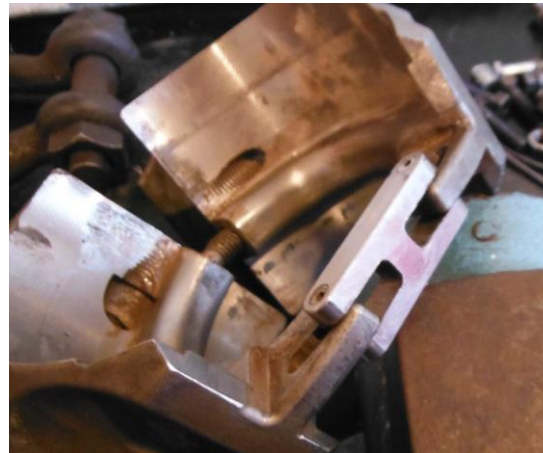
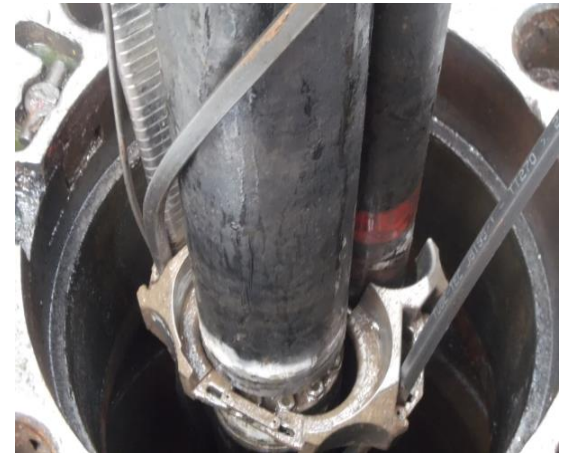
- The ESP wouldn't pass through the GE HXT (Helix)
 - 11 days spent trying
 - Testing Y-Tool on drill pipe, it rotated 60° through the Helix
- Detaching Pump Support Block Spear
- ESP Bypass Clamps failed
 - Clamp sheared and was riding against Y-Tool

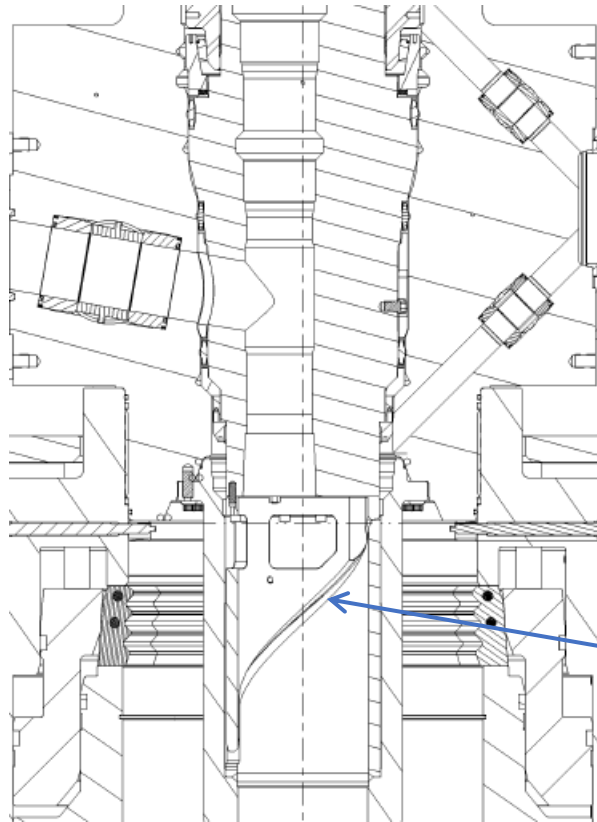
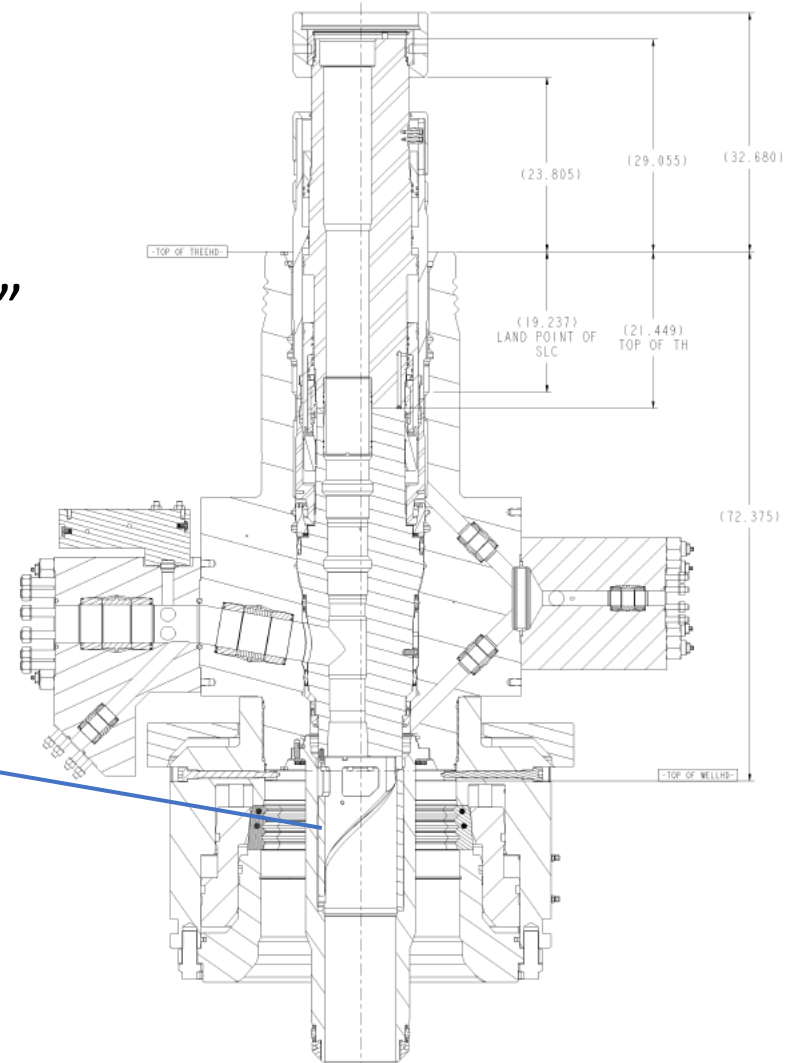
Helix profile
Tubing Hanger
orientation
9.760" ID with a
casing ID of 9.66"

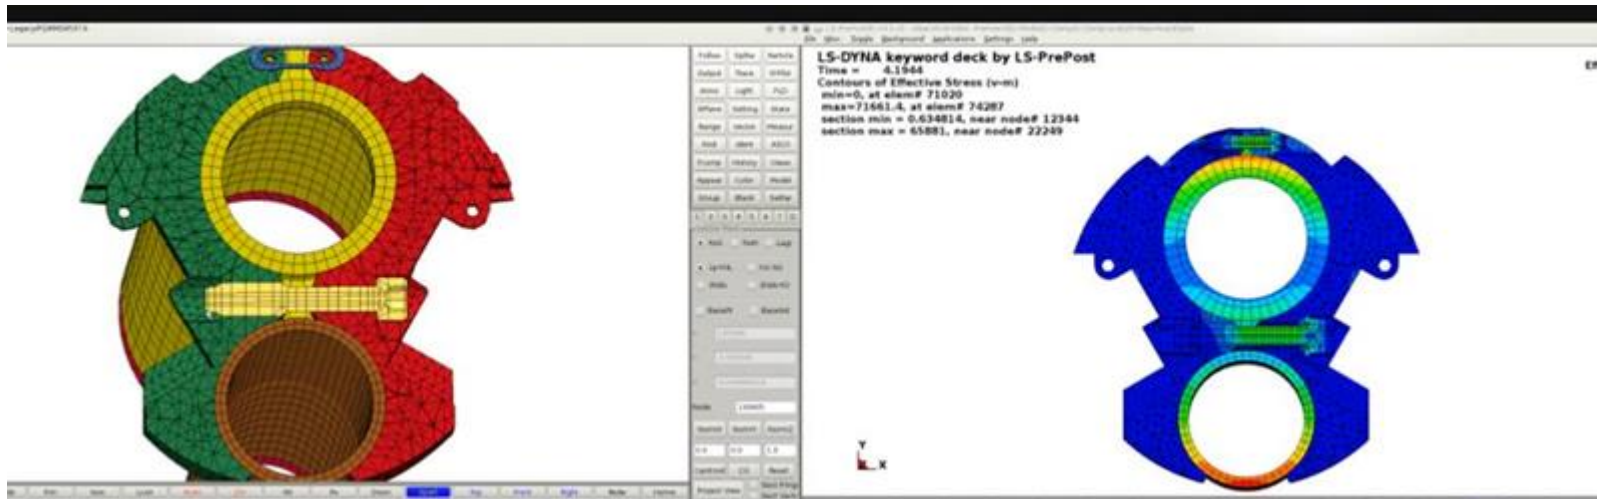
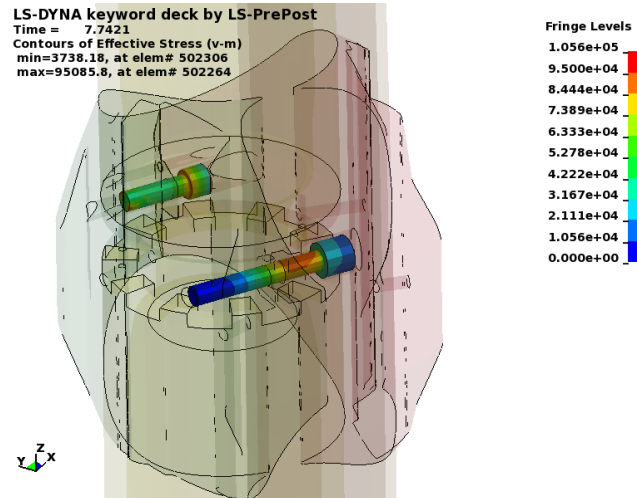
Bypass Clamp Design

- The Bypass Clamp redesign was a high priority due to issues faced previously
- RMSpumptools created a new design
- Robust two bolt clamp was created – no hinge.
- Reduced OD (9.563” to 9.504”)
- Nord-Lock Washers

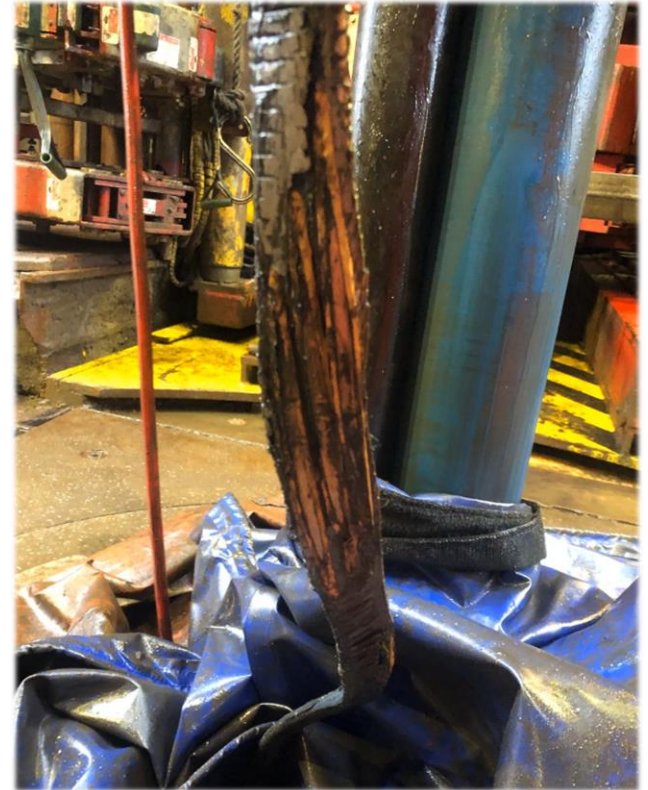
- There were some issues encountered...
 - Incident when a BPT joint was damaged, the ESP hung up at surface
 - Lost readings through the subsea umbilical. when the ESP was landed
 - Electrical readings were unable to be taken when landing
 - The MLE was destroyed by abrasion

- More provisions for electrical testing through Subsea umbilical had to be made to ensure integrity when landing
 - We ironed out a lot of this on Run 2
- Communication must be maintained at ALL times – this was the root cause of the BPT incident
- Base all MLE marking on actual measured lengths. Keep markings to a sensible minimum
- Bypass Tubing Lengths should be determined after the ESP design is finalised. Handling and ‘stick up’ should be planned
