# OPTIMISE PRODUCTION AND IMPROVE WELL ACCESSIBILITY WITH NOVEL REFORMED EXPANDABLE TECHNOLOGY

SPE Aberdeen - Well Decommissioning 2021 Tyler Whitney & Cherish Sims

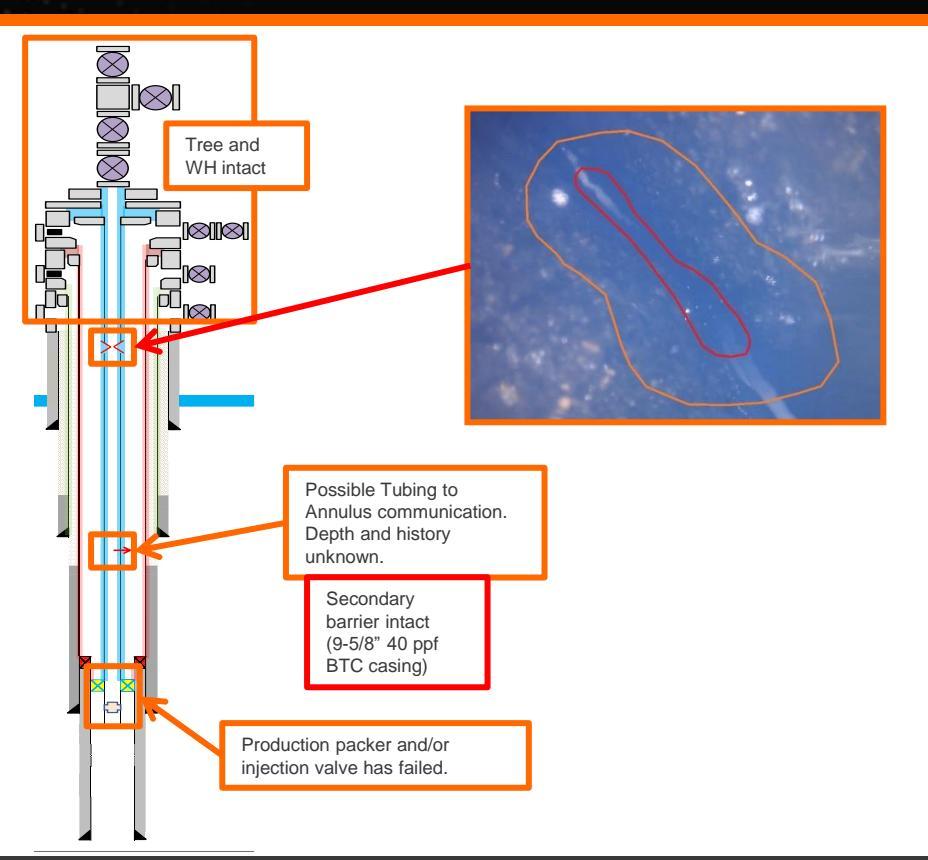
### Area of Concern

- 5-1/2" 17# K-55 LTC tubing
- Collapse began at 9m RKB, ~2m below ground level, and was of unknown length.
- Production packer and/or injection valve leak – could not access below collapse to determine leak path.
- Corrosion/erosion may have affected the tubing in this area
- Tubing was collapsed with effectively no gap, "pinched flat"

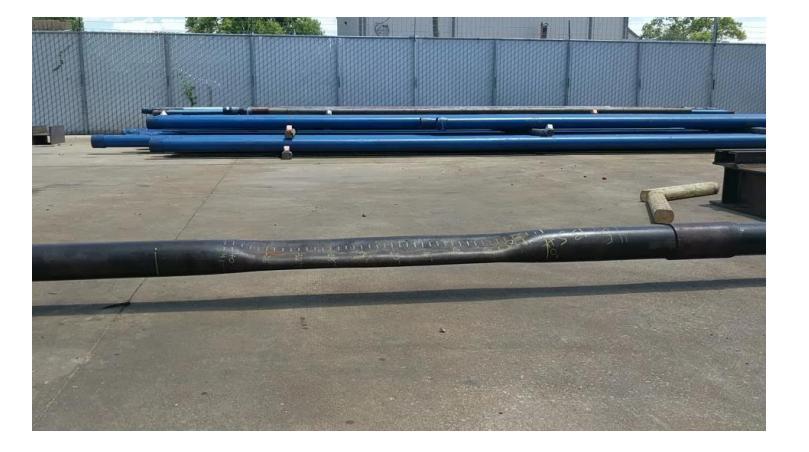
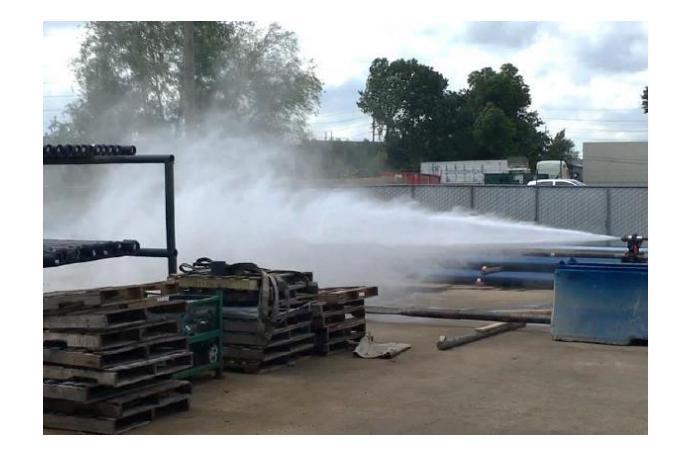
Crushed Pipe Prior to full scale test

Crushed Pipe partially reformed after first stroke

Fully Reformed after second stroke
