Enhancing Small Bore Tubing (SBT) Integrity

Minimising Hydrocarbon Leaks & Unplanned Shutdowns

Connor Munroe | SPE Topsides UK 2025 | The Chester Hotel | 12th November

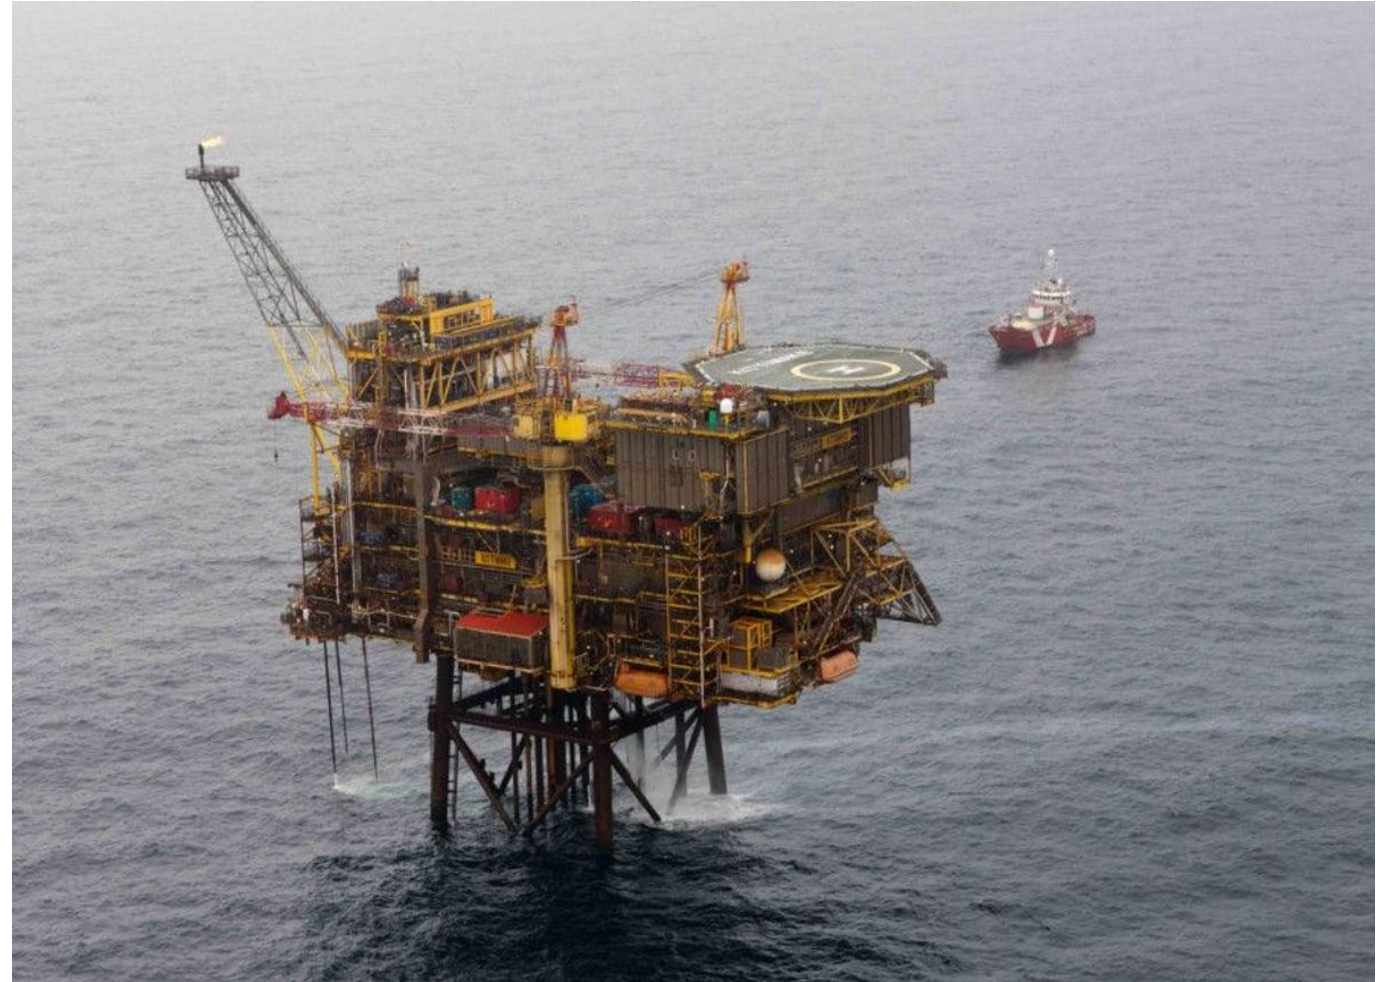
North Sea Platform (2015)

- Hydrocarbon gas release estimated
~2000kg over 84-minute period
- Originated from small bore instrumentation
tubing near gas compressor.
- HSE issued safety notice to operator for
failing to prevent leak.

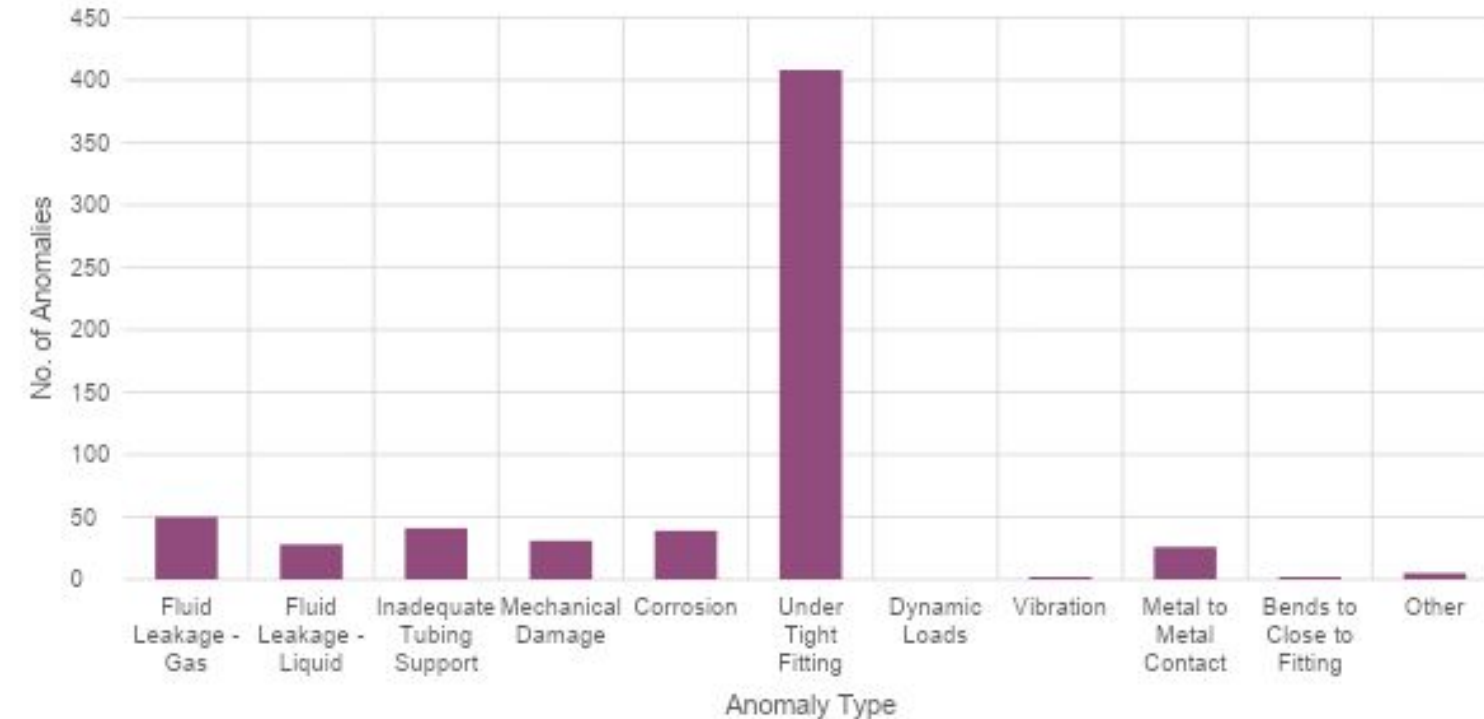
ROSEN assessment of 331 inspection reports for one platform:

- 632 individual anomalies reported during **SKN Offshore** SBT Inspection Campaigns.
- Primarily under tight fittings.
- Approximately 12% of anomalies were associated with a leak (either gas or liquid).

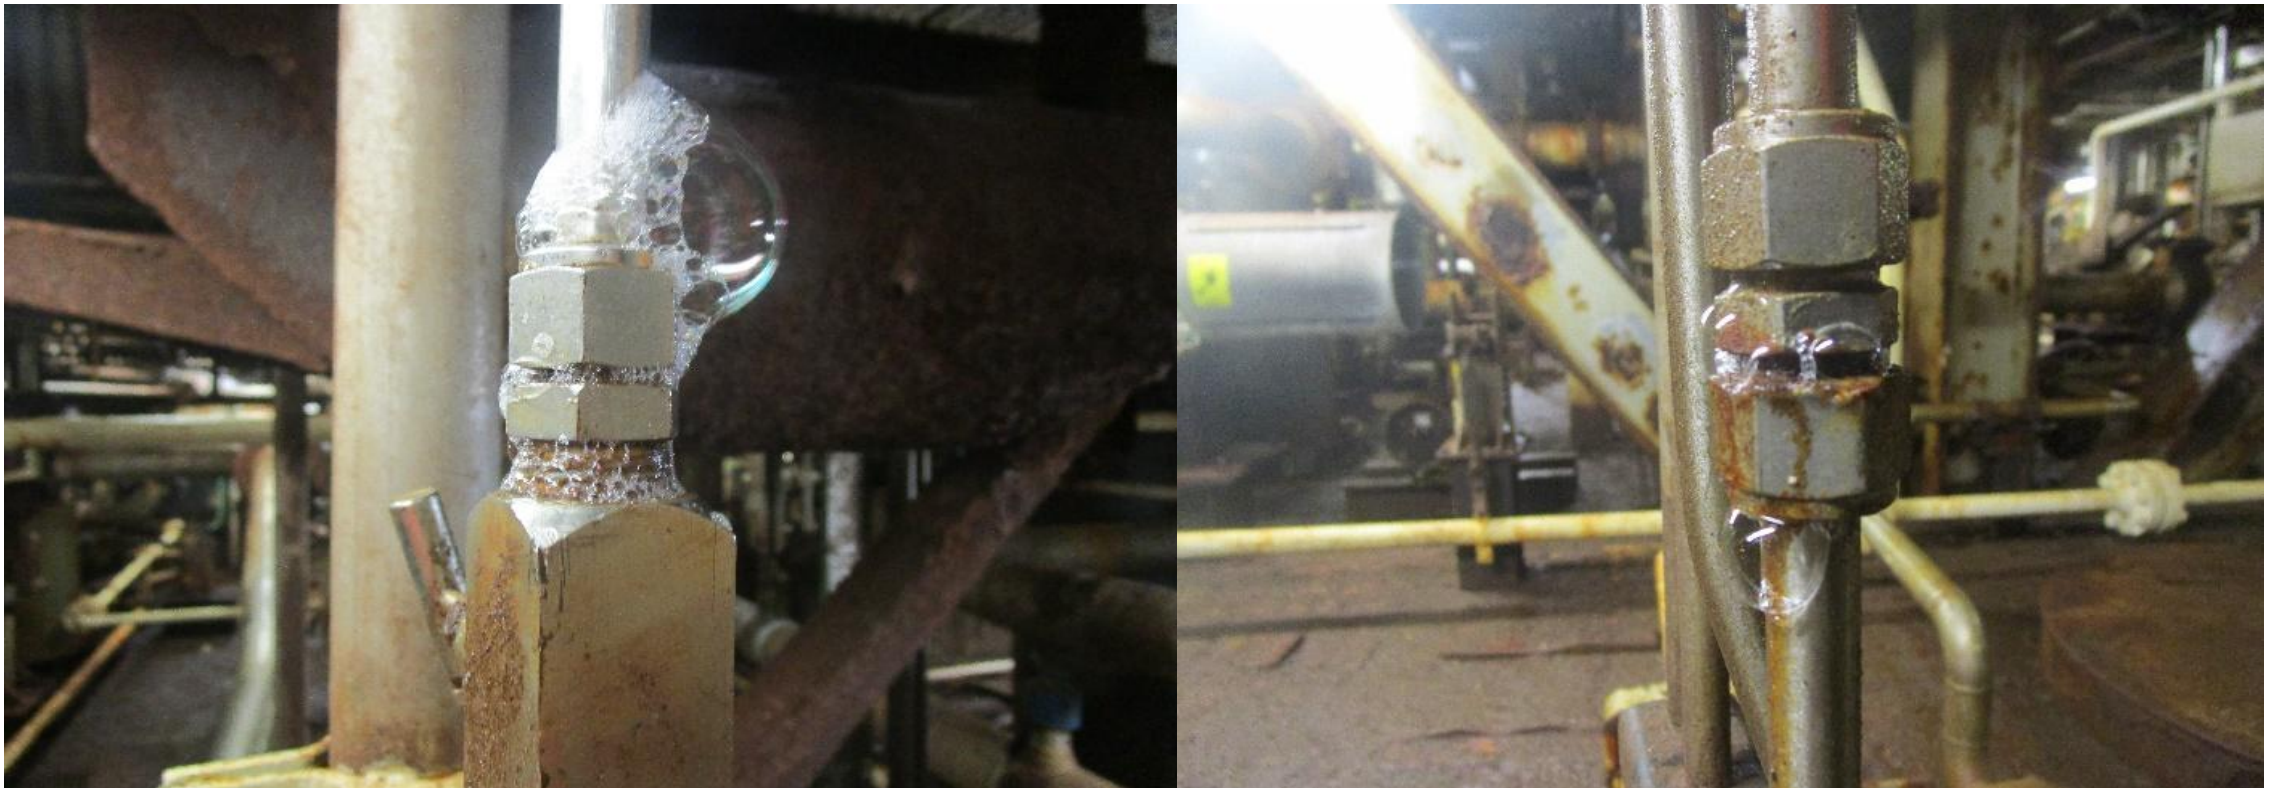
Hydrocarbon Gas Leak

- Both leaks are from Gas Lift System
- ½-inch tubing will contain hydrocarbon gas at lift pressure (100+barg).

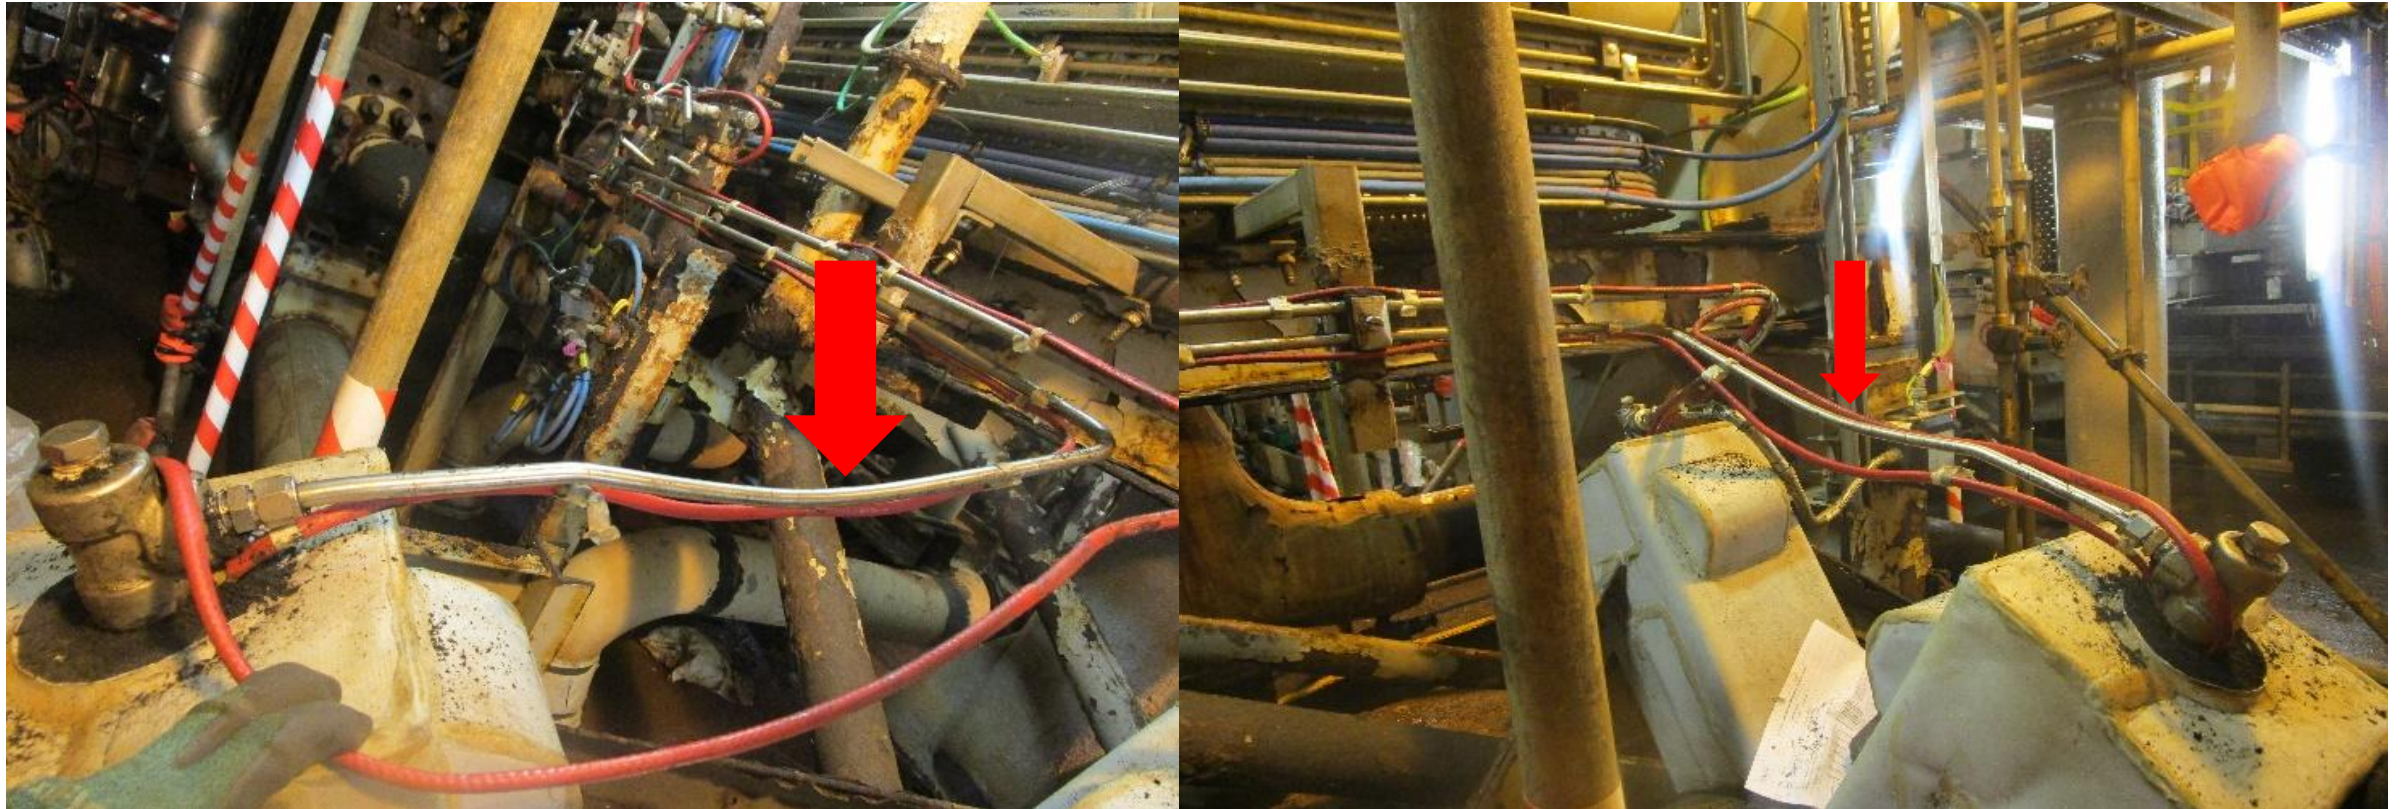
Example Mechanical Damage

- Inspector noted that he strongly suspects the tubing has been stood on.
- This tubing is connected to the 3rd stage injection compressor and could see pressures up to 240barg

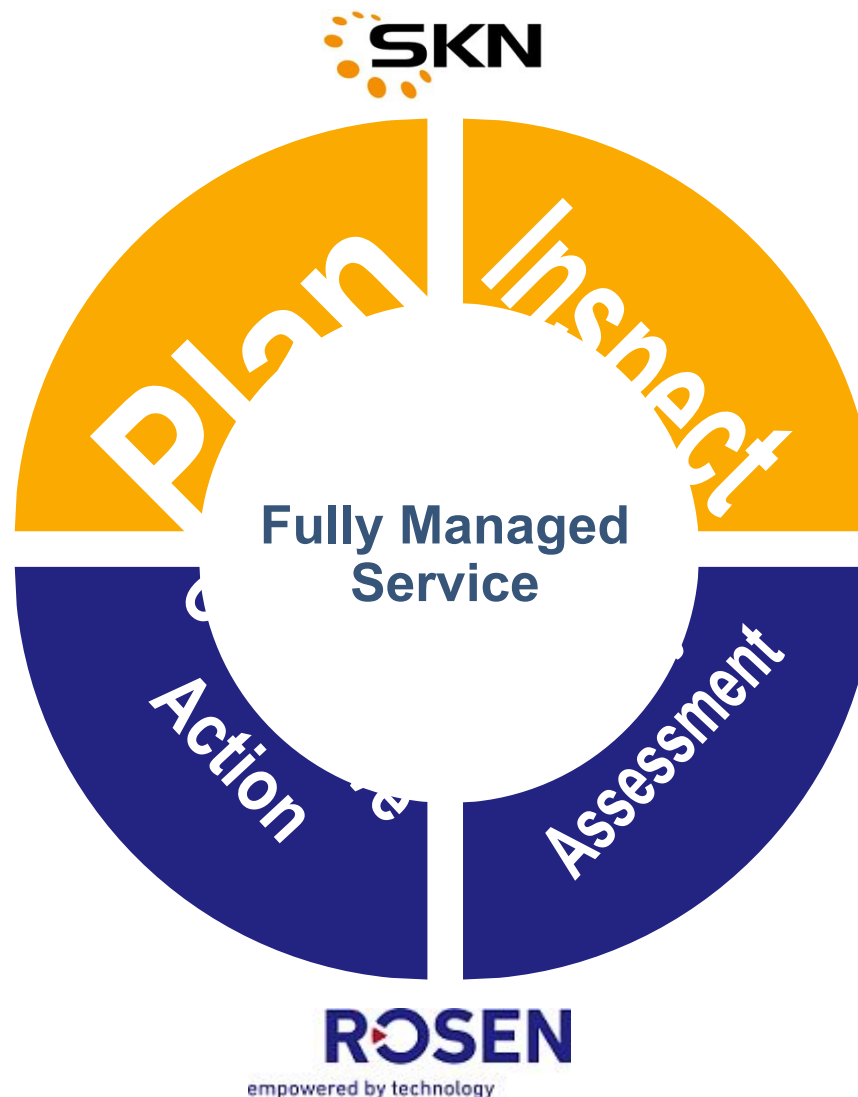
Offshore Inspection

- Carry out inspection
- Raise work orders
- Anomaly management

Onshore Integrity Assessment

- Review SBT inspection reports and provide engineering assessments aligned with client strategies and Energy Institute guidelines
- Prioritise anomalies using the client's 5x5 risk matrix.
- Technical support with SBT Integrity related issues.

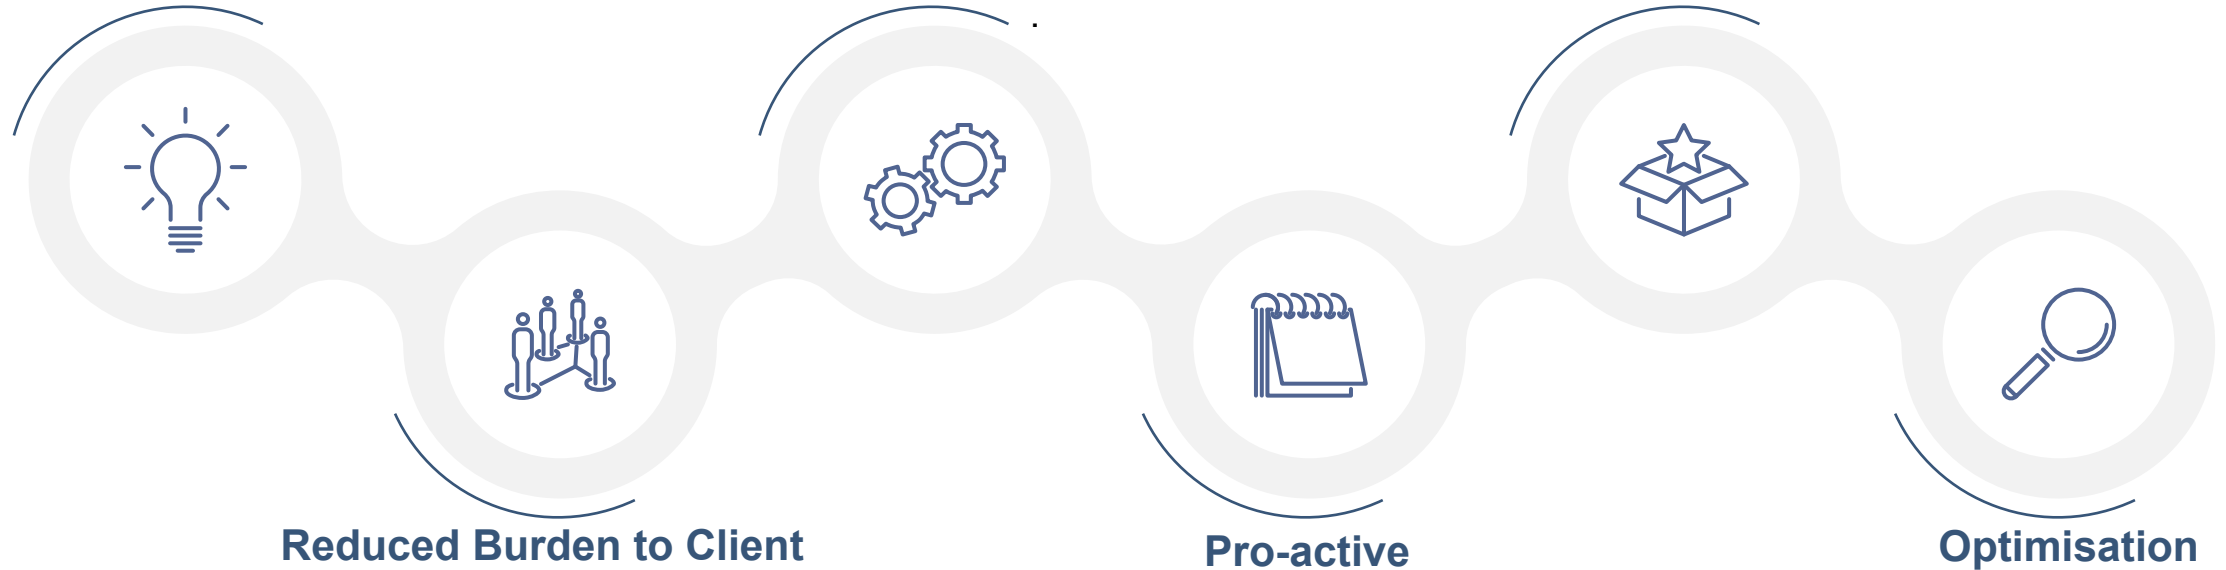
- This **fully managed** approach to SBT management streamlines the process and ultimately reduces burden for the operator.
- Promotes proactive repairs during campaigns when permitted and optimises prioritisation of corrective work based on the EI guidelines.
