## BEATRICE FIELD, INNER MORAY FIRTH

A Case Study In The Management Of Well Integrity From  
CoP Through To Well Abandonment

Richard Conway

7<sup>th</sup> June 2023

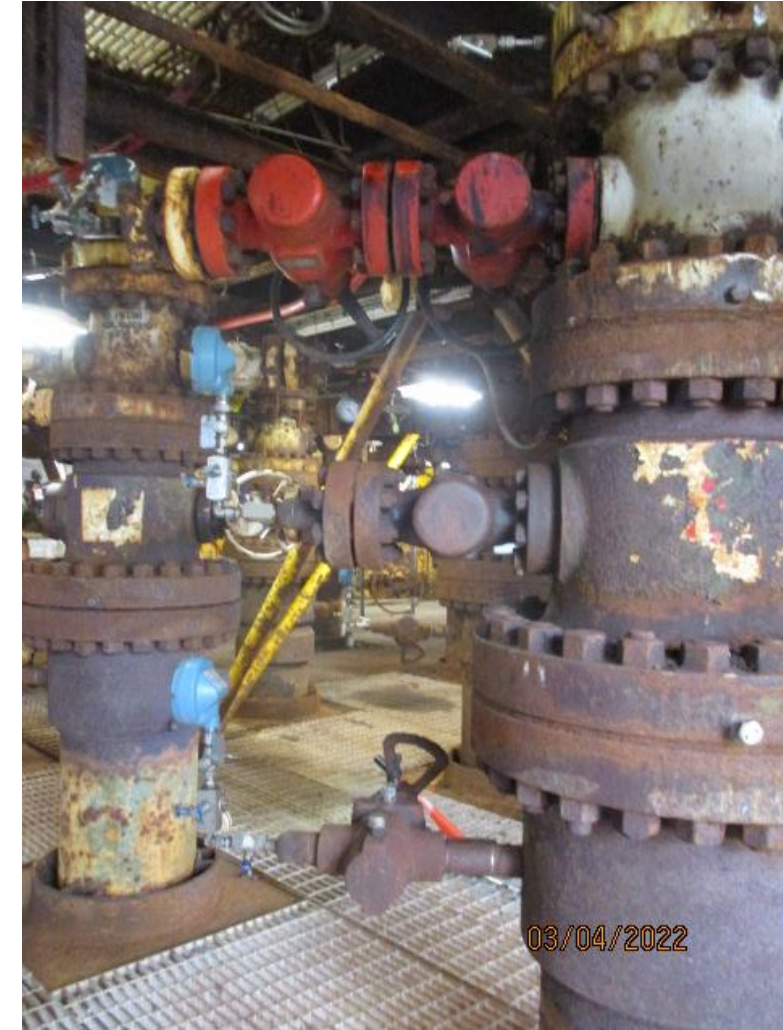
- ▶ 6 Monthly WVR: March
  - Function all valves
  - Inflow test DHSV (where installed)
  - Pressure Test / Inflow Test Control Lines
  - Inflow test plugs (1 hour)
  - Wireless gauge verification
  - KP4 survey (external condition inspection)
- ▶ 12 Monthly WVR: September – as above plus:
  - Inflow / pressure test tree and annulus valves
  - Sting wellhead voids
- ▶ Biennial Annulus Top-Up & Test
  - Each annulus topped up to surface with inhibited water
  - Pressure test to Operational MAASP

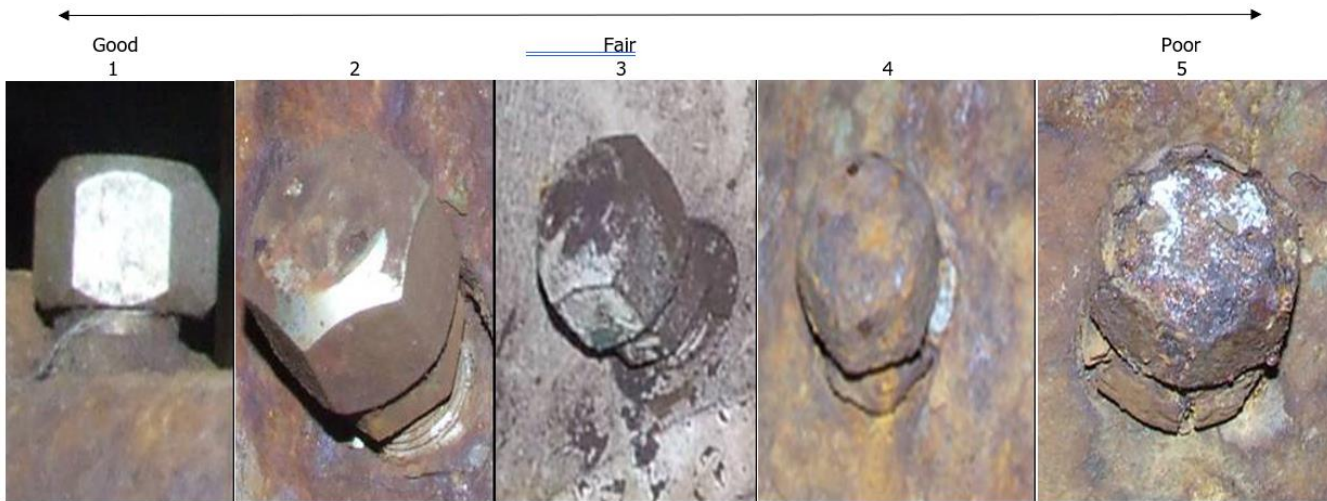
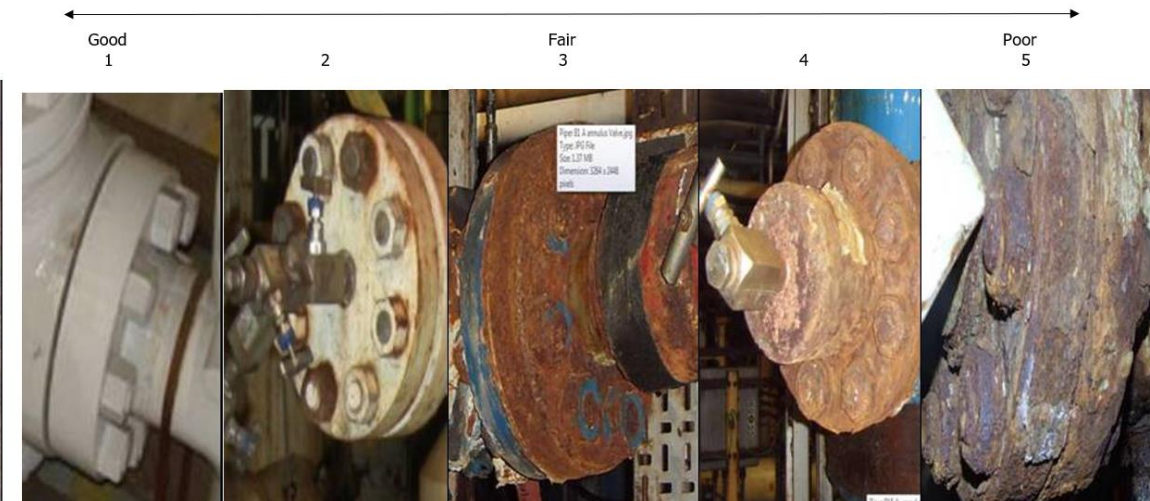
- ▶ We are required by HSE / BEIS to conduct a KP4 inspection every campaign due to NNA status, as a means to monitor any ongoing degradation (other platforms every two years)
- ▶ The crews score each component against a set of reference photos
- ▶ In addition, on each campaign a set of digital photos of each component are taken as a record
- ▶ Scoring and photo references are recorded in a spreadsheet (one worksheet per well)

REPSOL SINOPEC		Wellhead and Tree Inspection Form			
		TLM-WEL-121			
Platform	Arbroath	Well No.	T-02	Date:	16/12/2020
WH Manufacturer	McEvoy/Cameron	Tree Manufacturer		Technician	
<b>IMPORTANT:</b> Refer to WEL-PRO-TLM-073 when using this Worksheet					
<span style="background-color: #90EE90; padding: 2px;">Good</span> <span style="background-color: #FFD700; padding: 2px;">Moderate</span> <span style="background-color: #FF0000; padding: 2px;">Bad</span>					
TREE CONDITION	Tree Size	4 1/16"	Pressure Rating	5000psi	
SWAB	3	7			
UMV	4	2			Weeps ?
LMV	3	9			
KWV	3	3			
FWV	4	5			
Test/grease fittings	3	7	16		
Needle Valves	3	3	4		
Gauge	Rating				Calib Cert
Impulse Line to Gauge					Weeps ?
Tree Cap	4	1	8		Weeps ?
Remarks					
FWV actuator has been removed

- ▶ KP4 inspections are conducted every six months. Any component in poor condition is subject to a secondary inspection by FIE and may result in replacement or FM

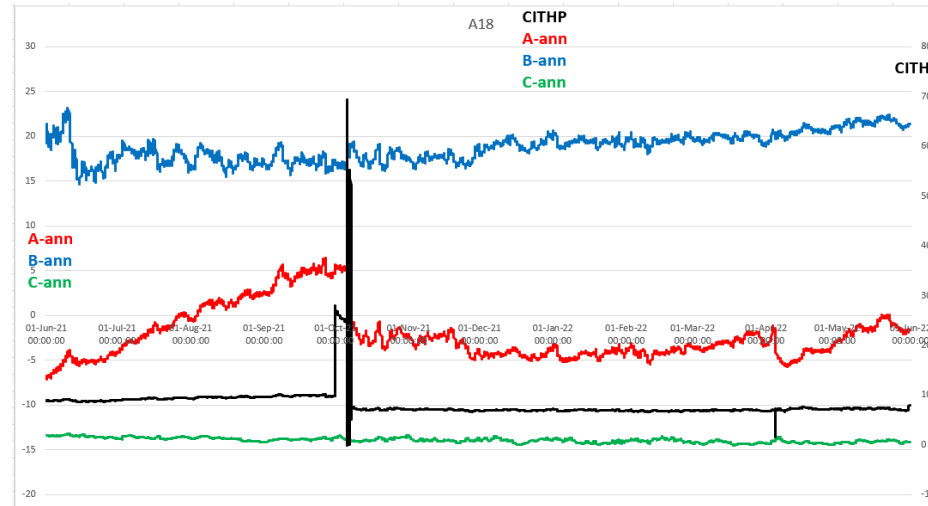
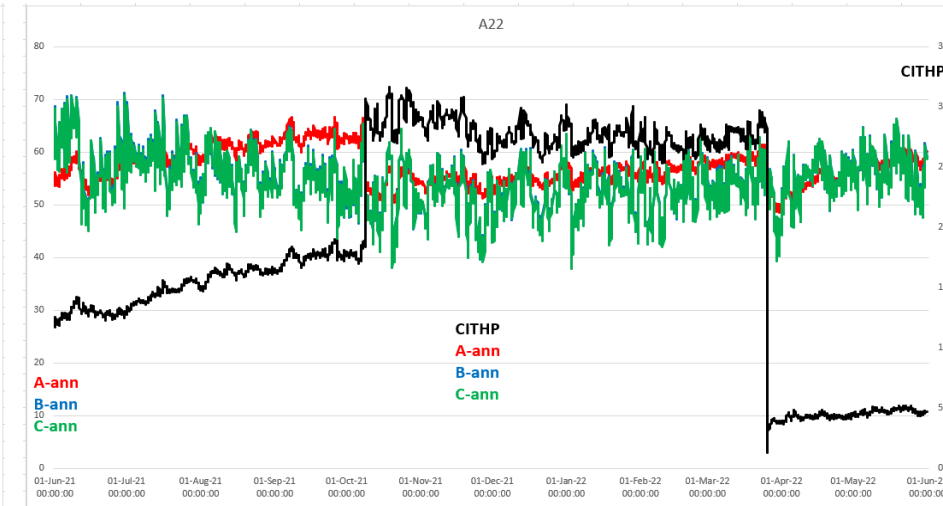
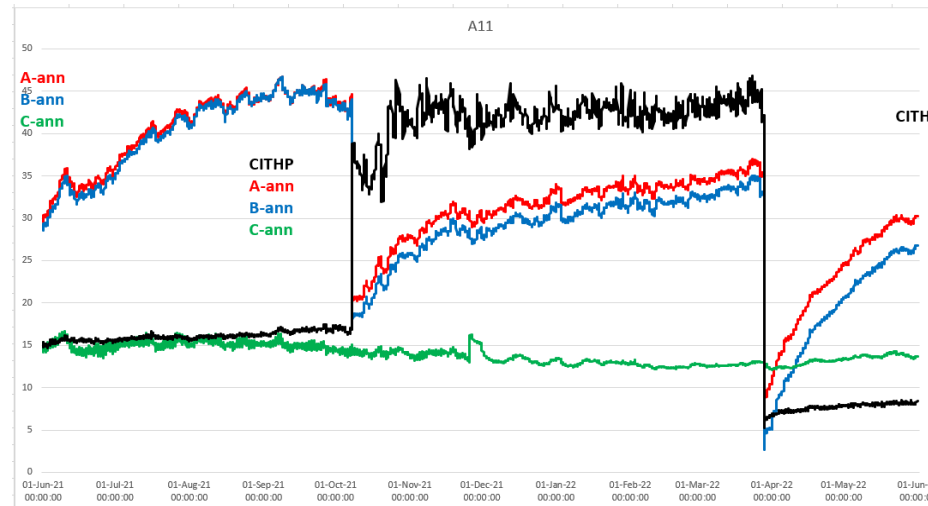
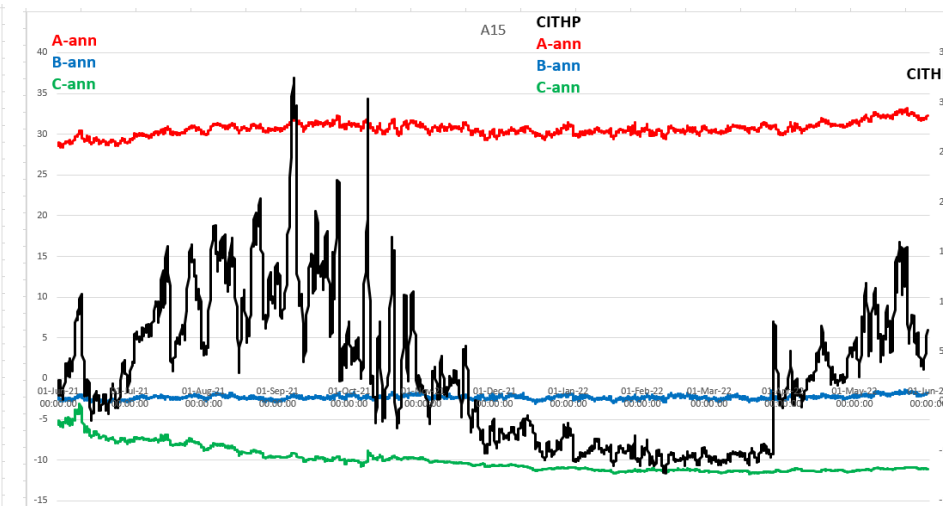
# Annulus Reviews

- ▶ Detailed annulus monitoring program in place long before NNA
- ▶ Annulus behaviour is well understood
- ▶ No threat of MAASP excursions during winter unmanned period (end of September to start of March)
- ▶ No reactive annulus management to date

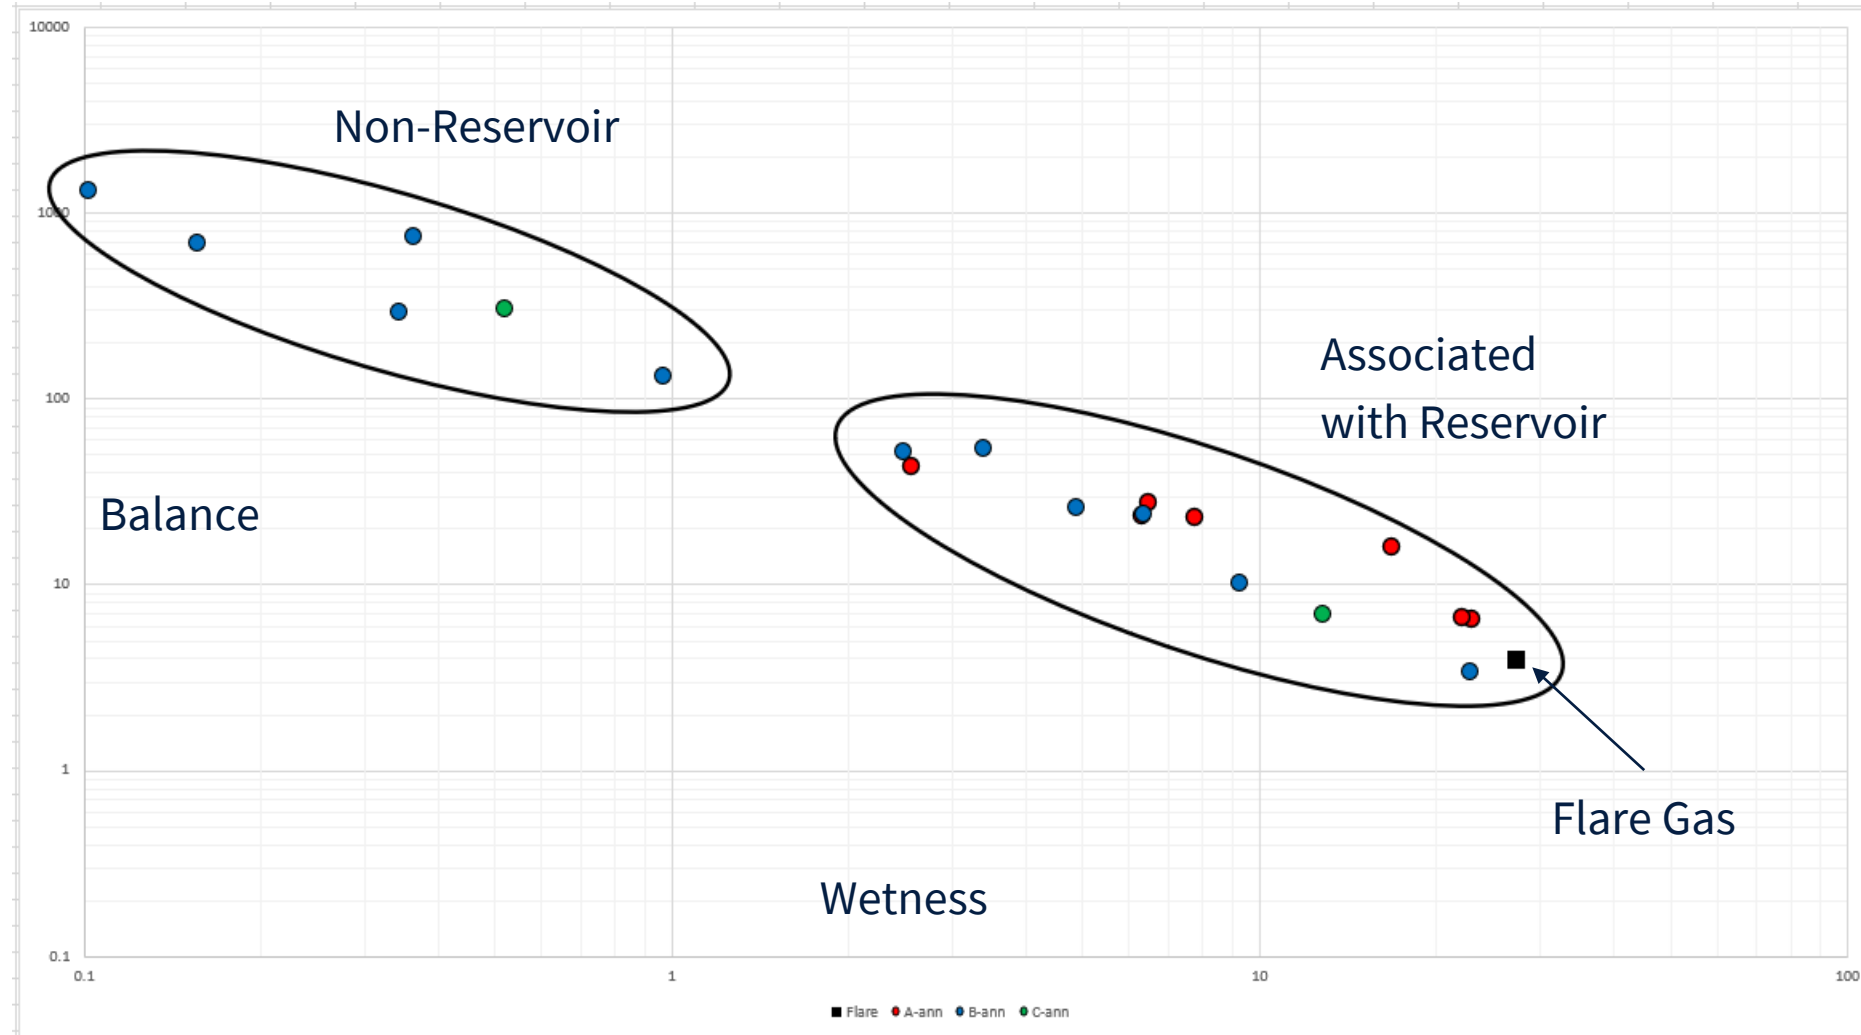
# Gas Ratio Analysis

▶ Haworth, Sellens & Whittaker: 1985

▶ Key to markers:

- Red – A-ann
- Blue – B-ann
- Green – C-ann
- Black – Flare Gas

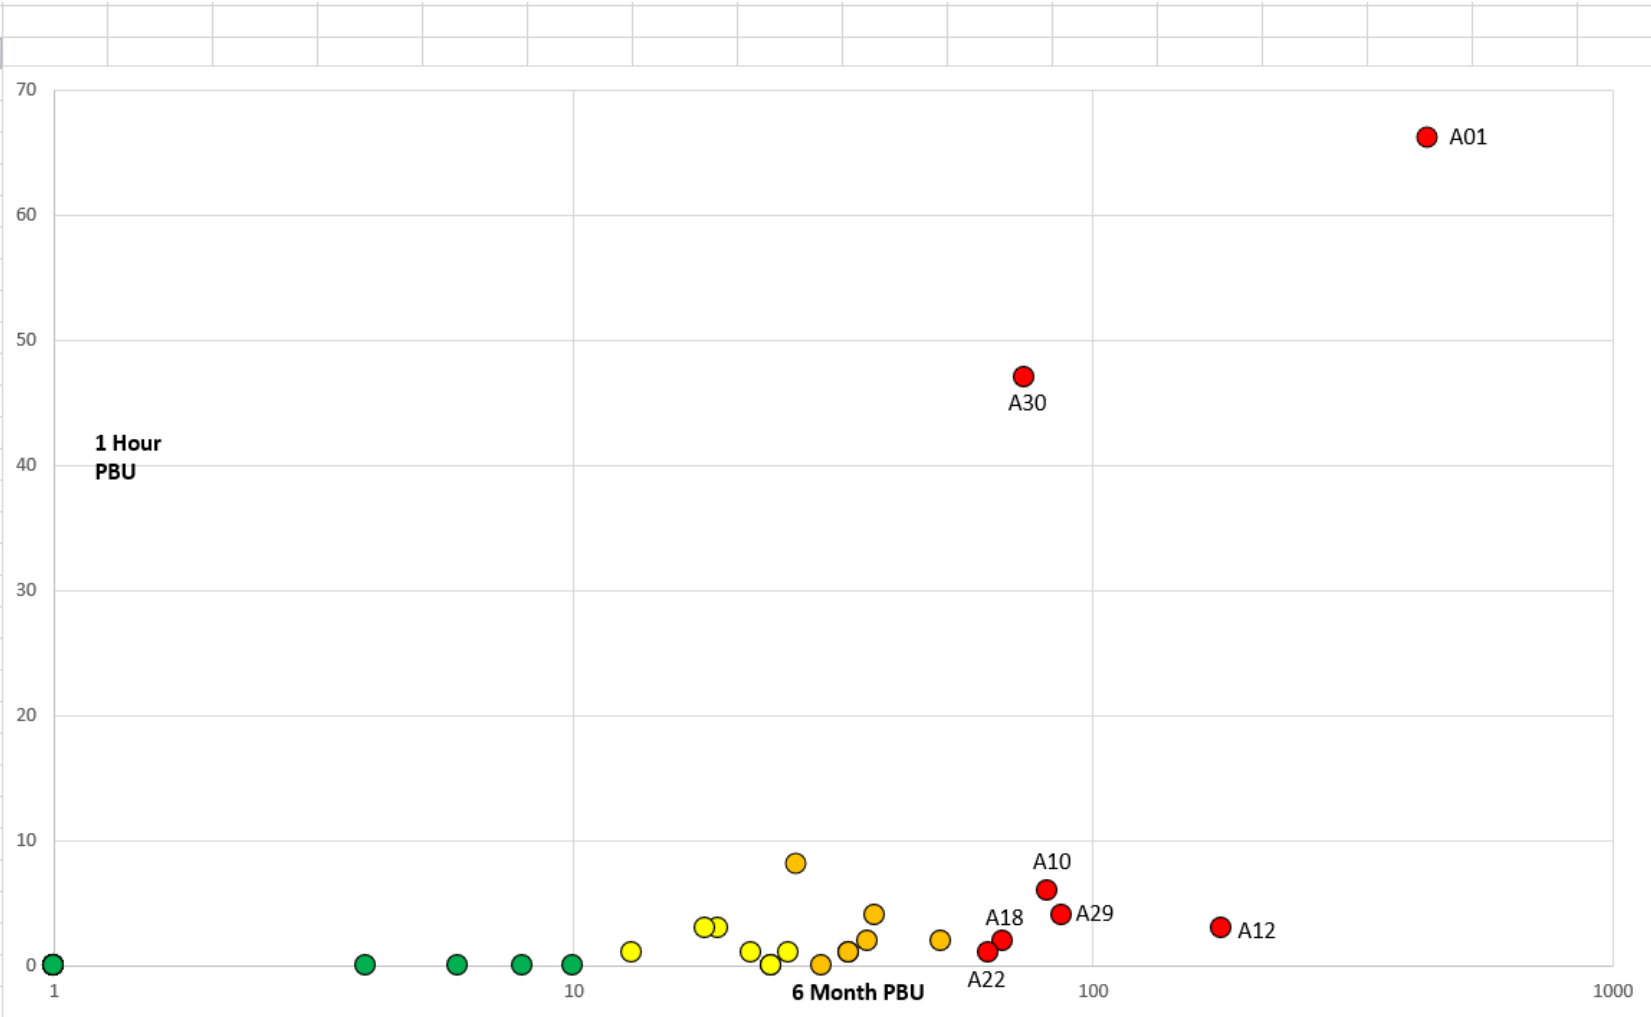
# Plug Evaluation

Wells divided into four categories based on leak rate characteristics

- ▶ Cat.1 – minimal pressure as found, no PBU
- ▶ Cat.2 – low pressure as found, definite PBU
- ▶ Cat.3 higher as-found pressure no PBU
- ▶ Cat.4 higher as-found pressure

- ▶ A number of plugs have been identified as passing based on as-found CITHP and 1-hour inflow tests. The plugs have been categorised by leak rate
- ▶ A plug remediation campaign is currently in progress (Q2, 2023). The objectives are to restore reservoir isolation on a number of key wells until final well abandonment operations are completed in Q4, 2026

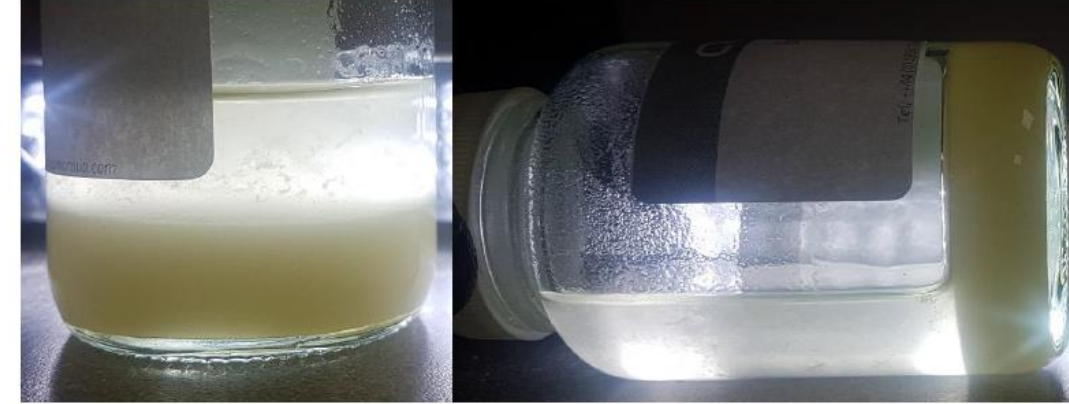
Cured gel, upright & tilted

- ▶ Eight wells identified for plug remediation through intervention
- ▶ Two technologies have been selected
  - Alloy / Thermite Plugs deployed on wireline
  - Gel plug spotted on depth using CoilHose with brine above
- ▶ Crew and equipment mobilised mid May for a 56 day campaign
- ▶ Day-time operations only, daily transfer by boat
- ▶ Well abandonment to commence Q2, 2024 with a planned completion of Q4, 2026 (from a jack-up)
- ▶ To avoid potential complications to abandonment, Alloy / Thermite plugs will only be run in wells where sufficient depth can be achieved

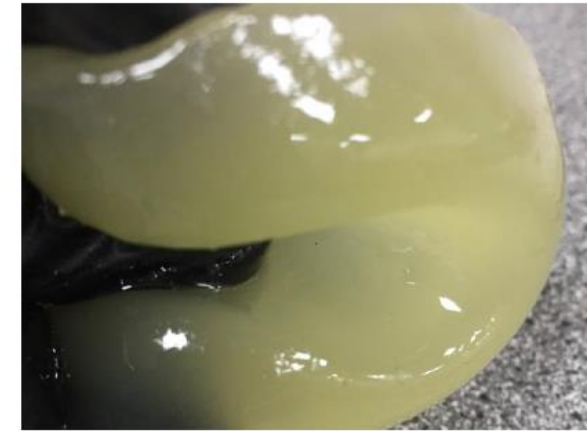
Plug removed from jar and deformed by hand
