Overcoming the Challenges of CCUS: Insights from Case Studies on Materials and Corrosion

Mark McLeod – OGC Energy

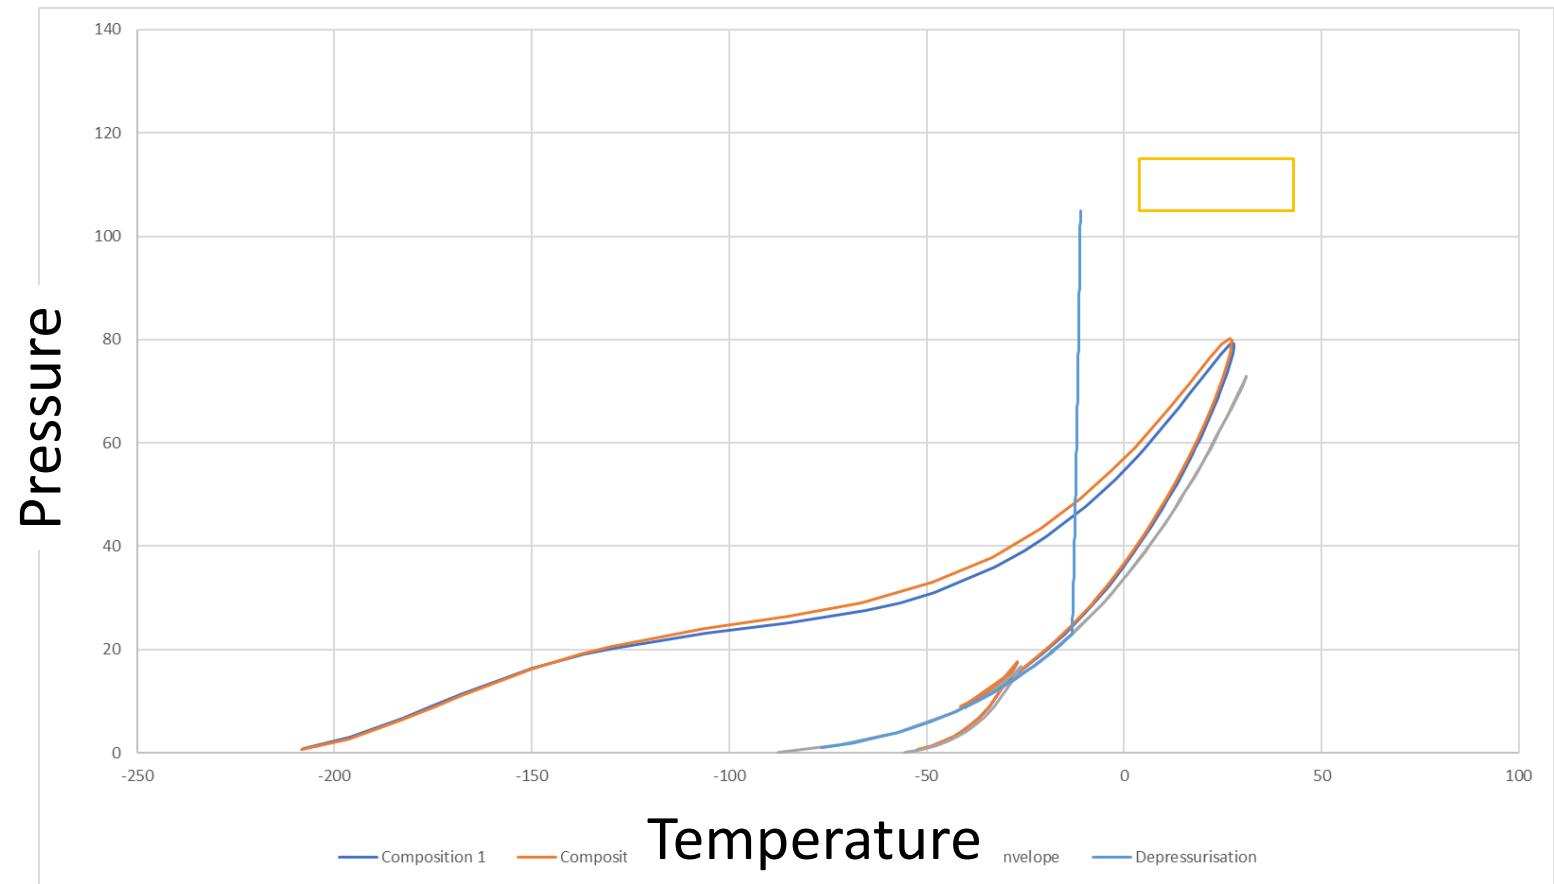
Proposed depressurisation curve would inflict multiphase flow on pipeline, potentially increasing the risk of corrosion.
