# SPE - Presentation

**Sub-Sea Wellhead Recovery - Back to the Future - Doing More with Legacy Equipment**

Weatherford UK – ISDT Product Line

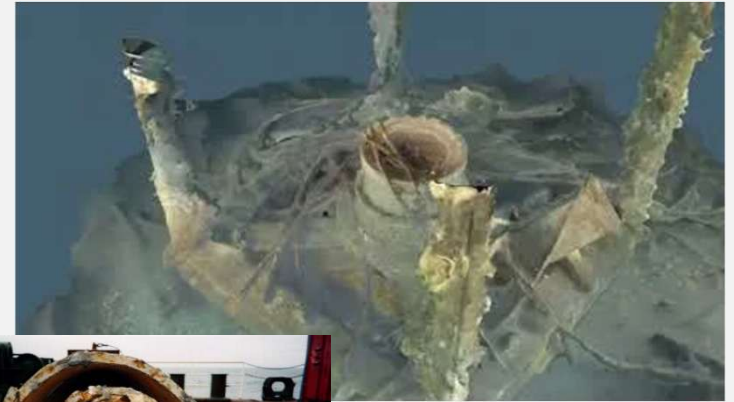
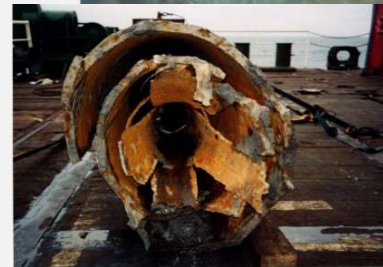
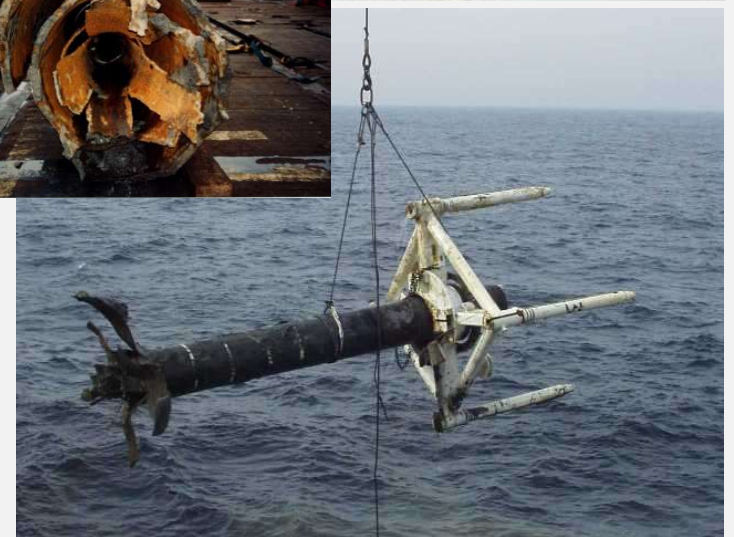
## The Subsea Wellhead: The Past.

- Around the late 60's to 70's to 80's to 90's. – High Exploration Activity
- Commonly recovered with rig – on location – End of Drilling Phase
- Weight set wellhead systems. 18 ¾” and 21 ¼” Two Stack etc
- PGB installed – TGB commonly not used.
- Explosive Option – Often Primary and Mechanical Option secondary
- Earlier designs had centralizing ribs on 18 ¾” Wellhead Extension

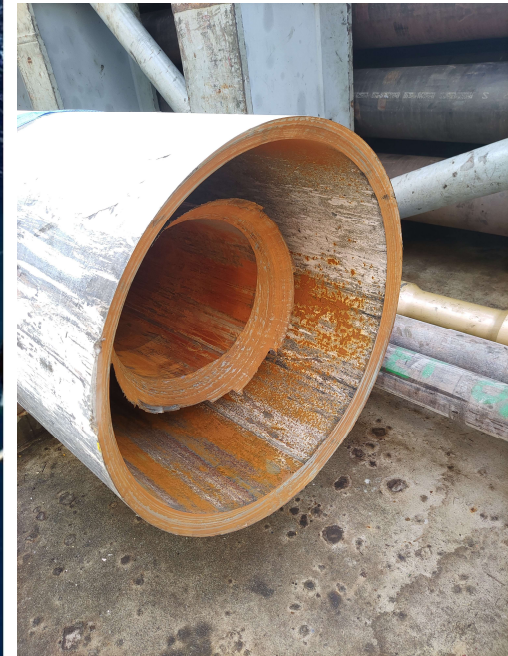
- Cement Excess on Conductor & Seabed
- Internal Restriction in Wellhead Bores
- Wellhead Ribs
- Multi String Cutting
- Short HP Housing Wellhead Extension
- Reduced Wellhead ID's
- TITUS Pipe

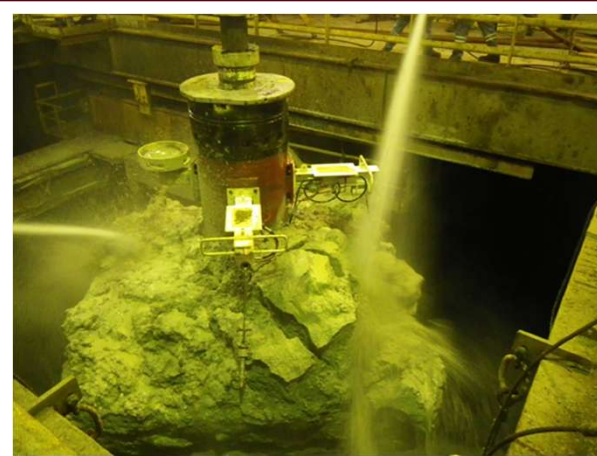
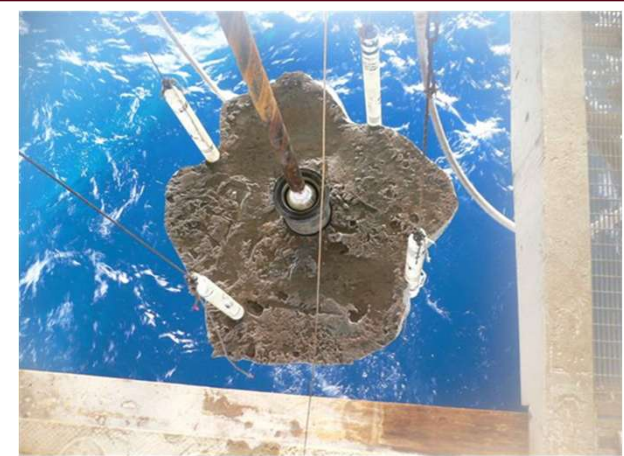
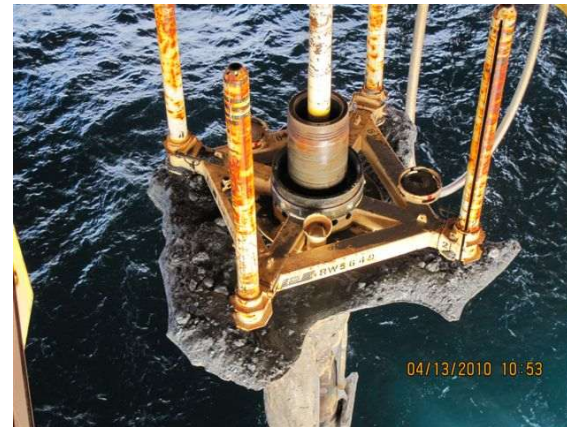
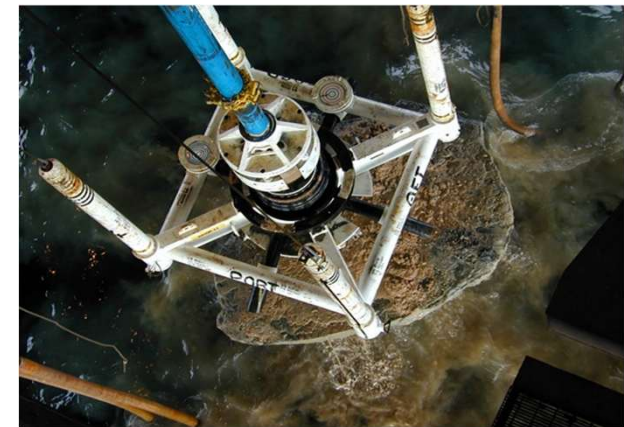
- **Cement Excess on Conductor & Seabed**
- Internal Restriction in Wellhead Bores
- Wellhead Ribs
- Multi String Cutting
- Short HP Housing Wellhead Extension
- Reduced Wellhead ID's
- TITUS Pipe

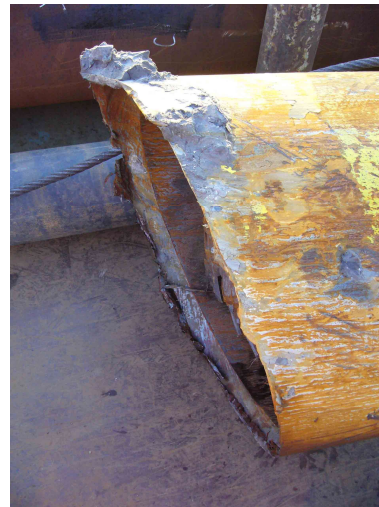
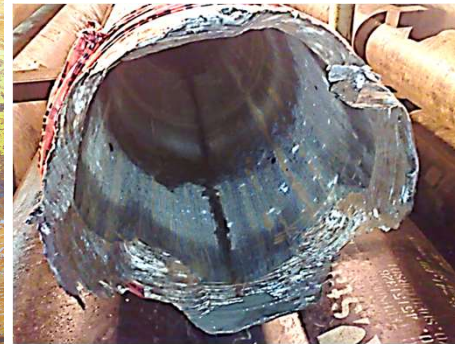
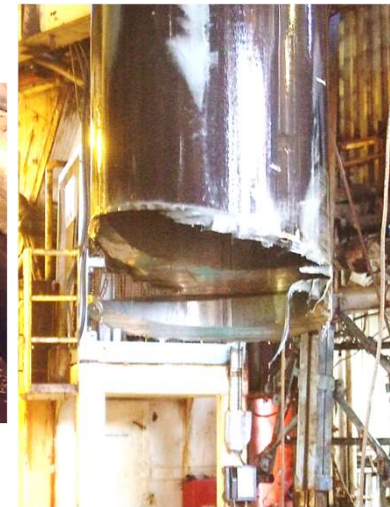
- **Cement Excess on Conductor & Seabed**
- **Internal Restriction in Wellhead Bores**
- Wellhead Ribs
- Multi String Cutting
- Short HP Housing Wellhead Extension
- Reduced Wellhead ID's
- TITUS Pipe

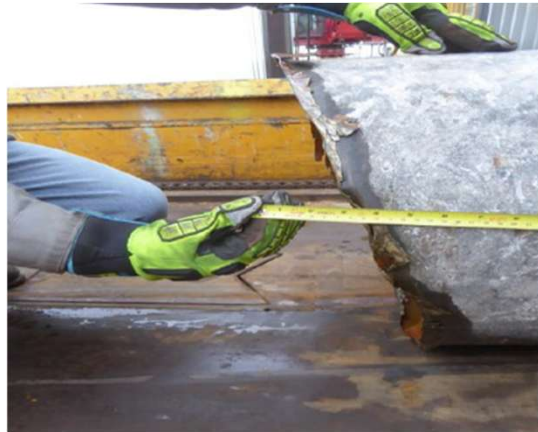
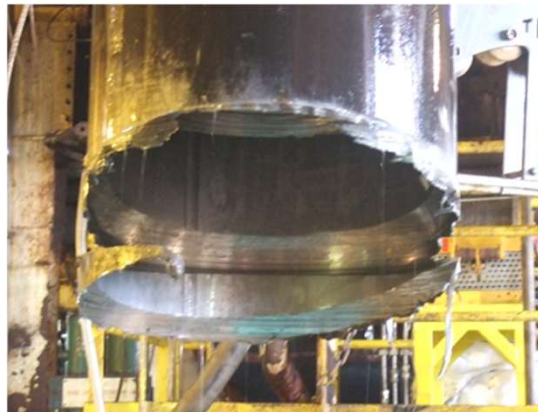
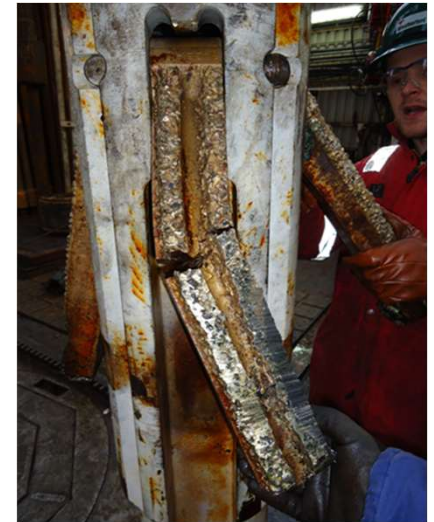
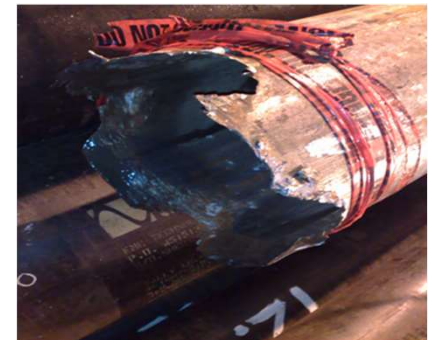
## Sub-Sea Wellhead Recovery - Consequences

- Unable to pull wellheads:
- Cement bonding
- Aborted Cuts
- Excessive Time for the Cutting Scope
- 18 ¾" Wellhead Strip Out
- Broken BHA Components
- Infringement – 10' BSB Guidelines

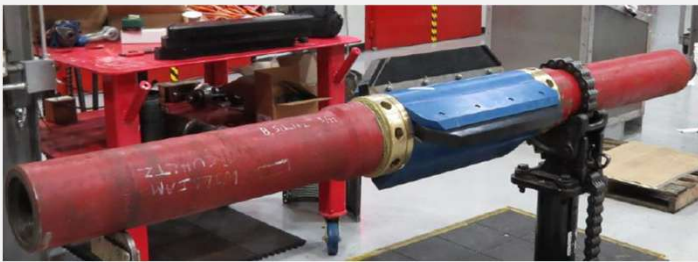
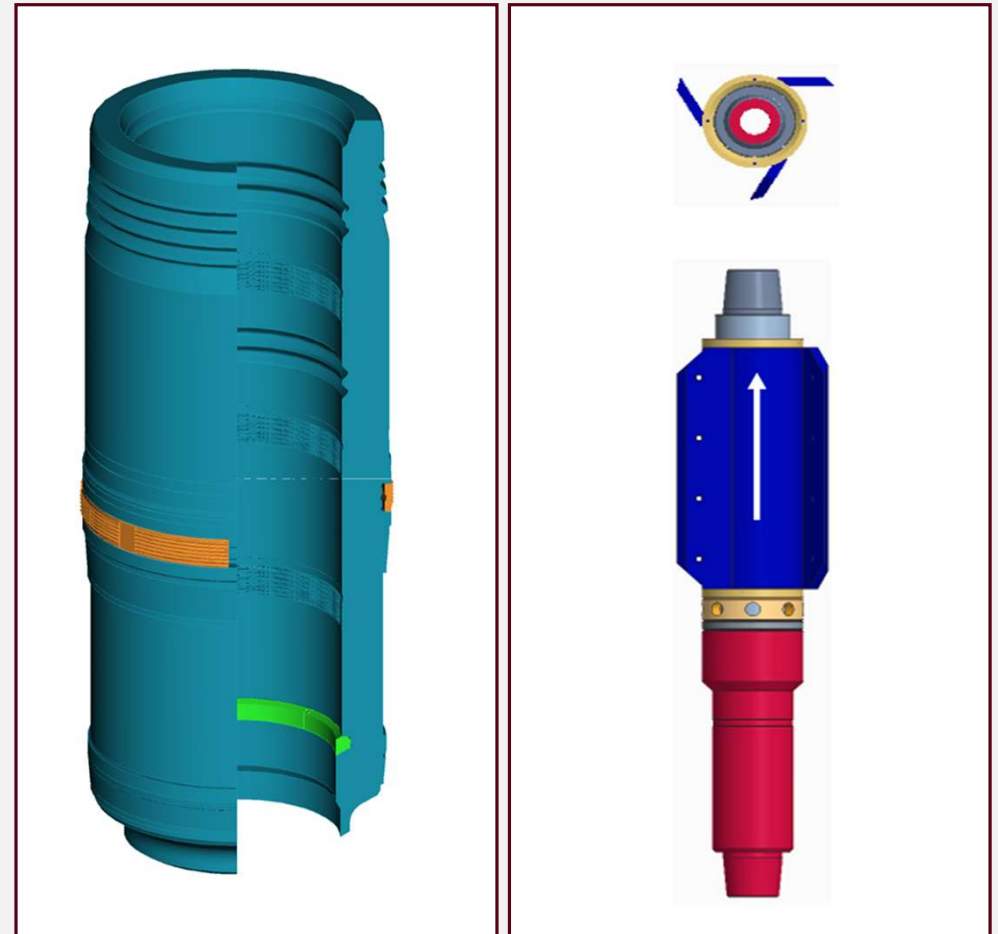
## Stabilisation

- Essential to the success of a casing cut.
- Flexible Blades allow the Stabilizer to collapse & pass wellhead Muti Load Shoulder with ID of 19.625”
- Blades re-expand to its original diameter
- Reduce vibrations and provide stabilization to the BHA

Expandable Stabiliser to enter  
reduced ID's and expand back to  
Surface Casing ID.

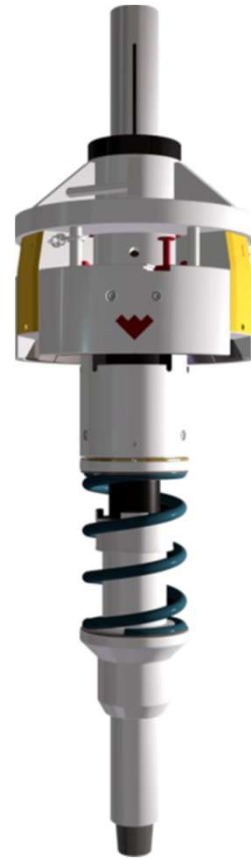
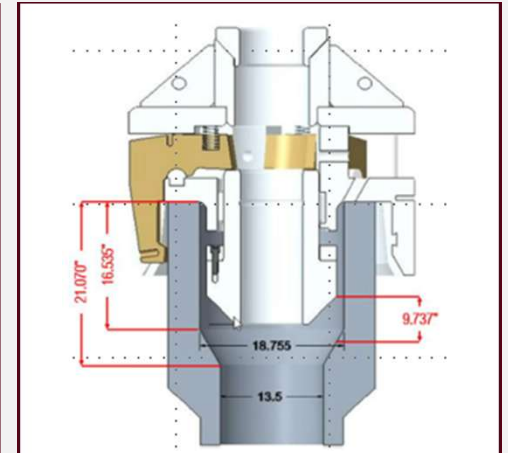
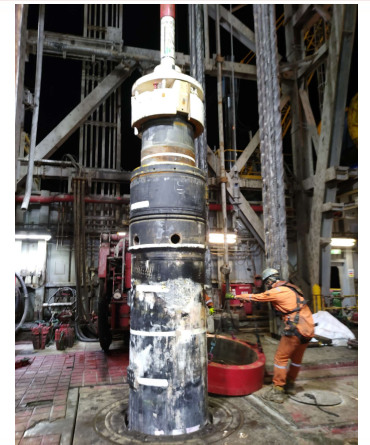
## External Latch

- Can accommodate tension or compression cuts – by simple BHA reconfiguration.
- De-risk wellhead strip out from 30” x 36” LPWHH
- Increased centralization in wellhead bore.
- Enhanced swarf dispersal

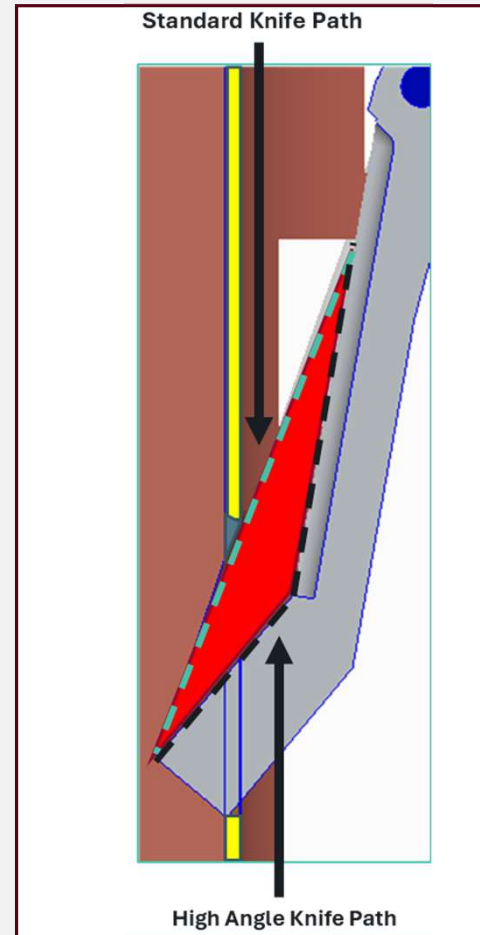
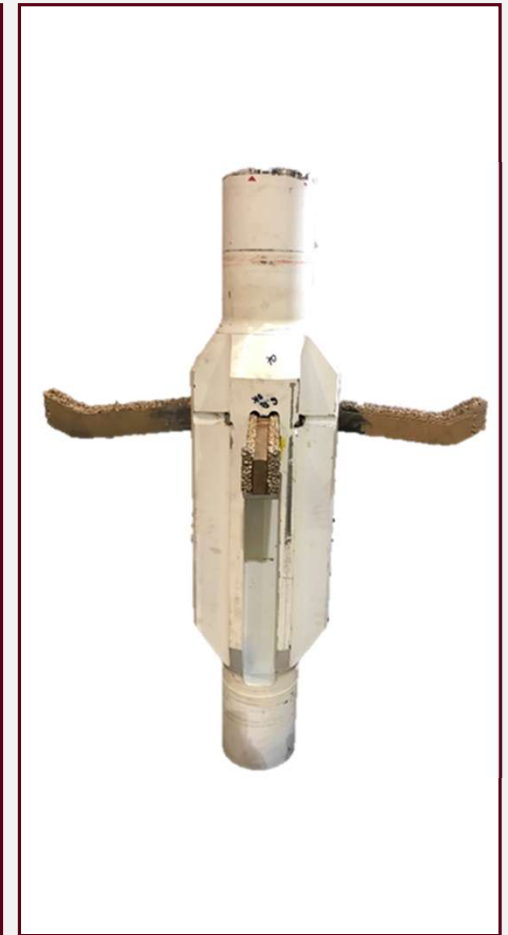
## Mechanical Casing Cutter Advancements

- From Traditional 12" to 17" OD Cutter Bodies
- Upgraded larger knife designs
- More carbide cutting structures per knife
- 4 Bladed Casing Cutters

Increased performance and  
results from upscaling casing  
cutter bodies

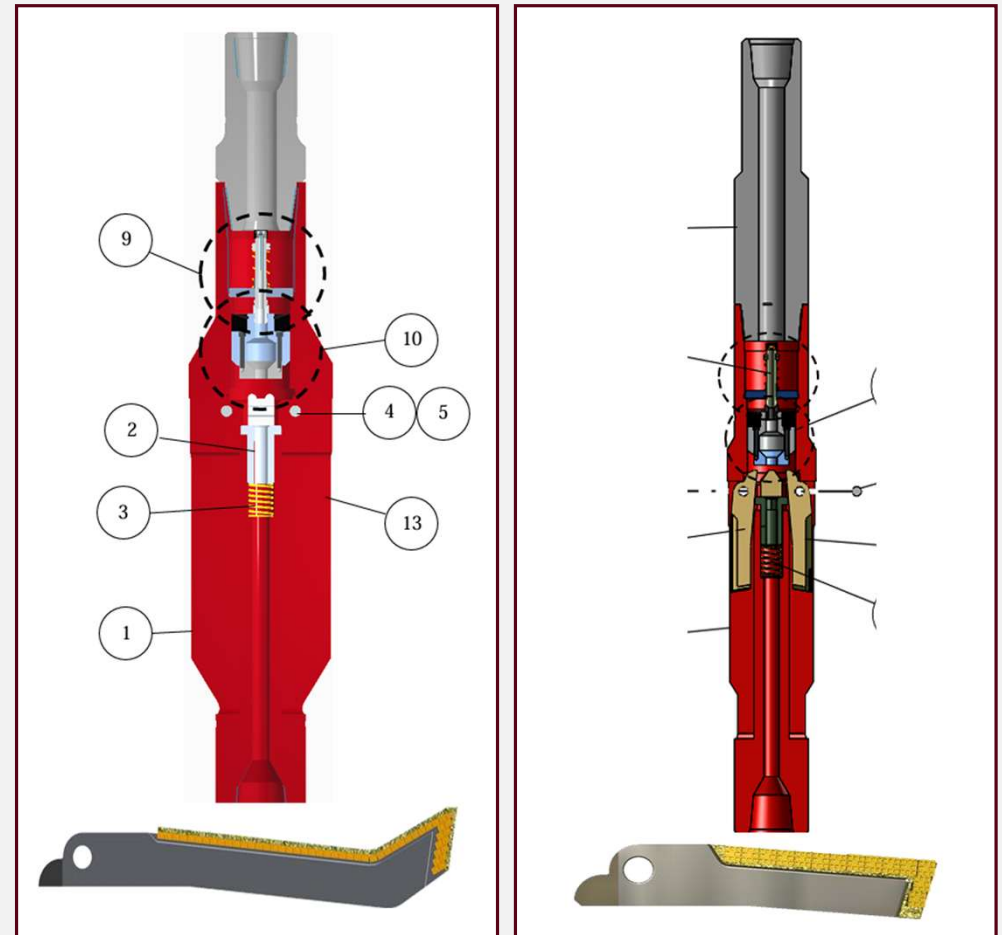
- 12" Casing Cutter – Standard Knife Design
- 17" OD Casing Cutter – High Angle Knife Design
  - Reduces contact area with 20" when cutting through to 30/36" LPWH
  - Dual Row of TCI (Inserts) for improved cut performance / reliability
  - Improved Stabilisation

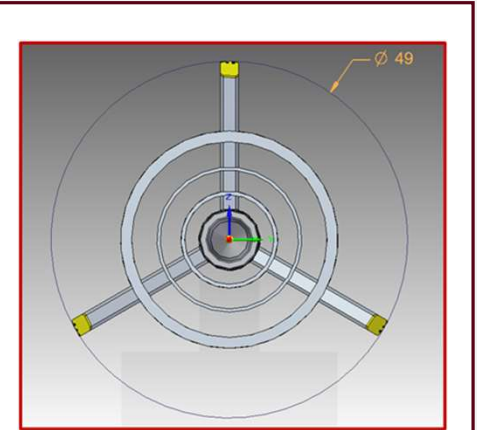
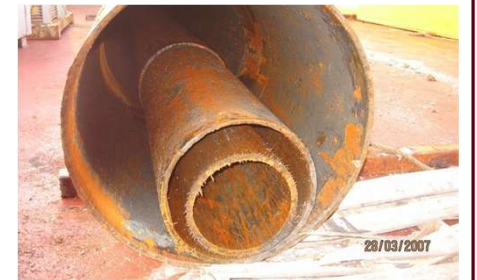
## Mechanical Multi String Cutting

- **Conventional:**
  - Currently a 2-3 run scenario
  - Creation of a Window using a series of spacer subs and knife lengths
- **Next Technical Barrier** – Technology Focus – 1 run
  - The Drawbacks
    - Uncemented Casing in Annulus
    - Casing Coupling Back Off

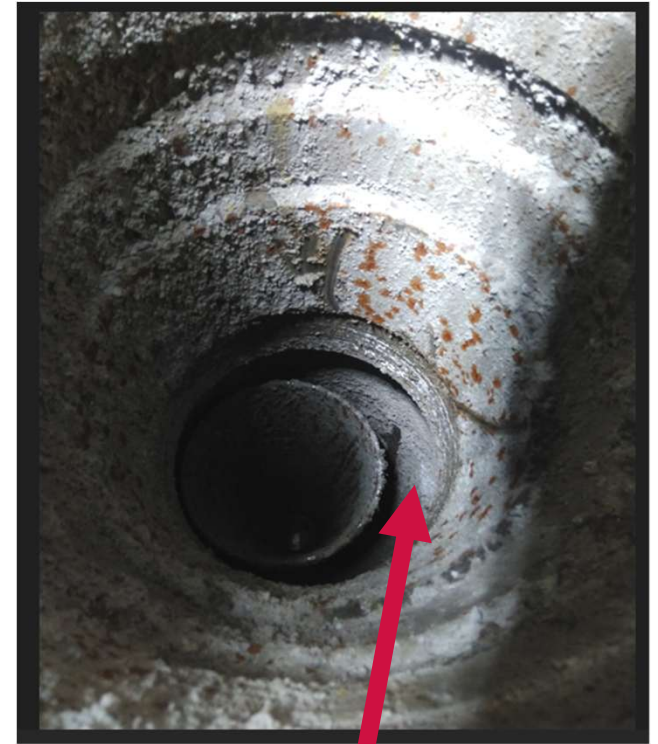
**13 3/8" Collar Back Off – Jan 2026**

- Casing Coupling Back Off
  - Uncemented Casing in Annulus
  - Tension Release from 13 3/8" Casing – Attempting Multi String Cut – Coupling Back Off at Casing Hanger.
  - **Mechanical Cutting Attempt Aborted.**
  - No Wellhead Seal Assy Running Tool to Release Lock Ring and Recover 13 3/8" Casing
  - Explosive Option Only. AWJC Not Possible
