**Use of Cement Bond Logs for de-risking annular cement remediation via Perforate, Wash and Cement (PWC) techniques & a newly designed Tubing Conveyed Perforation System to permit successful placement of PWC plugs between concentric casings**

Alex Lucas, SPE Aberdeen 7th European Well Abandonment Seminar, 27<sup>th</sup> June 2017

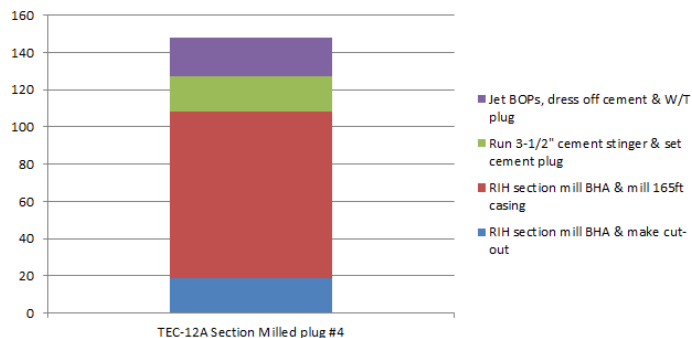
**Section mill 50m (165 ft) of 9-5/8" casing inside 13-3/8" & set plug:  
148 hrs / 6.2 days**

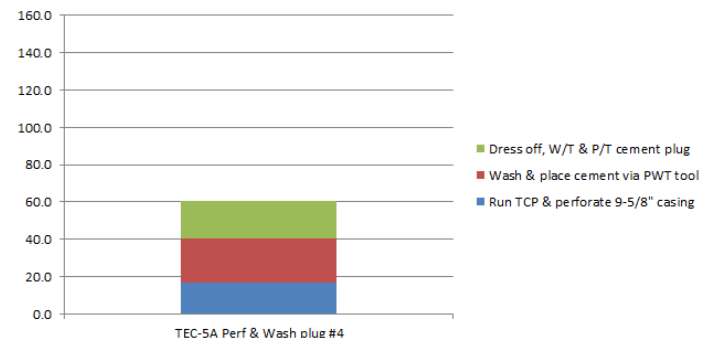
**PWC 50m (168 ft) 9-5/8" x 13-3/8" concentric casing annulus & set plug: 60.5 hrs / 2.5 days**

- When used correctly, Perforate & Wash can be a very efficient technique.
- Is performed in the more benign cased-hole environment = less risk.
- Can now be performed in concentric casing = even less risk, even more efficient & enabling a further step-change in performance
- Now ca. 2.5 times faster than 'typical' section milling performance (ca. 2 ft/hr).

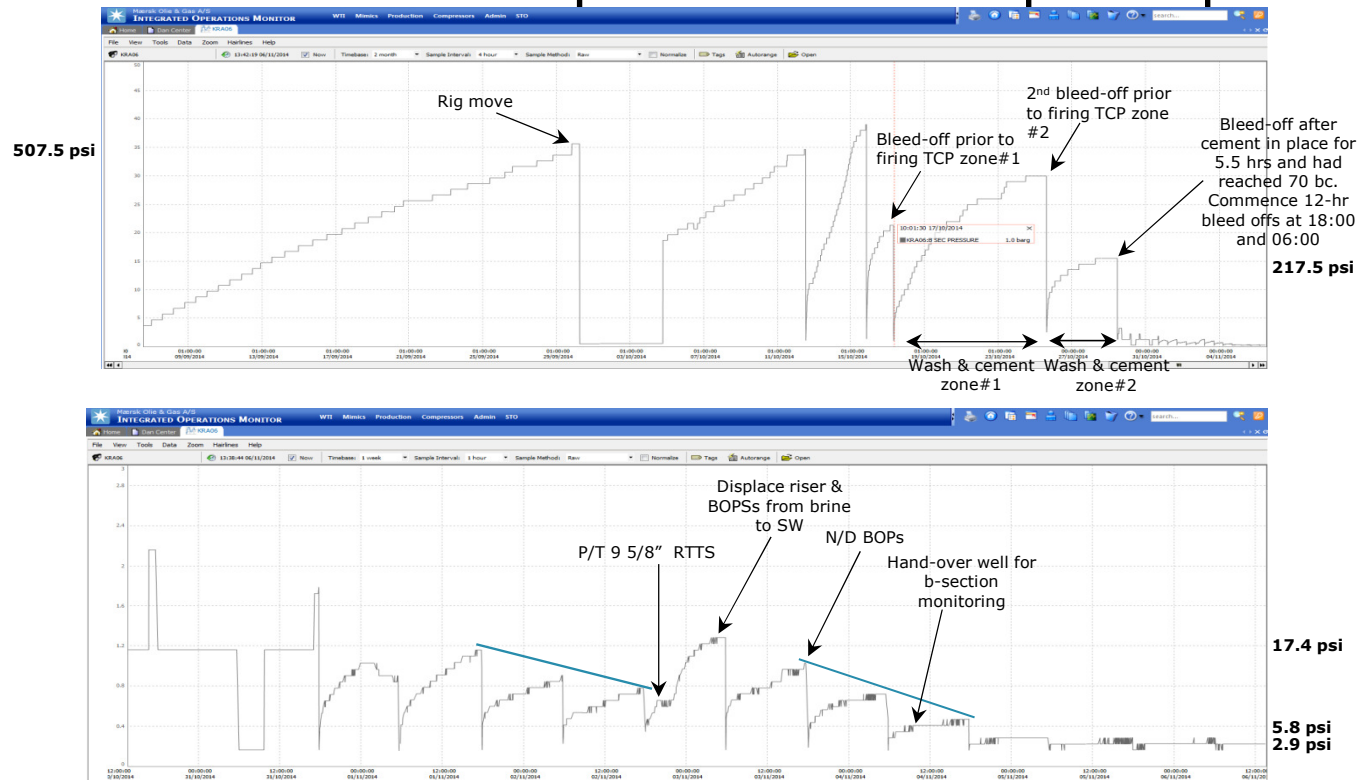
# Kraka A-6A: B-annulus pressure trend pre & post-treatment

- B-section pressure build-up rates originally 1.2 bar/day (17.4 psi/day).
- Well suspended after treatment & PBU trends were monitored for several weeks to determine if remediation had been successful.
- **Annulus stabilised & considered cured. Proceeded to install cemented tieback casing + completion.**
- **Monitoring period was key to success!**

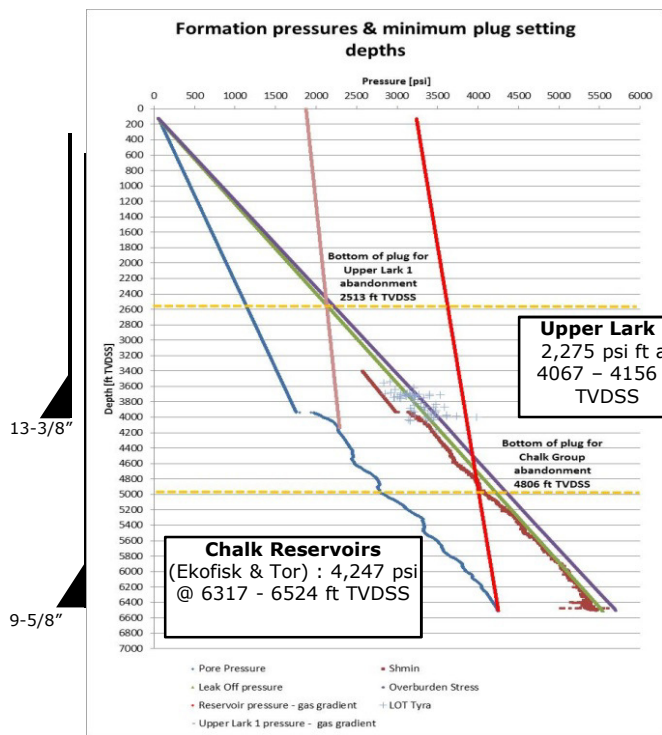
- Tyra to remain on production until 2042.
- Isolation strategy of double isolation (2 x 165ft) above Ekofisk and double isolation (2 x 165ft) above Upper Lark to '**restore cap rock**'.
- Virgin pressure assumed for minimum plug setting depths.
- Upper Lark 1 is usually the suspected source of SCP.
- Preferable to be able to remediate inside 13-3/8" shoe if possible (less risk & more efficient)

**Requirement for new TCP system to perf. thin 40# casing without damaging 13-3/8"**

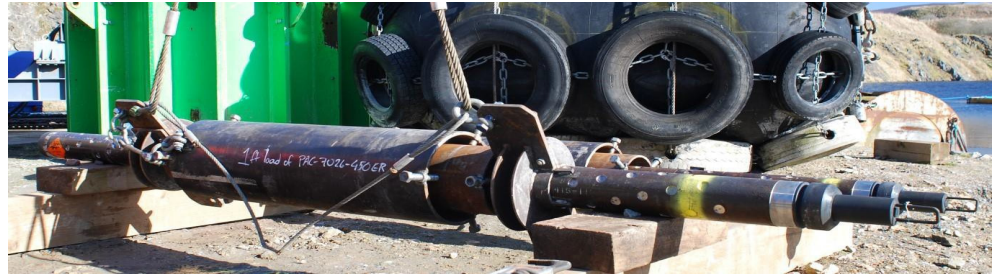
- 5-1/2" 18 spf, 140°/20° gun loaded with AP360 charges centralised inside 40# L-80 9-5/8" VM80HC casing placed inside 68# K-55 13-3/8" casing
- Lowered into survival pit water depth of 10-15 ft & detonated

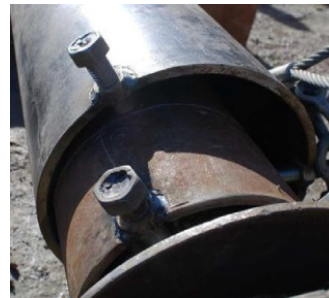
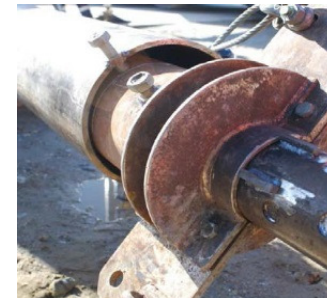
**Scenario 2**  
Fully centralised 9-5/8"

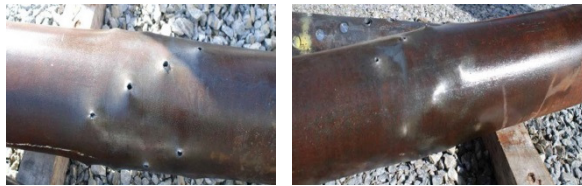
Fully decentralised 9-5/8" with  
0.3195" stand-off

- Charges did not damage 13-3/8". Only slag deposits seen.
- Average EH size **0.44** in for both tests.
- However for **fully decentralised** 9-5/8", only **6/18 (33%)** shots made hole. Others showed stretched/dimpled casing.
- For **fully centralised** 9-5/8", only **19/36 (53%)** shots made hole. Penetrations observed sporadically over the 2ft section. Casing looked stretched/dimpled at the perforating point.
- Suspicion at the time was that this may be due to chrome content of the casing, allowing casing to stretch and absorb charge energy.

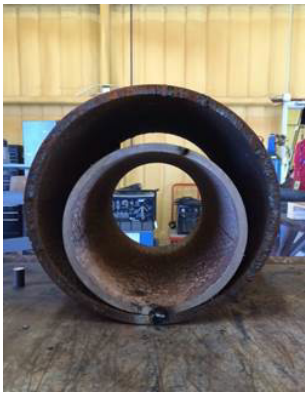
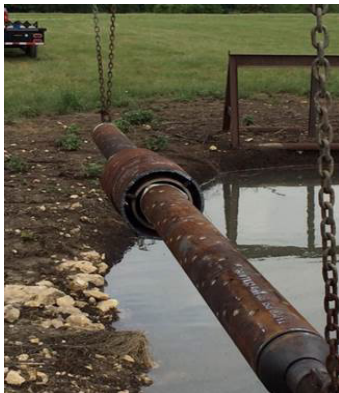
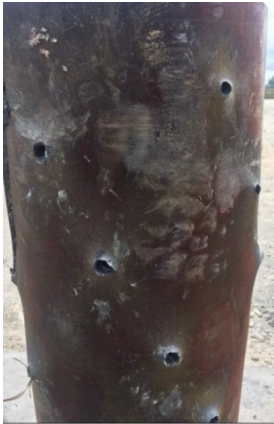
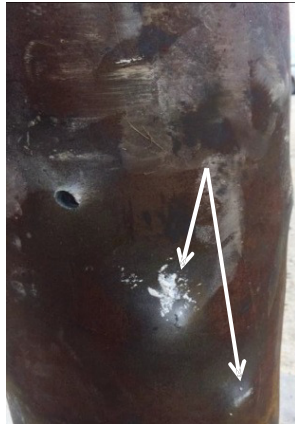
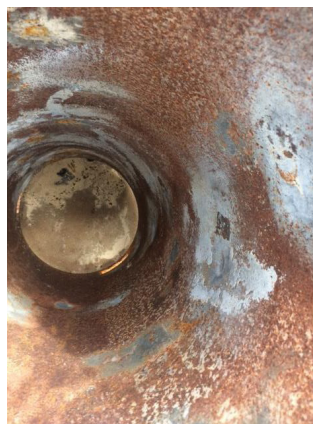
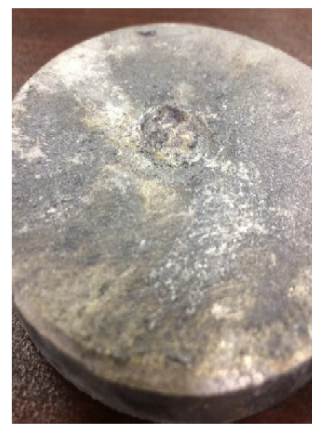
## **Both tests conducted with 9-5/8" fully decentralised:**

- **20/25 shots (80%)** made hole in **L-80 casing**. Av. EH size: **0.44"**
- **11/22 shots (50%)** made hole in **22Cr casing**. Av. EH size: **0.40"**
- Negligible damage (**0.005in**) to 13-3/8" casing
- Some stretch/deformation of 9-5/8" seen
- More shots expected to make hole in downhole conditions
- Coupon test directly on 13-3/8" showed only **~0.183"** penetration (38% of 0.48" WT)

- AP360 can perforate 40# L-80 9-5/8" without damaging 13-3/8"
- Chrome content has a *strong influence* on ability of these charges to penetrate casing
- Lack of holes in VM80HC due to higher tensile & yield strength

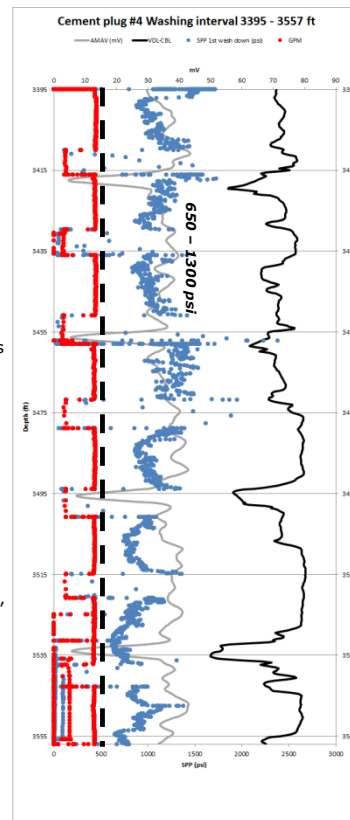
Inclination 7.0 degrees at top of section, 6.9 degrees at bottom of section.

- More consistent washing parameters seen at similar flow rates.
- Achieved 425 – 450 gpm @ 600 – 1300 psi over the whole section
- 1 ft/min planned washing rate achievable
- Actual washing time: 4 hours.
- Total job time including dress off & W/T & P/T cement plug: 60.5 hours / 2.52 days

- CBL is generally ca.  $\geq$  70 mV, and washing parameters are more stable in the 650-1250 psi range and circulation is always possible.
- AMAV is generally ca.  $\geq$  30 mV

- The TCP system worked.
- Able to successfully wash behind perforations in concentric casing annulus with CBL >10-15mV.
- AMAV also needs to be ca. 10 mV or above?
