Probabilistic Assessment of Composite Repairs

SPE Alternatives to Welding Conference – 30 April 2019

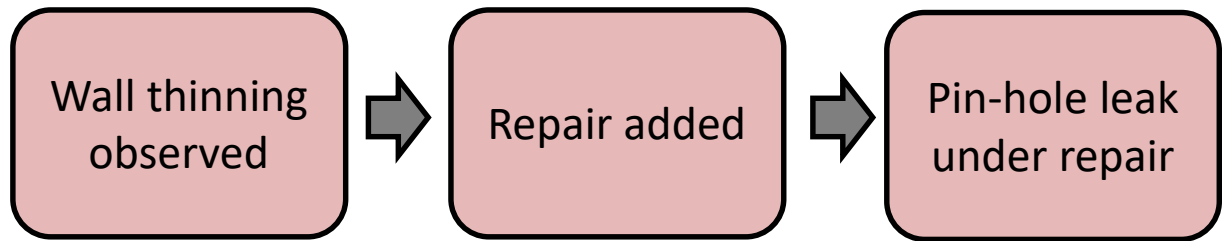
Calculation of erosion rate is possible but highly dependent on operating history, and availability of data

Phase 1: Timescales dictated by erosion rates

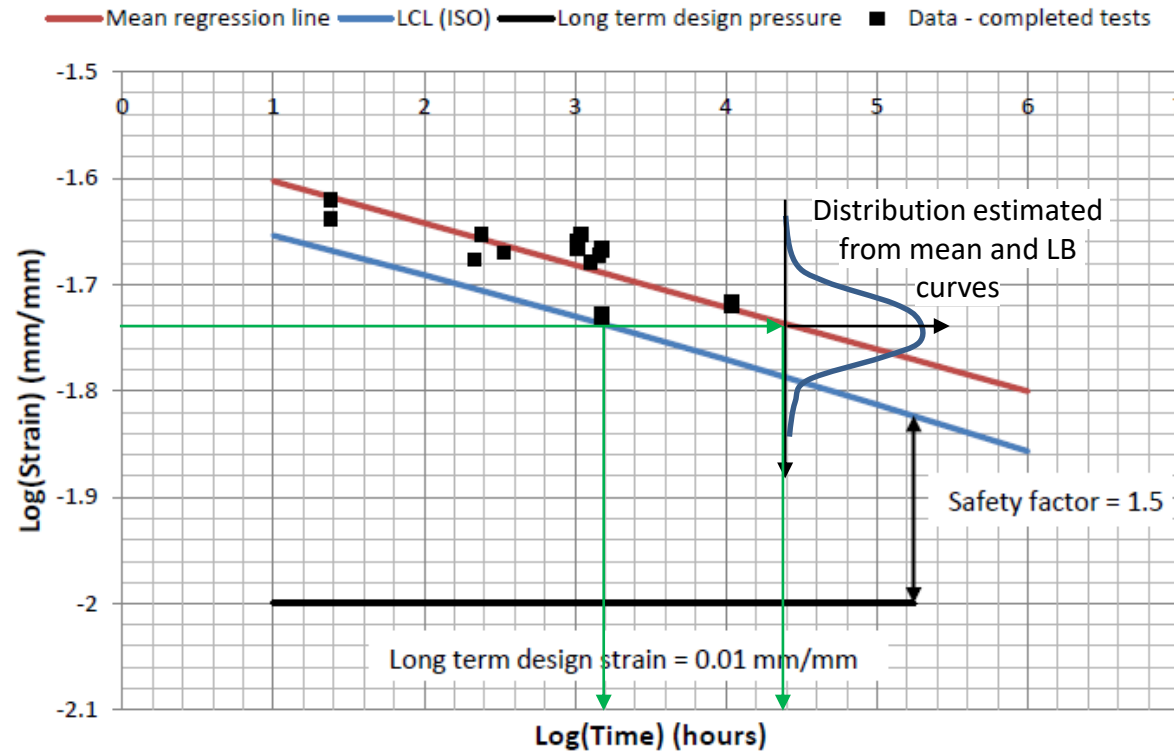
Laminate failure test data

Test data provided by repair laminate manufacturer, used to estimate failure life distributions

Note test data is relatively limited

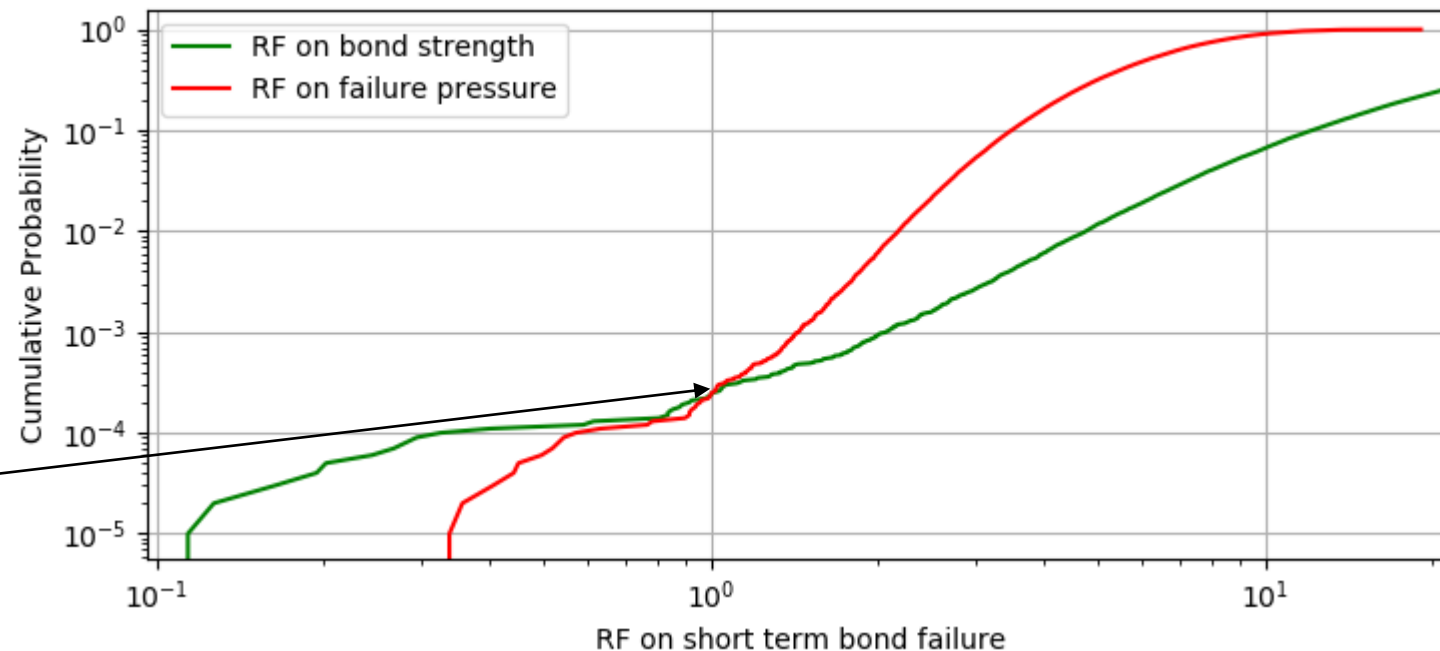
Results: Failure Probability of Bond Line

- Reserve factor against short term bond failure can also be calculated (either based on bond strength or margin on pressure)

Risk of $RF < 1$ is approximately $2e-4$

In practice, the fact that the repairs have not failed tells us short term failure is unlikely unless operating pressures increase

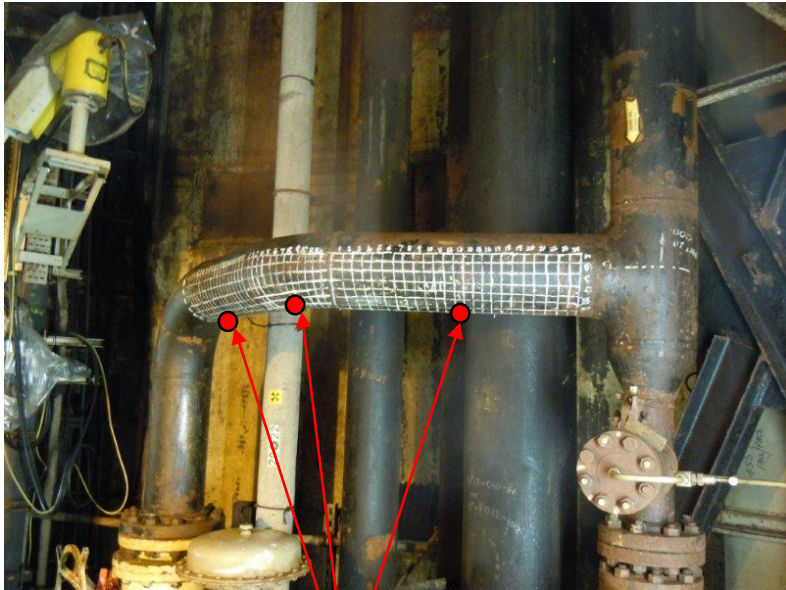
3 areas of external corrosion identified

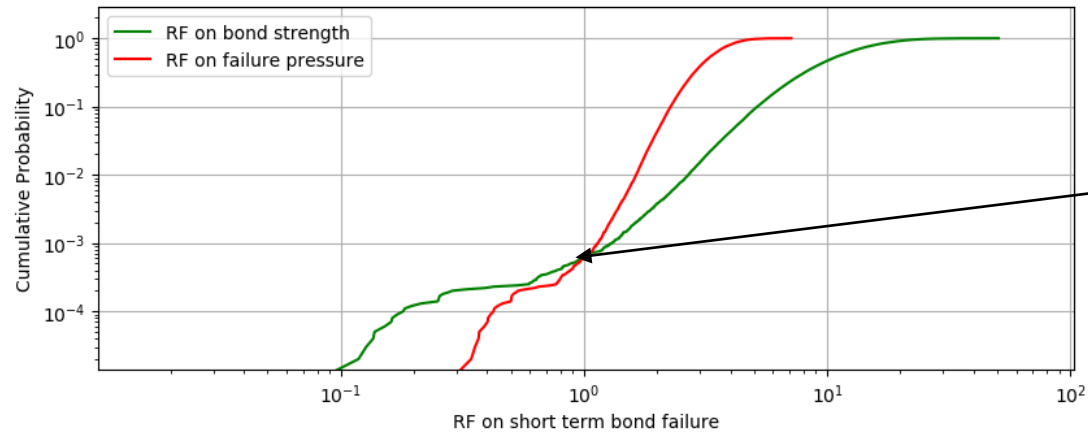
Risk of short term failure predicted to be ~1/1000
