What No MLE Splice Below the Packer?

Retrievable ESP Packer Solves Reoccurring ESP Electrical Failure Issue

Presenter: J. J. Xiao, Saudi Aramco

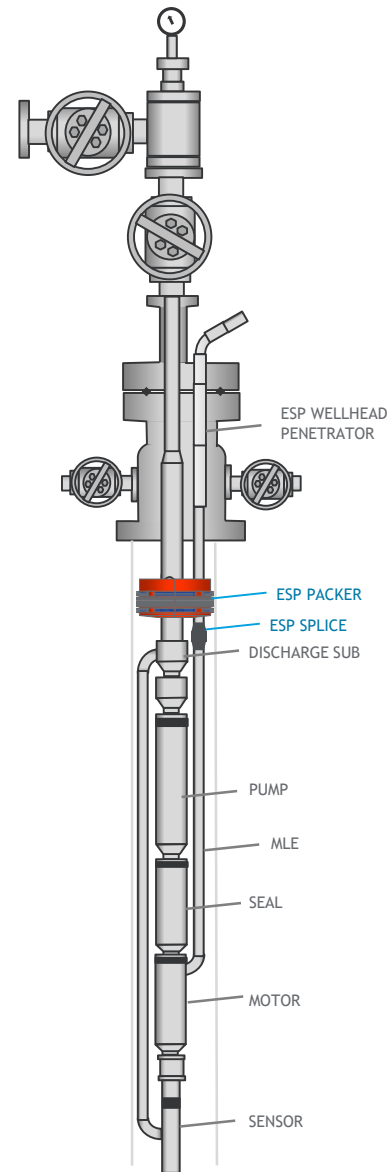
Standard ESP Completion

- ESP Wellhead Penetrator
- Discharge Sub
- Pump
- Protector
- MLE
- Motor
- Sensor
- ESP Packer
- ESP Splice

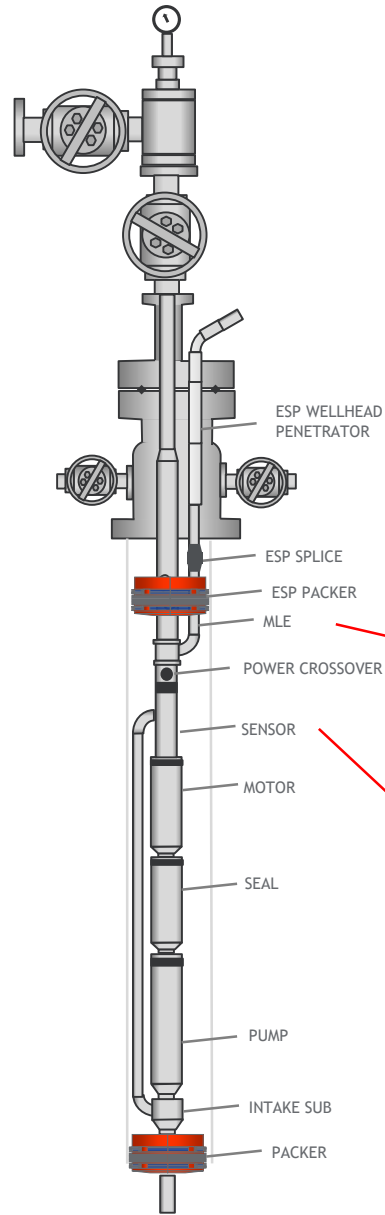
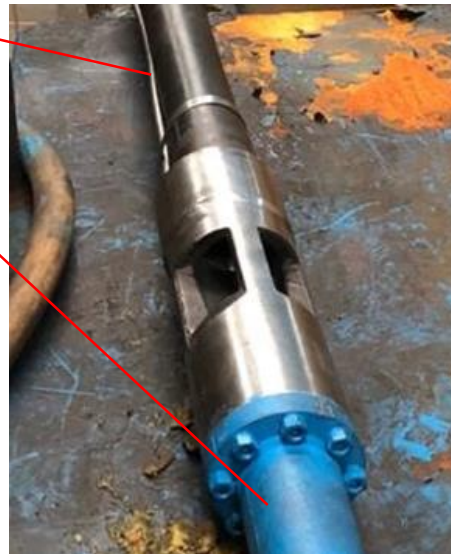
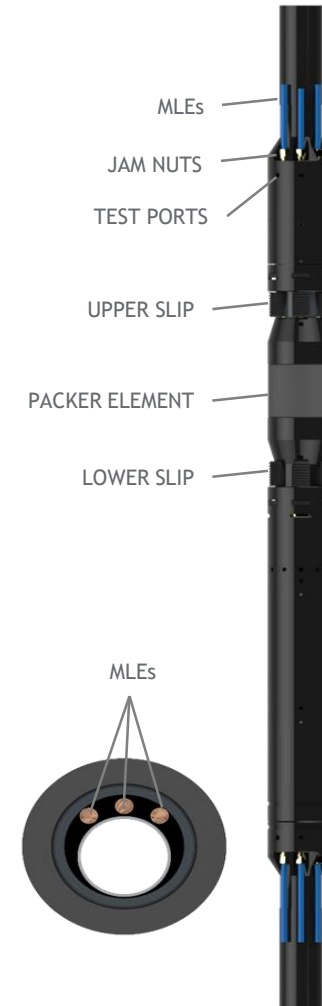
Inverted ESP Completion

- ESP Wellhead Penetrator
- ESP Splice
- ESP Packer
- MLE
- Power Crossover
- Sensor
- Motor
- Protector
- Pump
- Intake Sub
- Packer

Hyd Set, Ret.
ESP Packer

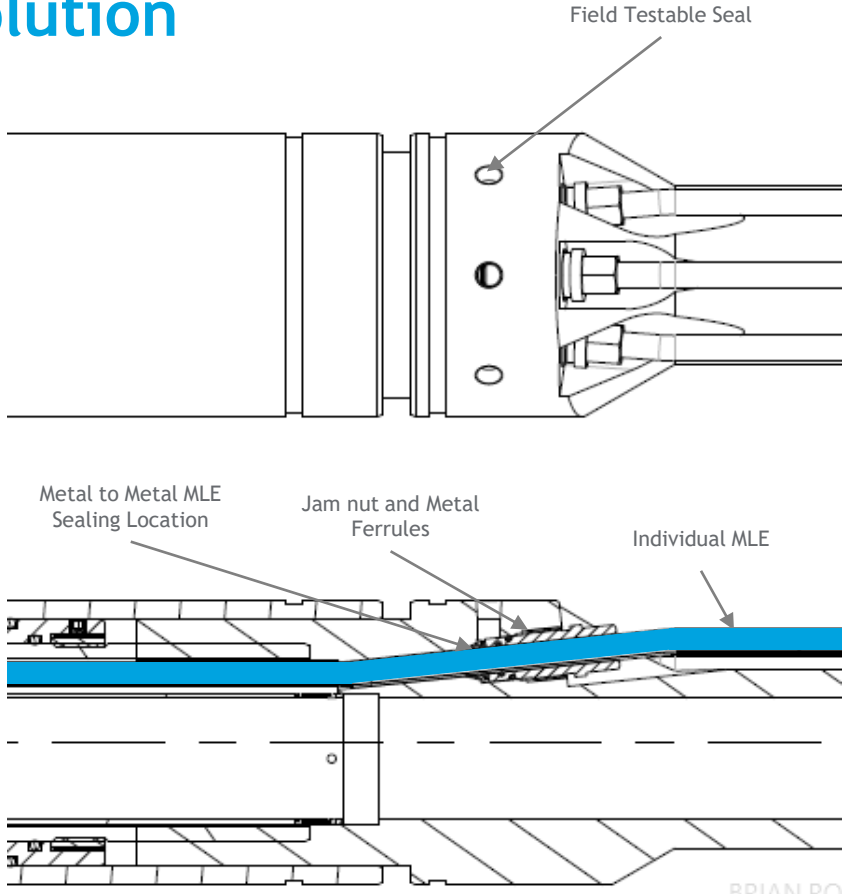
Lower Feed-thru
Cross-section

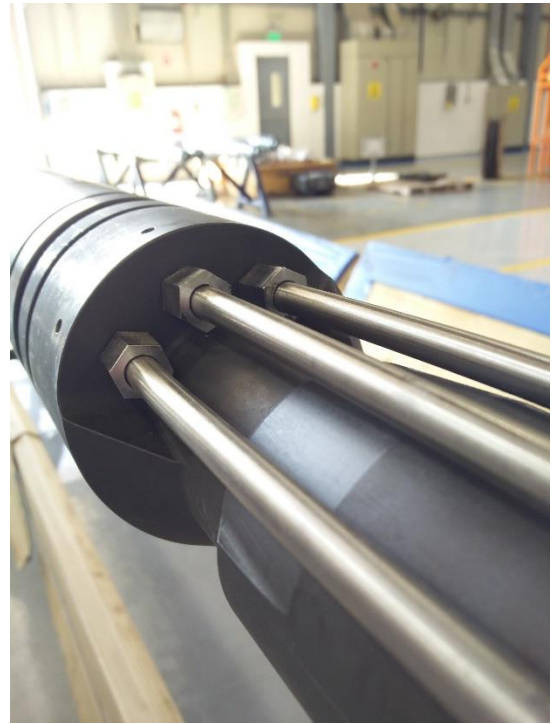
MLE Made Up to Packer

Ferrules
Jam Nut

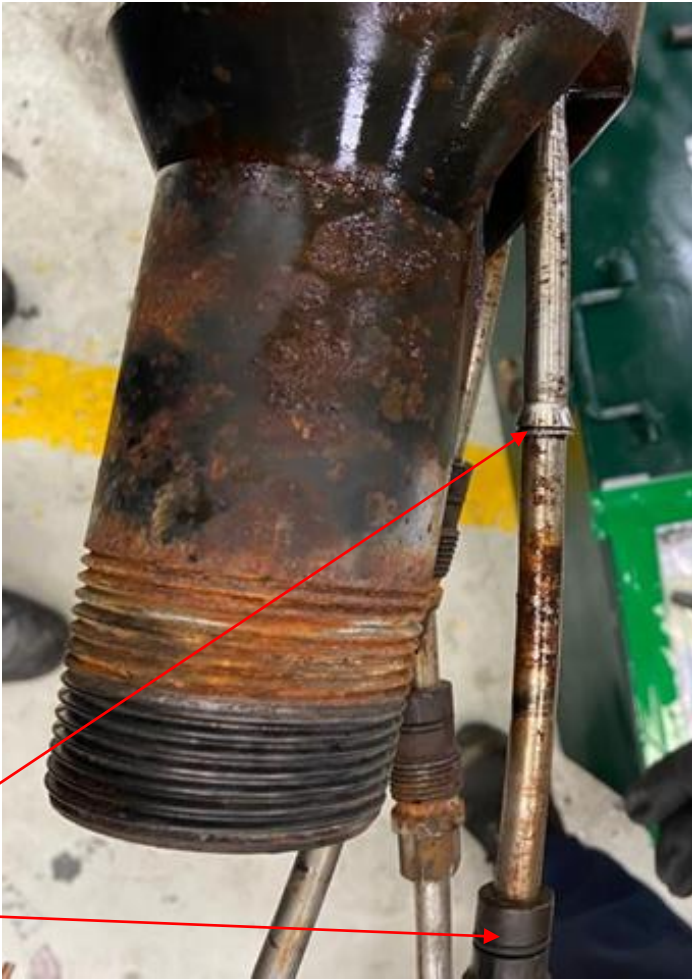
Recovered ESP Packer

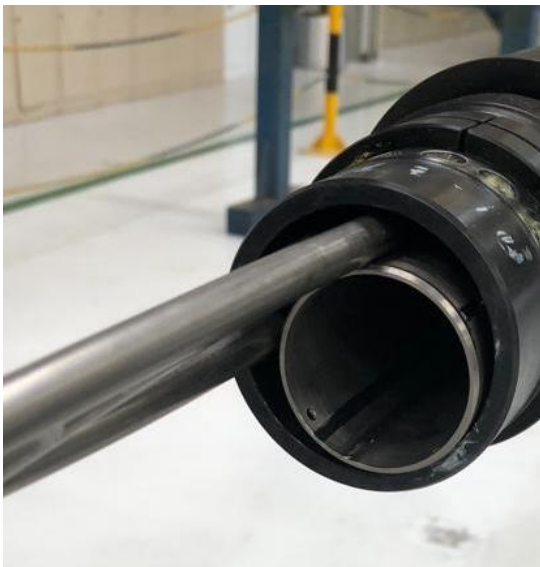
MLE's feedthrough packer

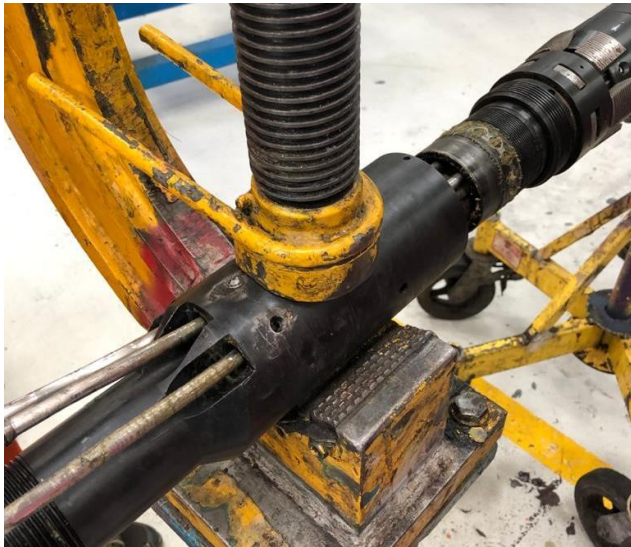
Packer top sub installation

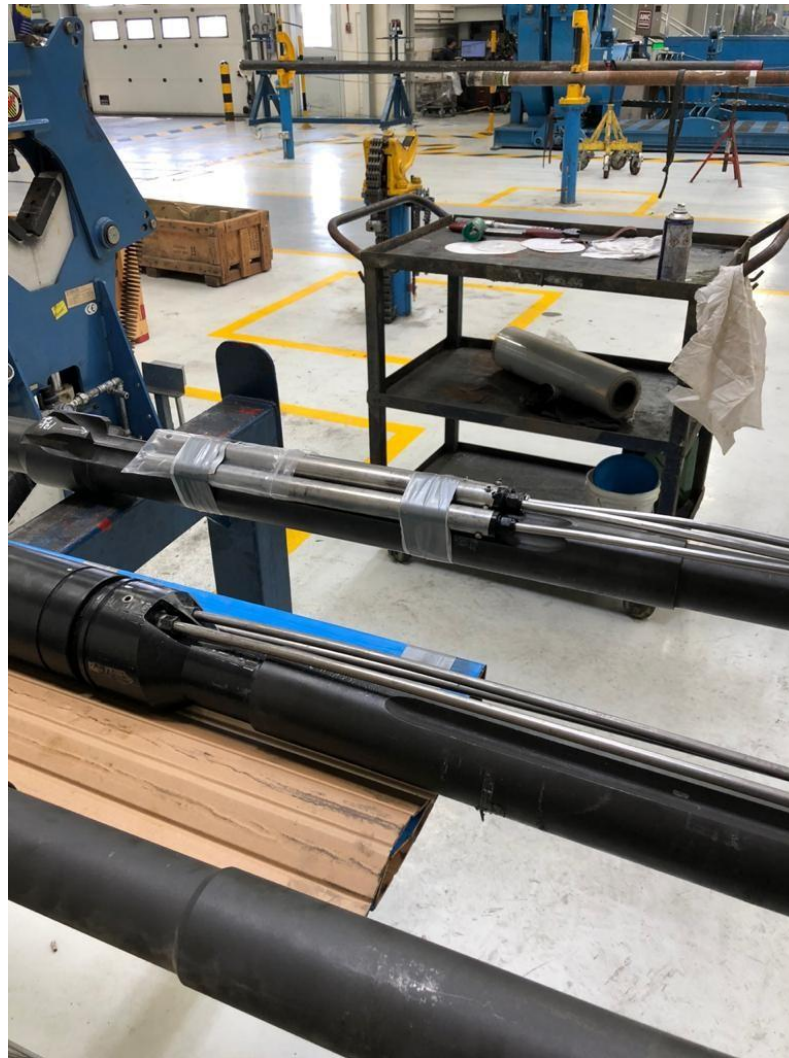
Two subassemblies
splices above packer in back

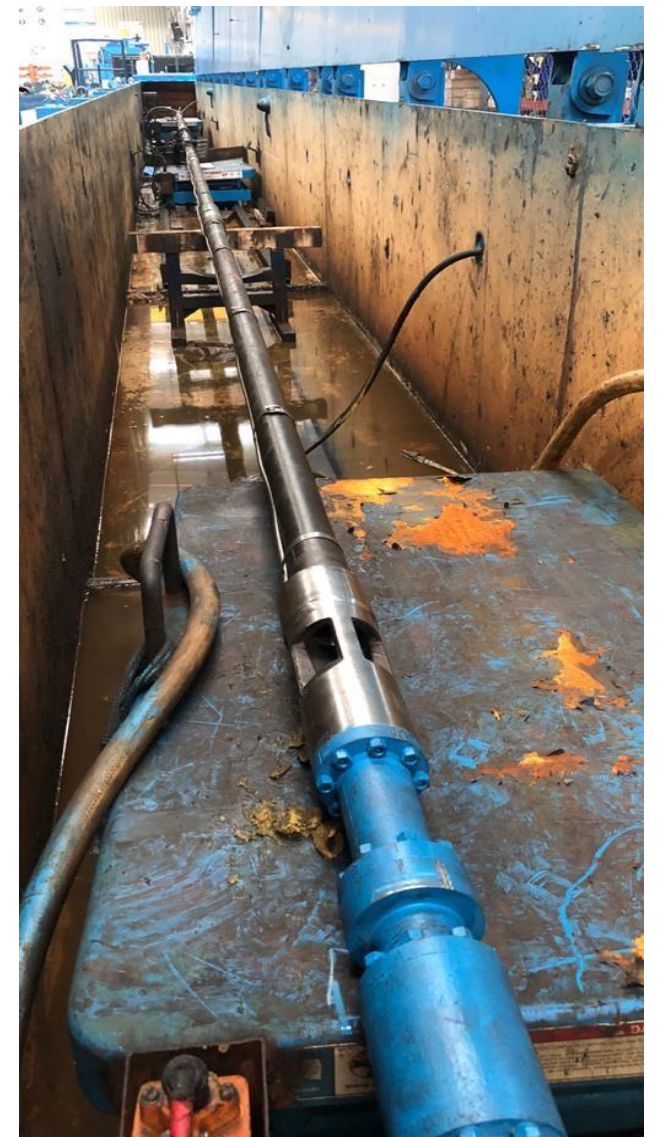
Complete subassembly in test bay

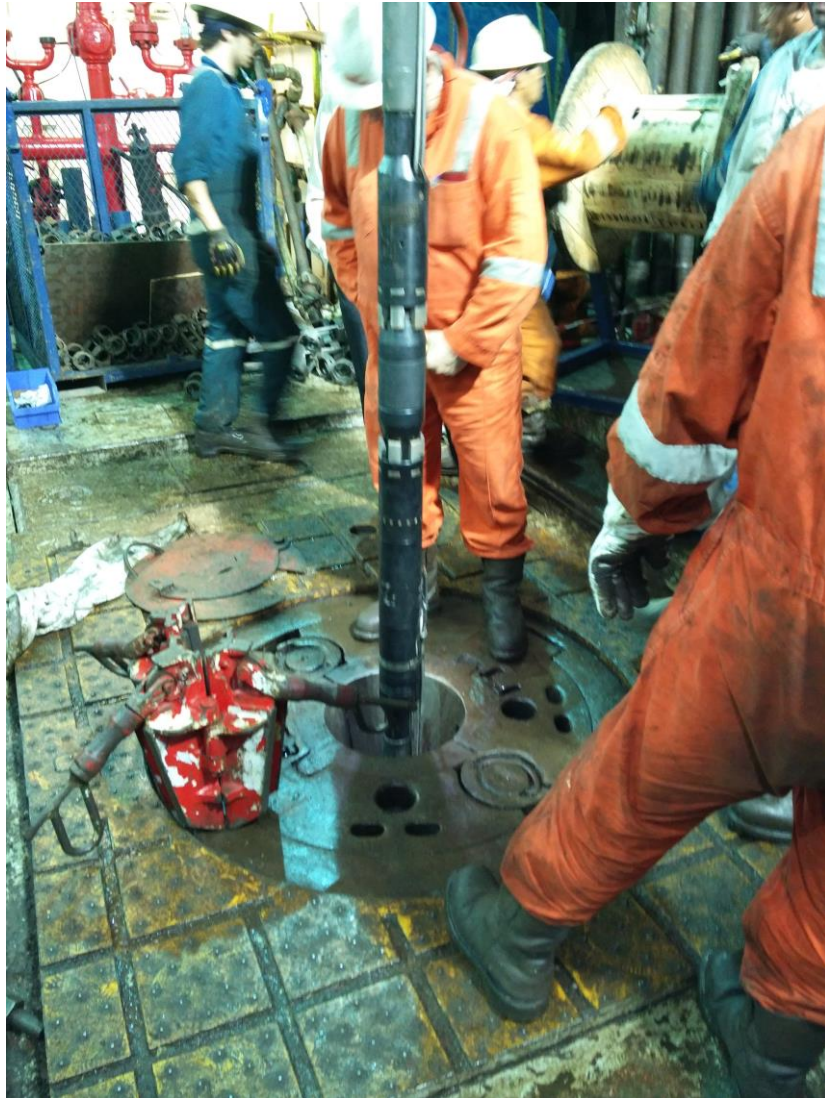
Non-Spliced MLE below the Packer

- Three ESP Installations to Date
- Two Operating > 1 year
- One Failed due to ESP Mechanical Failure
