# OFFSHORE BOLT CORROSION

Welded and Non-Welded Connections

SPE/IMechE

MARCH 2021

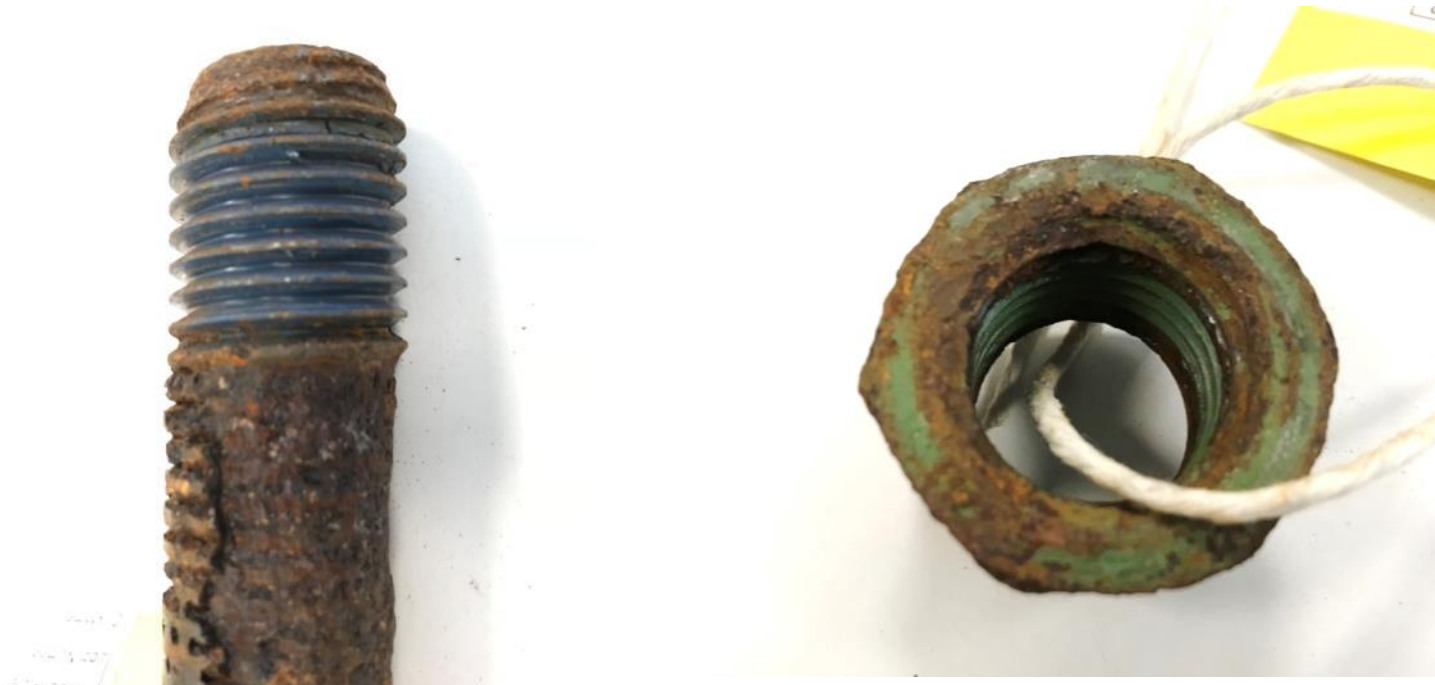
# Samples – Common features

- Contact protects
  - Threads within nuts clean
  - No loss from nut face contact area

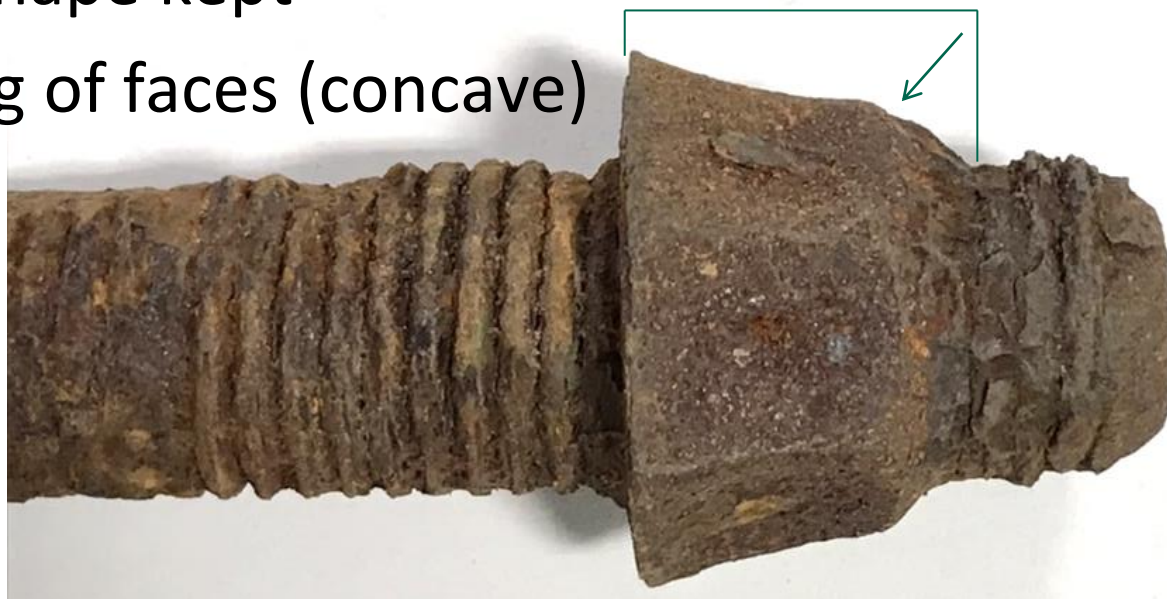
## Samples – Common features

- NUT Features
  - Corrosion at bottom limited by contact area
  - Height and diameter lost from top
  - Hexagonal shape kept
  - Slight dishing of faces (concave)
