Platform Well Abandonment – Cormorant Alpha

Planning for the Modular Rig-based Well Decommissioning Operations on Cormorant Alpha

May 2021

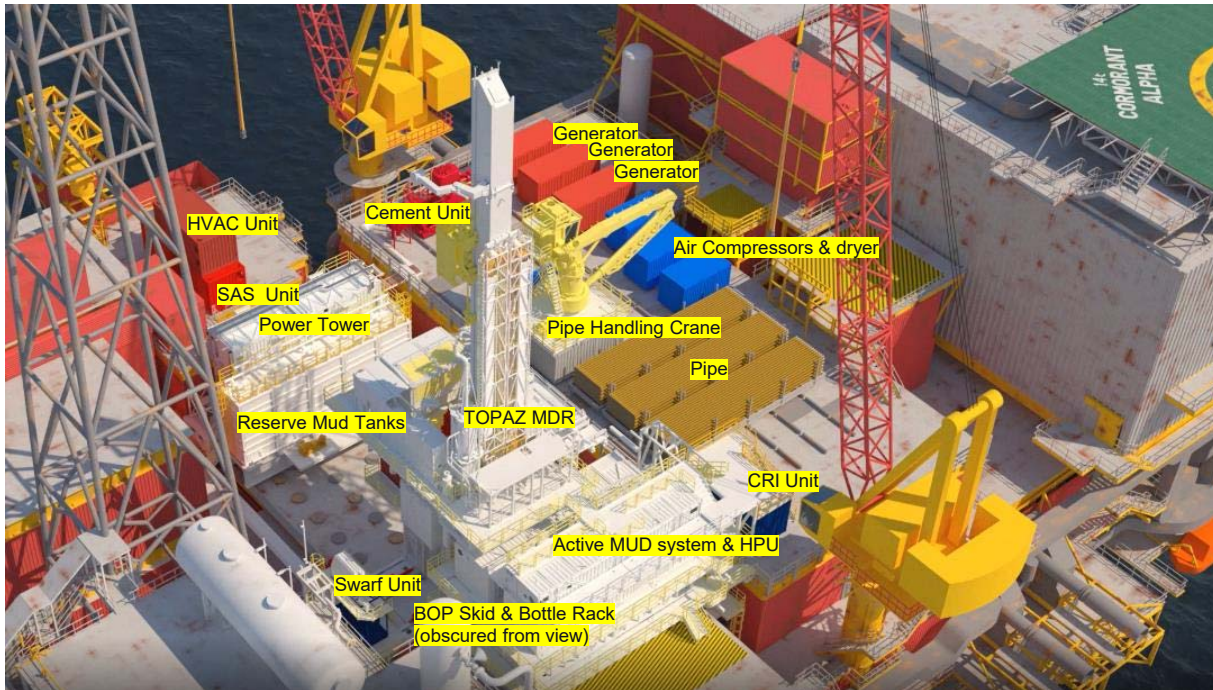
Archer Topaz Modular Drilling Rig

Summary: The Archer TOPAZ MDR has been contracted to undertake the well abandonments of the Cormorant Alpha well inventory. It will be modified and adapted to operate on the installation prior to mobilisation. It will be coupled with several existing systems on the Cormorant Alpha to enhance its functionality and to make best use of the existing support infrastructure.

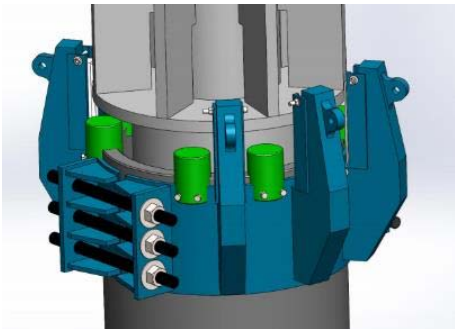
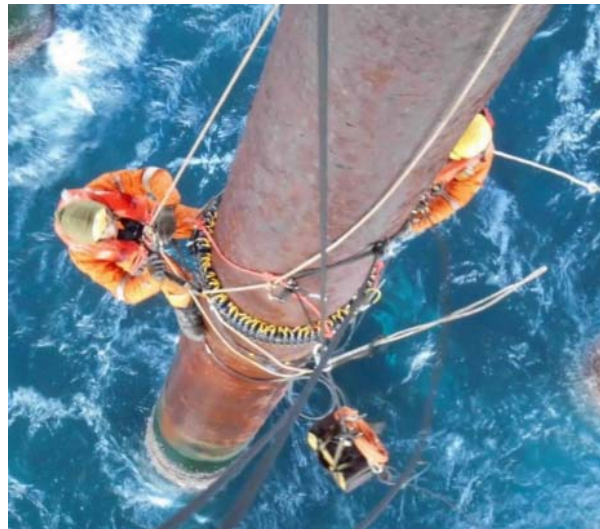
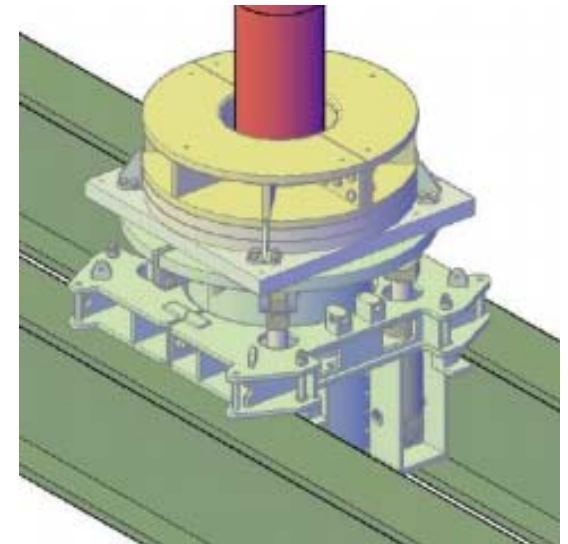
Tension Table

Surface Casing: The surface casing is either landed out on the conductor or a clamp will be run to transfer the well load to the conductor.

Environmental Load Assessment: Sonomatic tool is being run as a screening tool to identify potential areas of corrosion and areas that may need additional support during well operations

Tension Table: Well load needs to be transferred to East-West skid rails. Commitment required to tension table prior to achieving results.

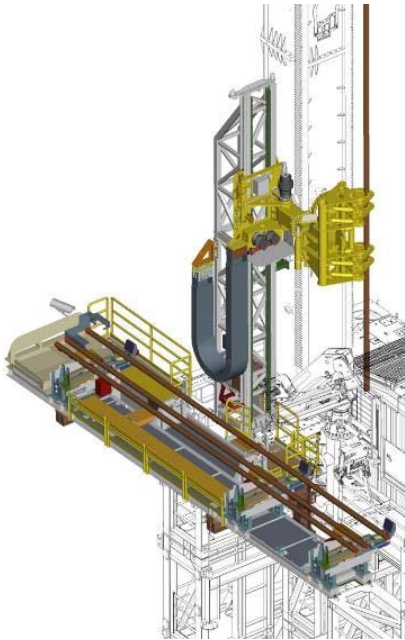
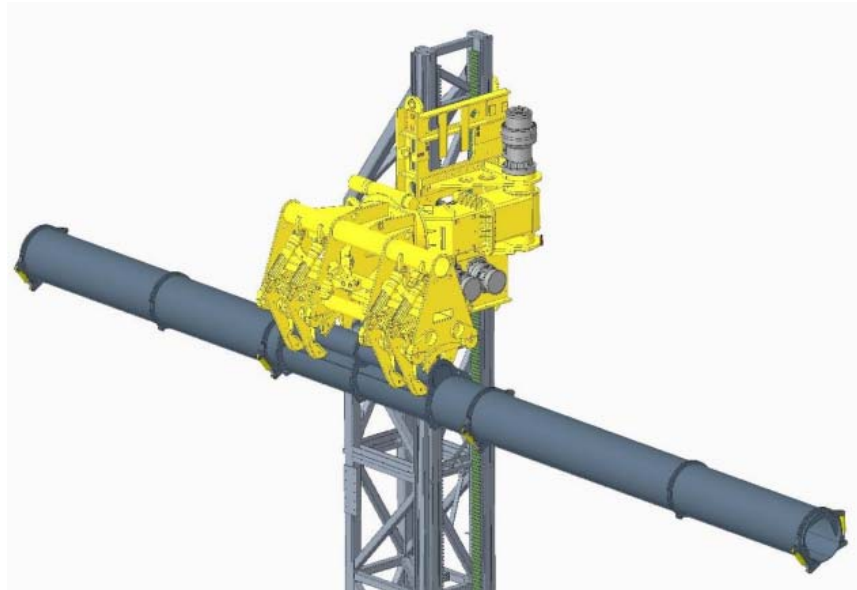
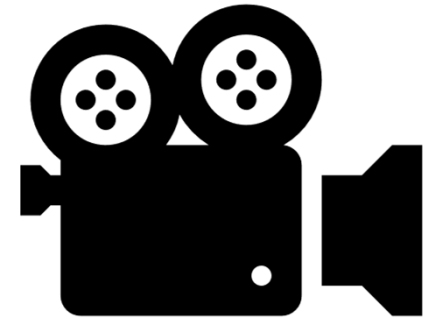
Corroded Pipe Handling Tool

Issue: A technical solution for handling pipe was sought due to concerns relating to structural failure of corroded completion tubulars recovered from the well.

Solution: The drilling contractor Archer approached the Original Equipment Manufacturer (OEM) of the MDR, Streicher, to propose an integrated solution that would support the pipe and contain any potential dropped objects.
