# Technical Insulation for Reducing Risk, Lowering Costs & Reducing Environmental Impact

Prepared by Andrew Shaw, Aspen Aerogels

# Site Visit Overview

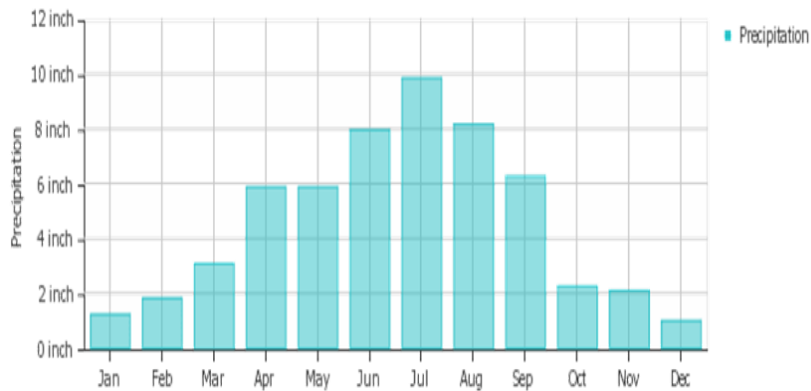
Average precipitation (rain/snow) in Chungmu, South Korea Copyright © 2016 www.weather-and-climate.com

- Extensive CUI over many years
- Reduced throughput – Especially during wet weather.
- Continuous inspections increased costs.
- Process unstable.
- MW Degraded resulting in increased Energy use

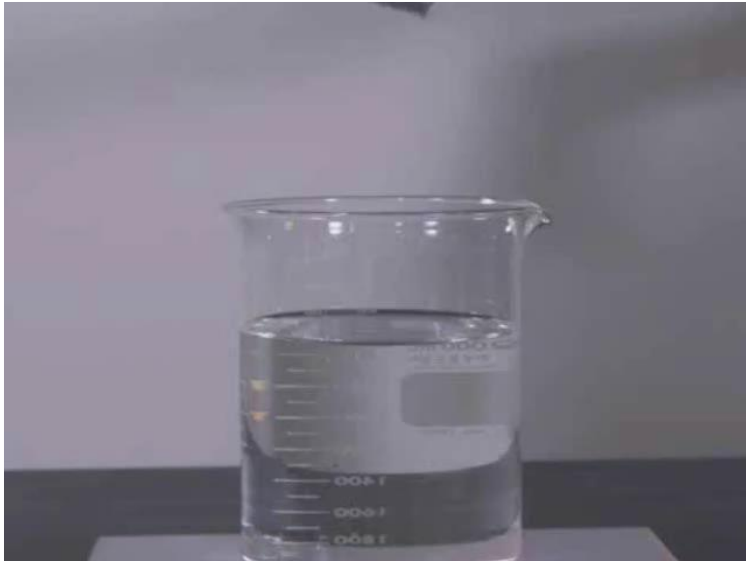
- Pyrogel is water repellent and will not absorb water
- Water vapour permeable – allowing vapour to escape
- pH is engineered to be  $>7$  to prevent corrosion
- Pyrogel does not degrade and will perform consistently for the lifetime of the plant.

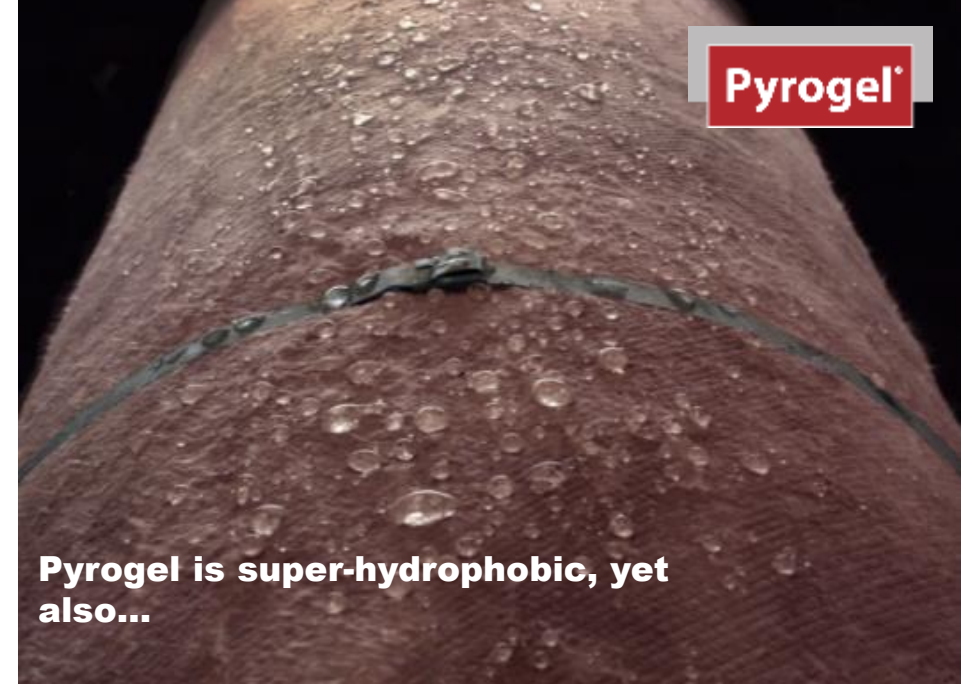
**Pyrogel is super-hydrophobic, yet also...**

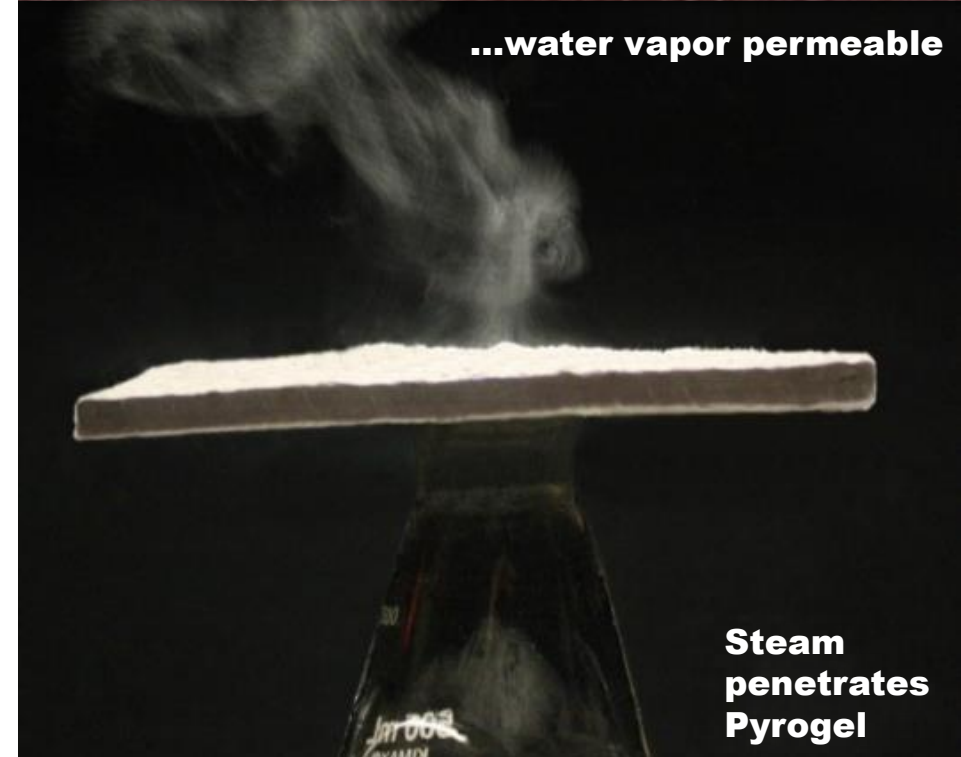
**...water vapor permeable**

**Steam  
penetrates  
Pyrogel**

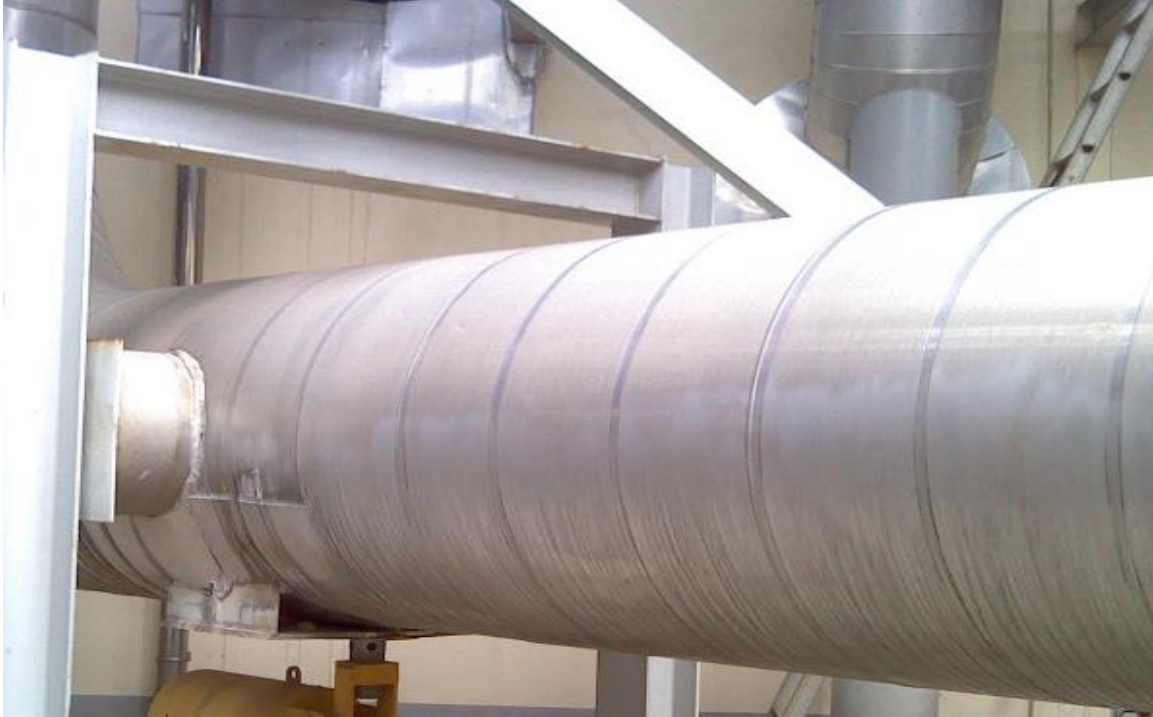
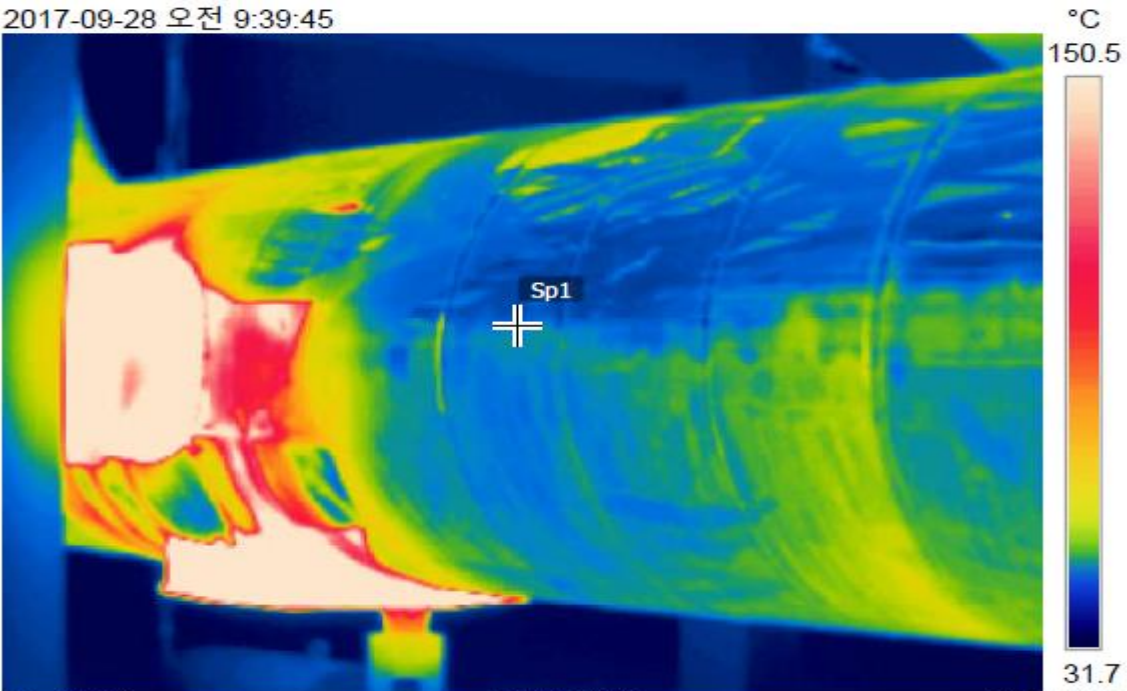
## CASE 4 High Degradation Risk

NPS	36"
Process Temp.	430°C
Ambient Temp.	23.7°C
Wind Speed	1.4 m/s
Material	Pyrogel XT 50mm
Surface Temp. Measured	45.9°C (Probe) 46.5°C (FLIR)
Surface Temp. Calculated	53.9°C Emissivity 0.3

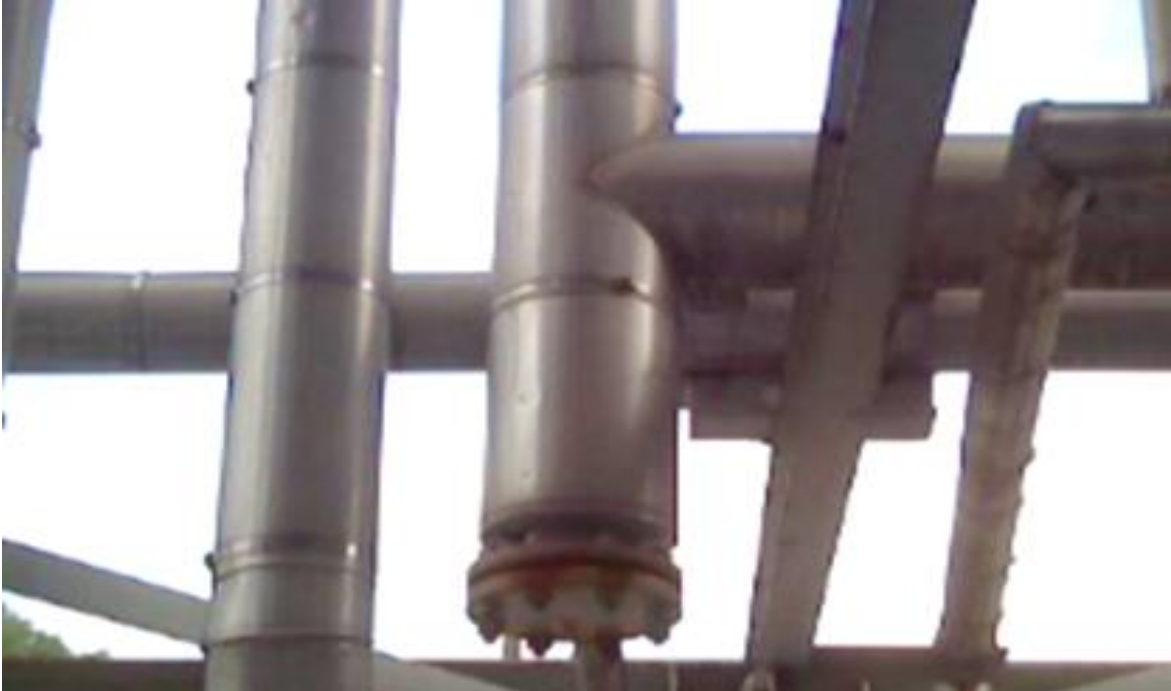
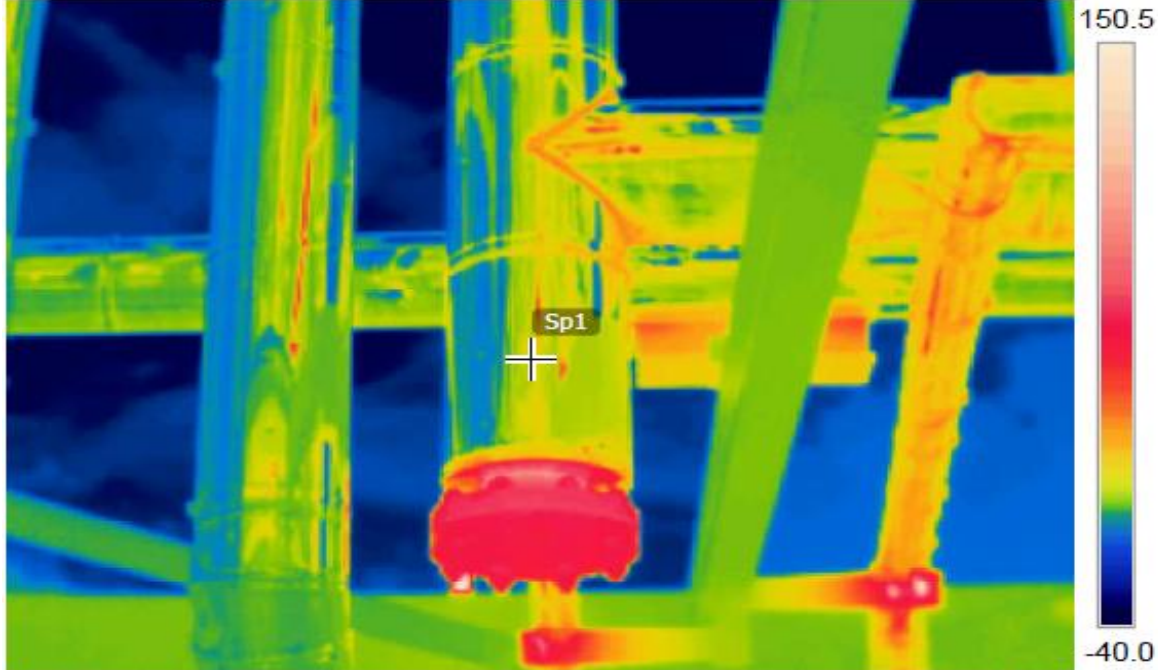
## CASE 1 CUI Risk

NPS	4" Low Pressure Steam Pipe
Process Temp.	135°C
Ambient Temp.	22.7°C
Wind Speed	1.2 m/s
Material	Pyrogel XTE 20mm
Surface Temp. Measured	32°C (Probe) 33.8°C (FLIR)
Surface Temp. Calculated	31.2°C Emissivity 0.3

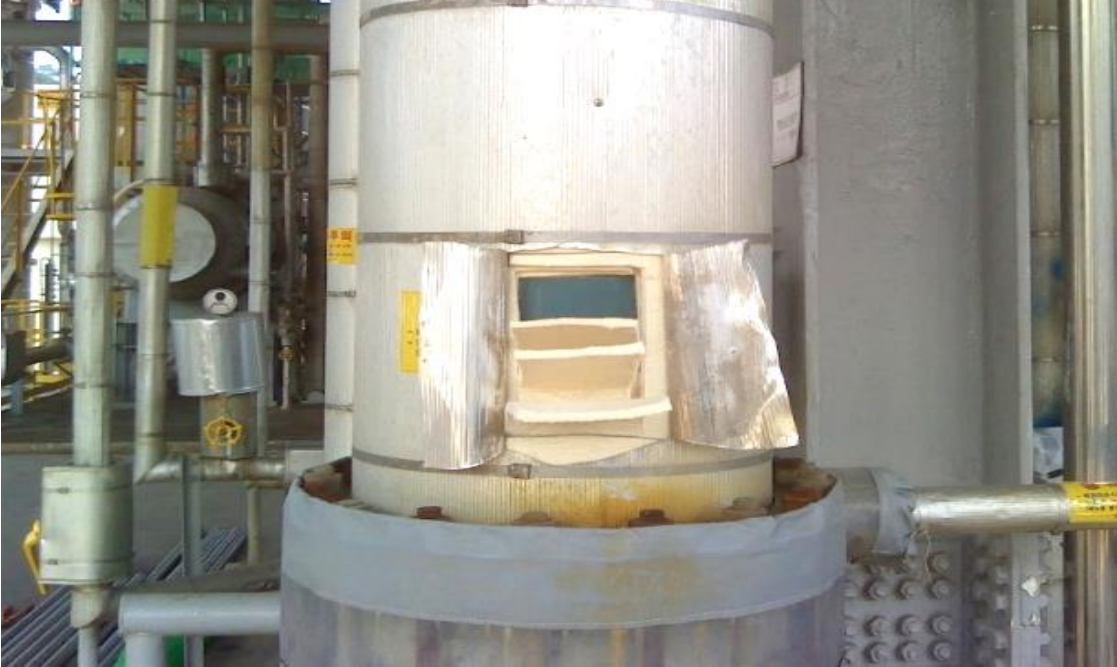
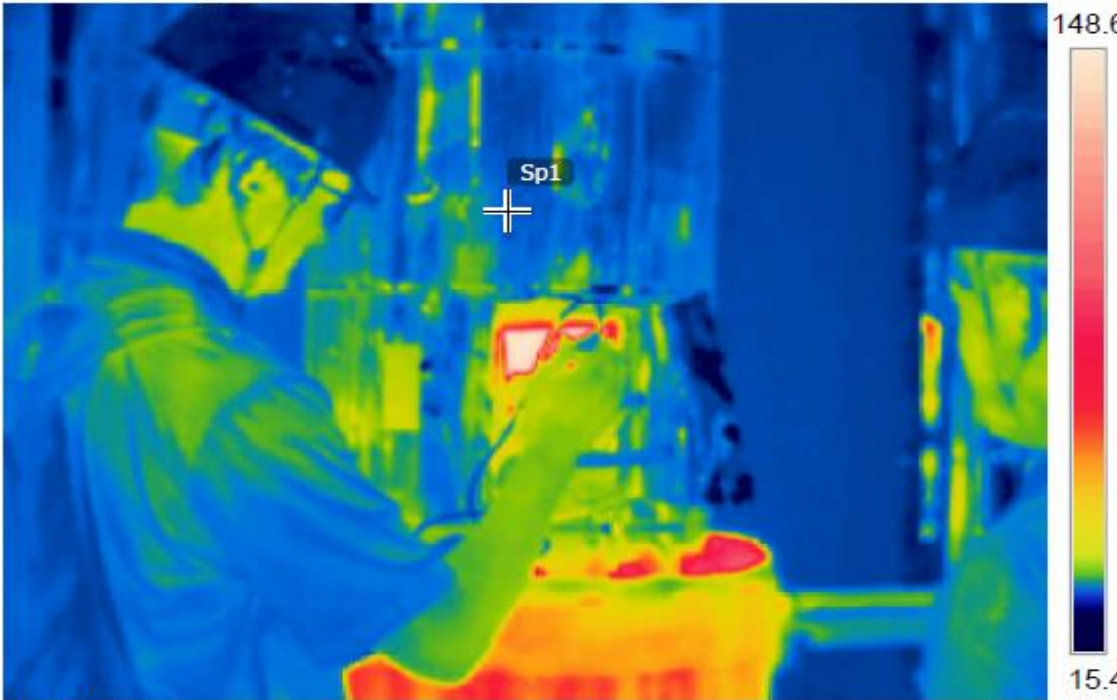
## CASE 3 CUI Risk

NPS	14"
Process Temp.	90°C
Ambient Temp.	26.5°C
Wind Speed	0.7 m/s
Material	Pyrogel XT 20mm
Surface Temp. Measured	35.0°C (Probe) 33.7°C (FLIR)
Surface Temp. Calculated	36.3°C Emissivity 0.1

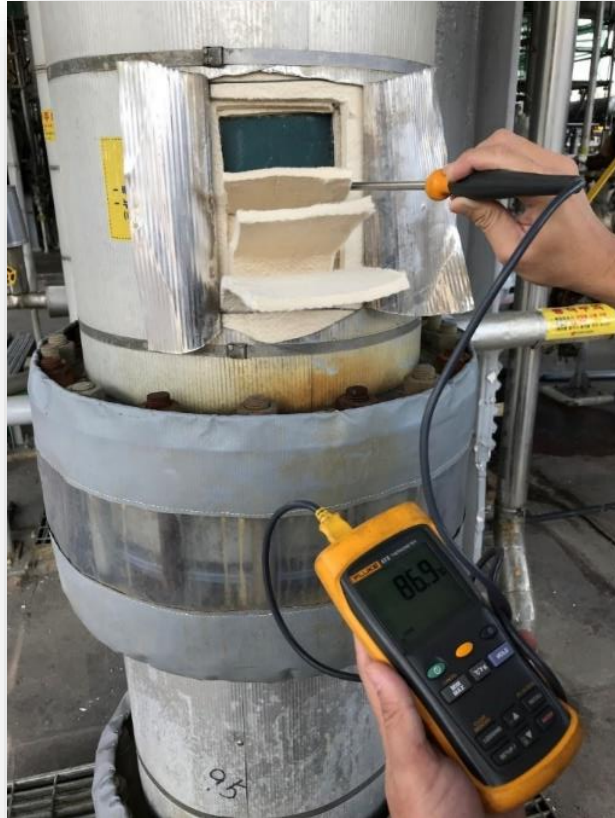
**Insulated with  
30mm Pyrogel XTE**

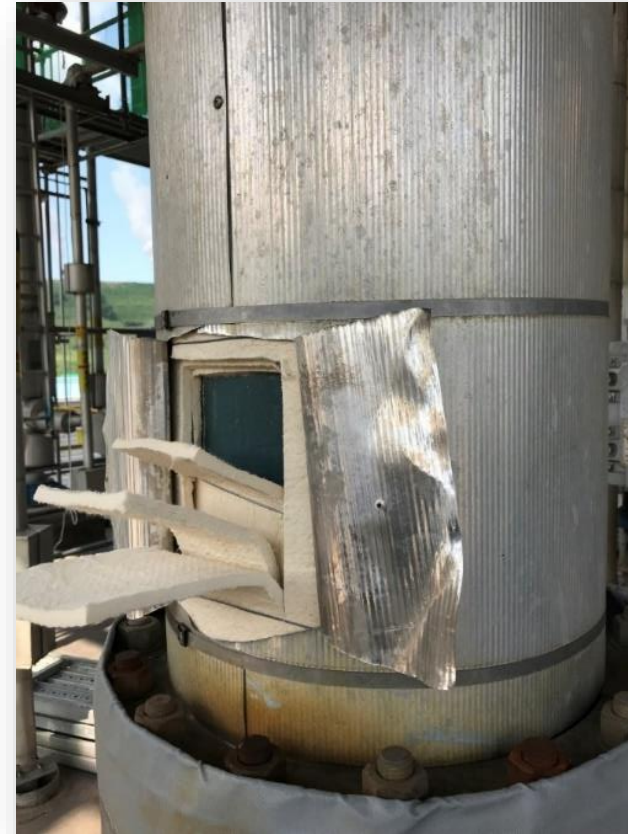
**NO CORROSION!**
