**PEGASUS WEST 43/13B-7
SENTINEL WELL MONITORING**

PASSIVE TECHNOLOGY

PEGASUS WEST 43/13B-7 SOLUTION

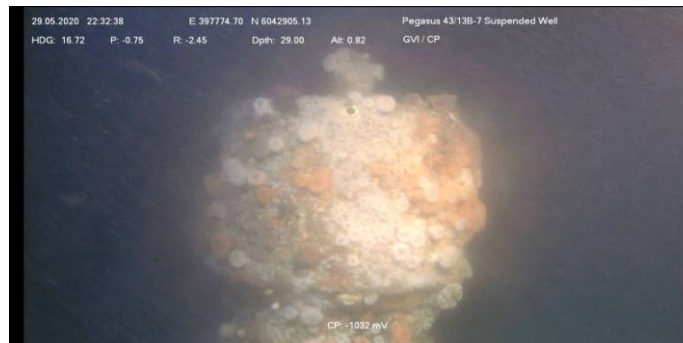
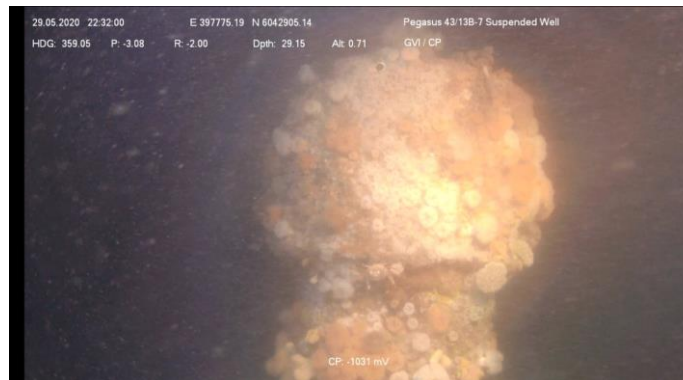
June 2020 IRM

- Long-term suspended well without active monitoring
- No infrastructure in place
- Bi-annual visual inspection (IRM) only
- Looking for a remote monitoring solution
- Deployment integrated with 'routine' IRM campaign

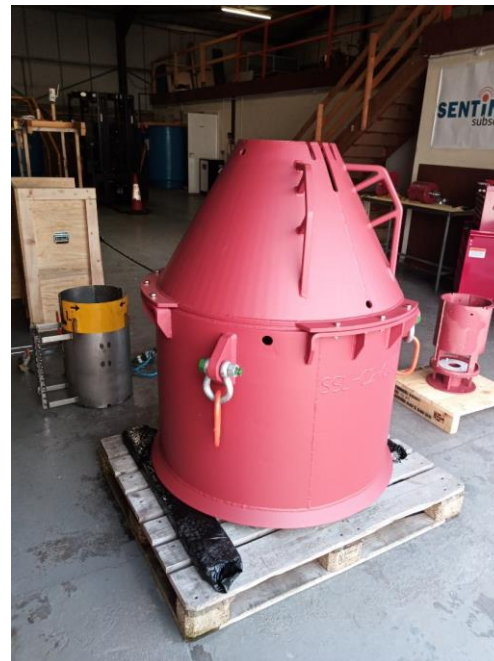
- Modified 30" Debris Cap (Coral Unit) housing WellSentinel™ passive monitoring equipment
 - Collects and physically detects gas and /or oil in the subsea environment
 - Technology does not require active electronics for emission detection
 - Passive detection Triggers degraded by natural gas
 - Once exposed an individually coded Alert Beacon is released to surface and communicates via satellite
- 10+ years monitoring with no intervention
- Simple deployment with DSV during existing IRM campaign
- Early alert through existing Iridium satellite network

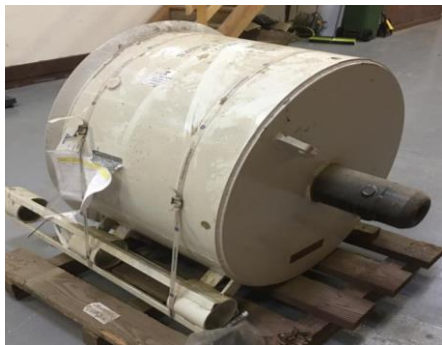
- Modify this...

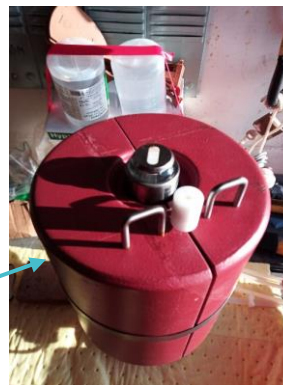
Monitoring Unit

- Sub-assembly houses all the critical monitoring equipment (Triggers, locking mechanism, alert beacon, silo unit, reaction chamber etc.)
- Deployed into top aperture of the modified Debris Cap (Coral Unit)
- Small and lightweight modular design
- Designed for ROV handling

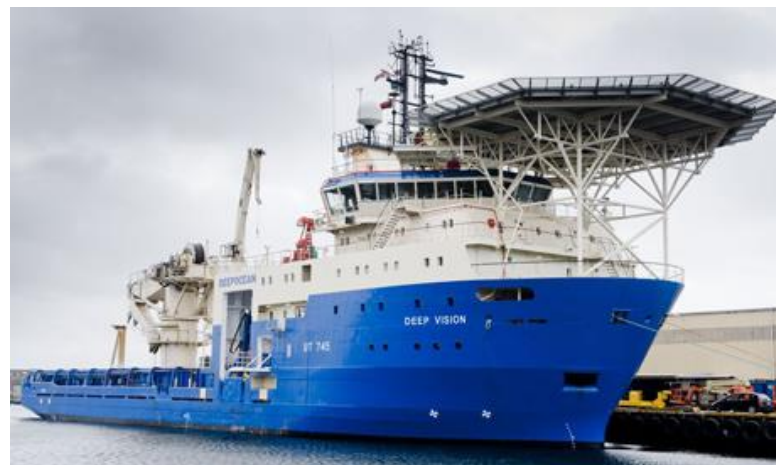
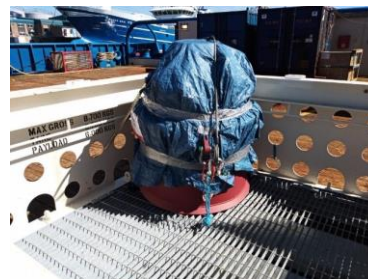
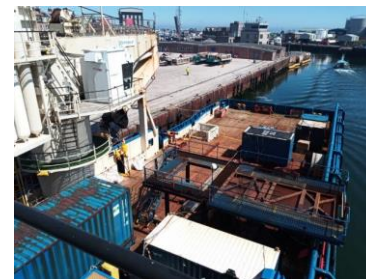
- Subsea IRM and survey vessel
- DP 2
- 60Te active heave compensated crane
- 1 OBS Class ROV (ObsROV)
- 2 Work Class ROV (WROV)
- Deployment part of 3 week IRM campaign

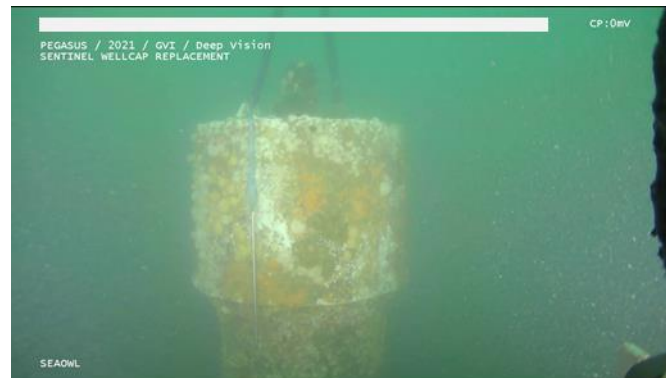
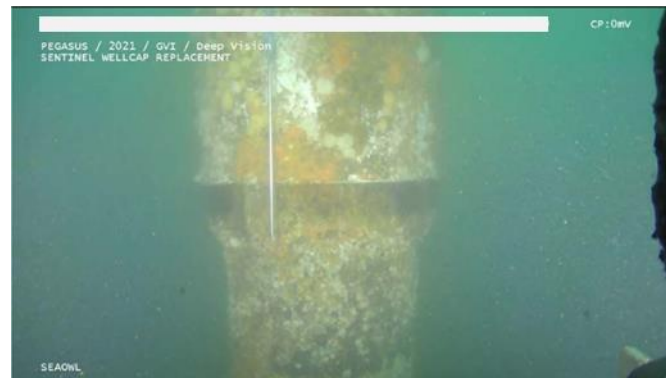
- The rigging assembly and sling set installed via WROV onto the cap
- The crane then lifted the existing cap from the wellhead
- The cap was then placed inside a subsea basket for recovery at a later point in the operation
- When the existing cap was removed, gas was observed at the wellhead

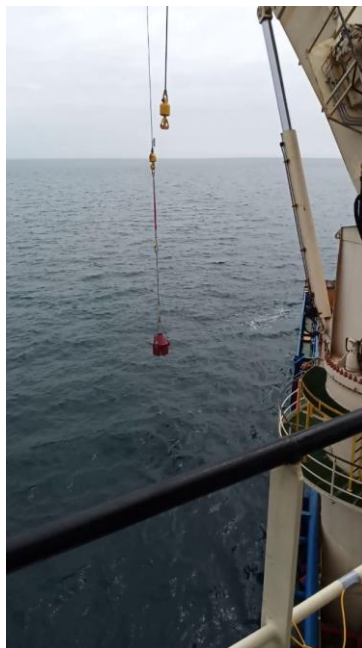
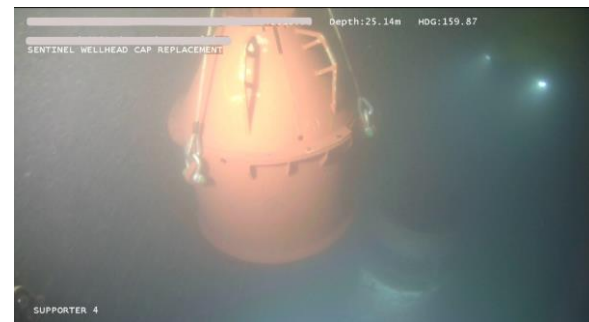
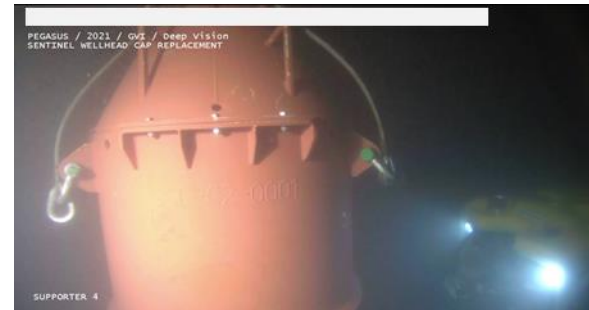
- The Coral Unit was rigged on deck and lowered down by the crane to the conductor
- The cap was aligned with the WROV manoeuvring the Coral Unit into place
- ObsROV was located at the base of the conductor, looking upwards, to assist with the alignment

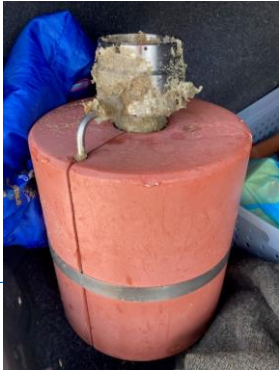
Alarm Alert - Pegasus (43-13b-7) UKCS

Key	Value
Timestamp	2021-06-17T06:35:05.000Z
Surfaced	true
Alarm	true
Plain Text	Surfaced
