Pelican PU-P16S1 Abandonment Summary

Darren Bewick
Senior Completions & Interventions Engineer

Introduction to PU-P16S1

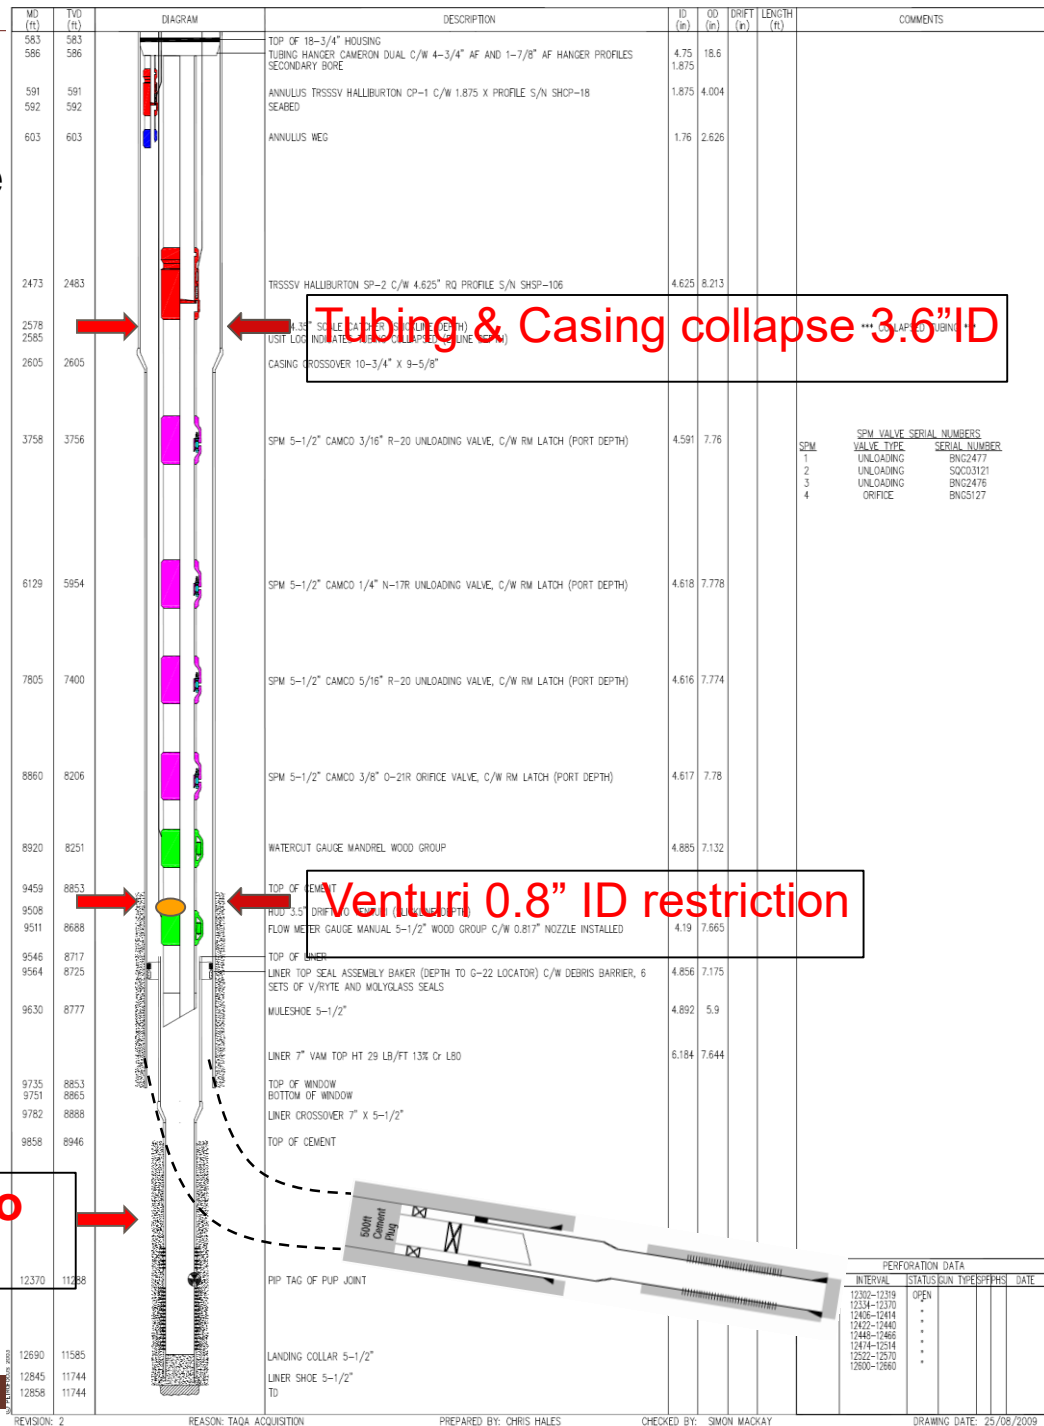
PU-P16S1 – Well ISSUES

- Original well bore isolation can not be classed as primary barrier for permanent abandonment therefore need two barriers above 9-5/8" shoe.
- Tubing to Annuli communication
- Potential scale denying access
- Potential issues in the recovery of damaged tubing.
- Would also need to 'open up' the 10-3/4" casing to get tubing out if collapsed.
- Bottom line is that the well needed a base to safely carry out operations to place abandonment plugs due to the potential issues with tubing & casing collapse.

We need to get access to here
