# A case study in the use of a mechanical clamp on a non-typical joint

4 March 2021

Minor seepage detected in a gas pipeline around a monolithic isolation joint.

30" (773.7mm OD) Carbon Steel API 5L X65, 28.6mm wall thickness

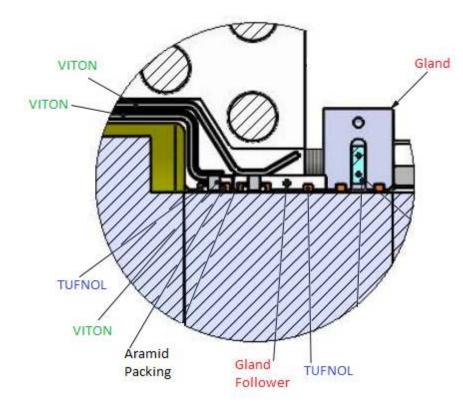
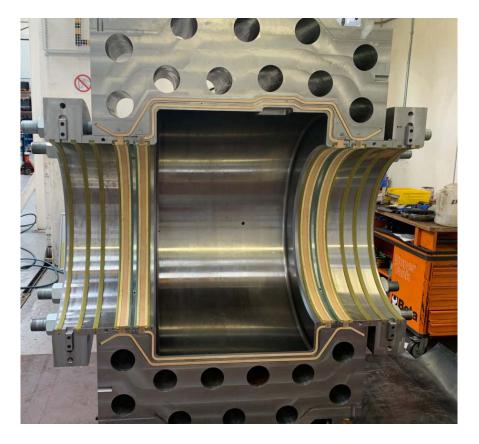
- Non standard seals due to electrical isolation requirement
  - Larger aperture
  - Different grade Viton mc616 non- carbon

- Tufnol 10G/40 rings to provide separation
- Isolation test
  - 2000V, 50Hz for minimum 1 minute no flash over or breakdown
- Resistance test
  - 500V dc isolation tester, resistance shall exceed 50 Mohm
- Failed first FAT
- Capacitive effect
