# OPTIMISE PRODUCTION AND IMPROVE WELL ACCESSIBILITY WITH NOVEL REFORMED EXPANDABLE TECHNOLOGY

SPE Aberdeen - Well Decommissioning 2021 Tyler Whitney & Cherish Sims

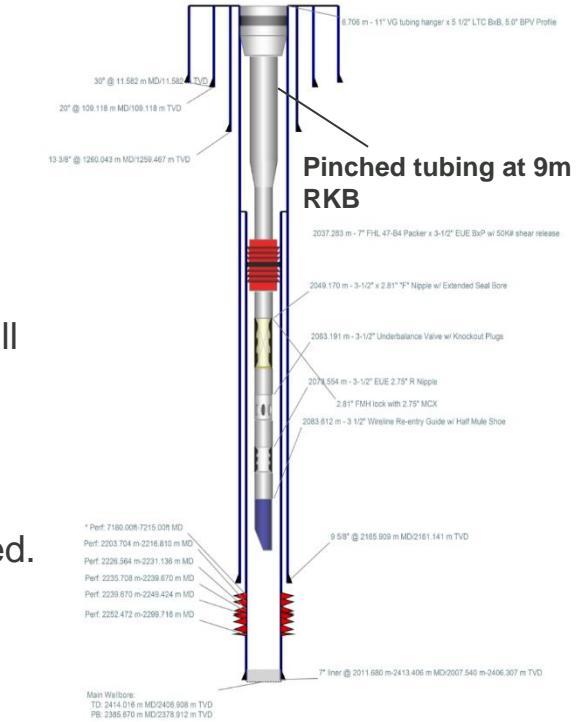
### Area of Concern

- 5-1/2" 17# K-55 LTC tubing
- Collapse began at 9m RKB, ~2m below ground level, and was of unknown length.
- Production packer and/or injection valve leak – could not access below collapse to determine leak path.
- Corrosion/erosion may have affected the tubing in this area
- Tubing was collapsed with effectively no gap, "pinched flat"

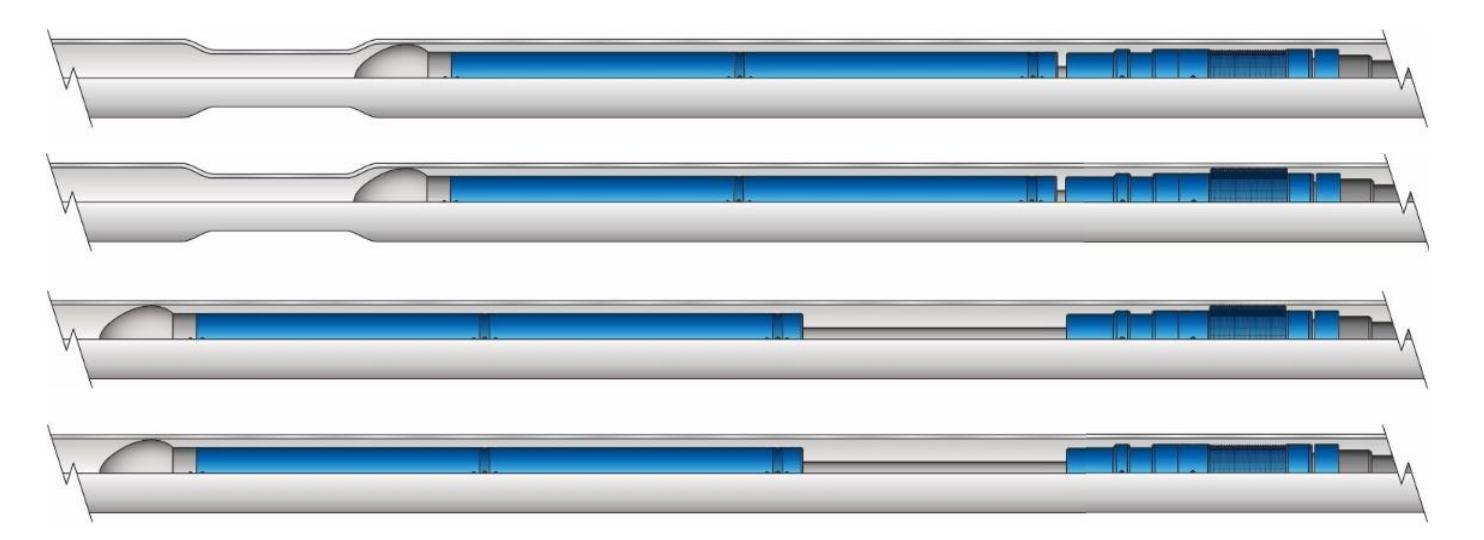
## **Proposed Tool Operation**

Shape provides easy entry in to collapsed section OD chosen based on goals of operation and collapse severity

This pressure will extend the mandrel and apply force to the reform cone

The ID anchor sets inside the tubing/casing and anchors the tool shaft to the tubing/casing.
