# Application of novel downhole video technology leads to the diagnosis and successful remediation of injectivity performance issues in deep saline CO2 storage well

22 FEBRUARY 2022

AQUISTORE®

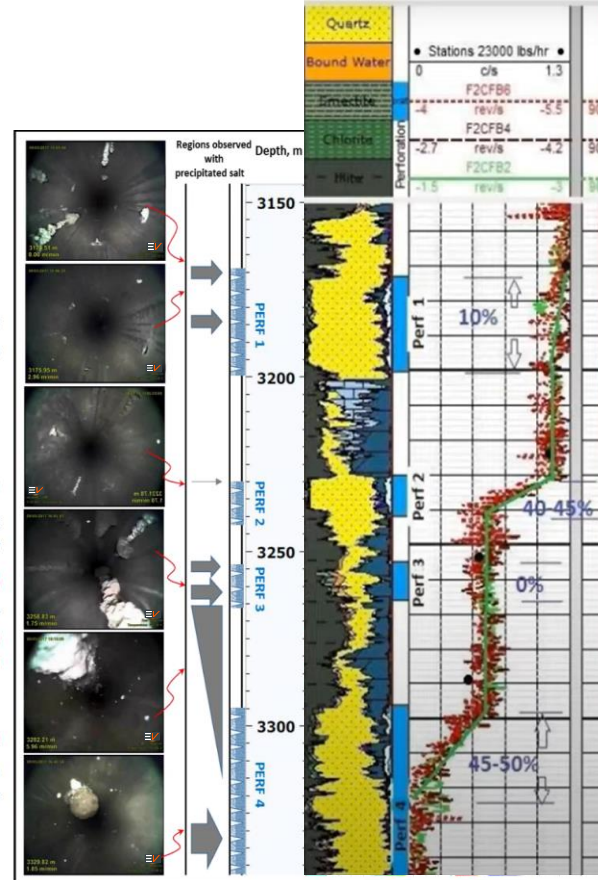
Formation	Interval (mKB)
Black Island	3173-3200
Deadwood	3230-3242
Deadwood	3255-3266
Deadwood/Precambrian	3296-3366

**Perf Zone 1**  
Highest permeability at the bottom of the zone

**Perf Zone 2**  
High, relatively constant permeability

**Perf Zone 3**  
Low permeability  
Plugged based on spinner survey

**Perf Zone 4**  
Variable, low to intermediate permeability

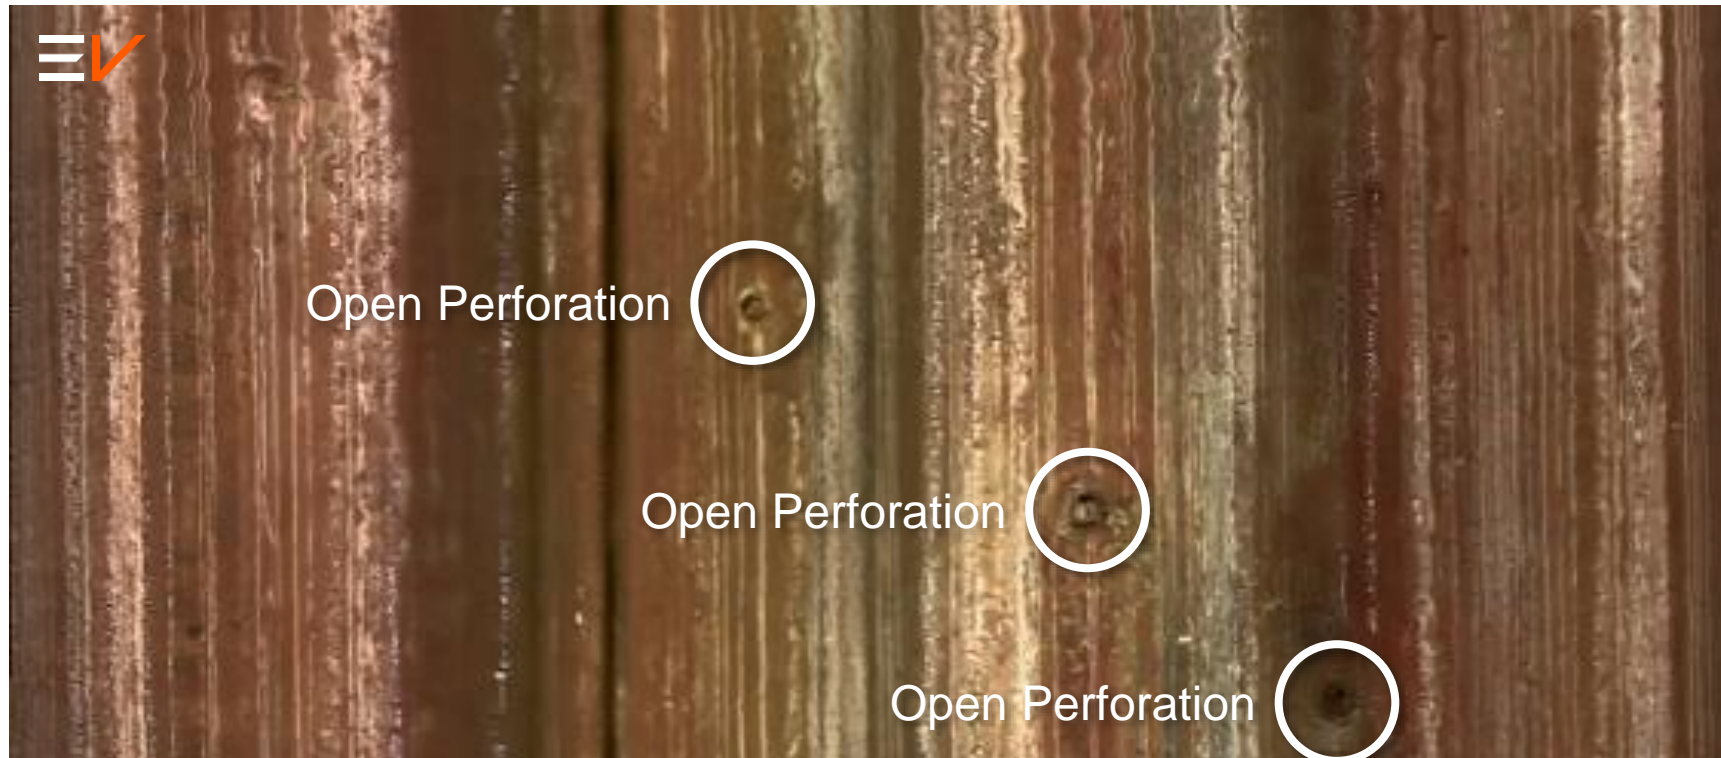
## VIDEO RESULTS 2020

- Revealed more detailed images of solids structure
- Granular / porous texture confirmed at all zones
- 360° field of view allowed detailed imaging of every perforations in each zone

- No “Type 2” structures: Deadwood C wellbore clean
- Type 1 structures evident in all perforated zones
- Degree of precipitation variable across each zone
