COMPREHENSIVE ASSET INTEGRITY AND PERFORMANCE SOLUTIONS

Topsides 2025

WrapAssure

Reinforcing Integrity of Composite Repairs

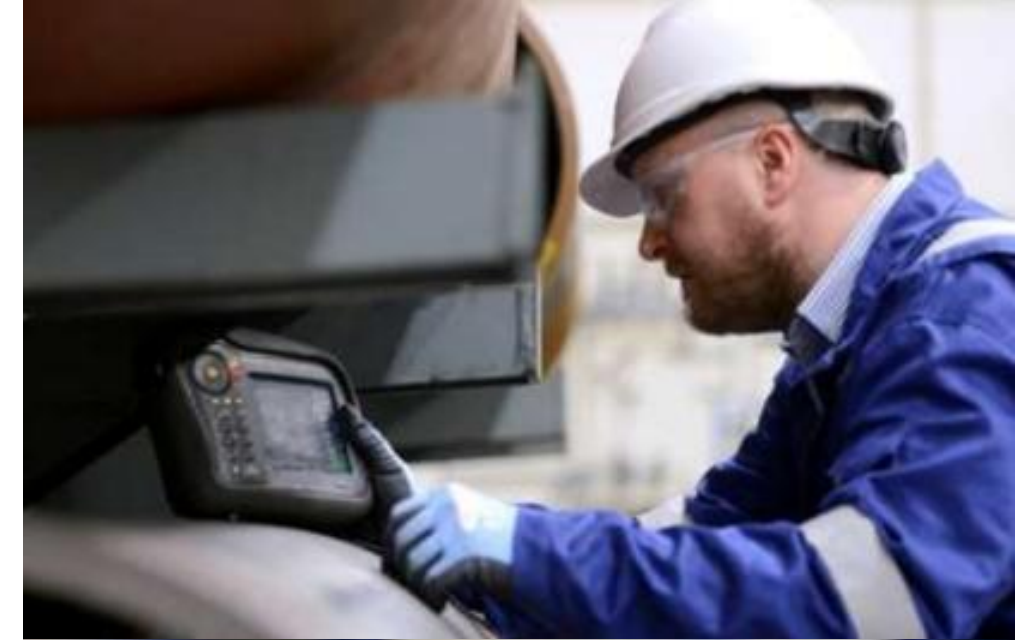
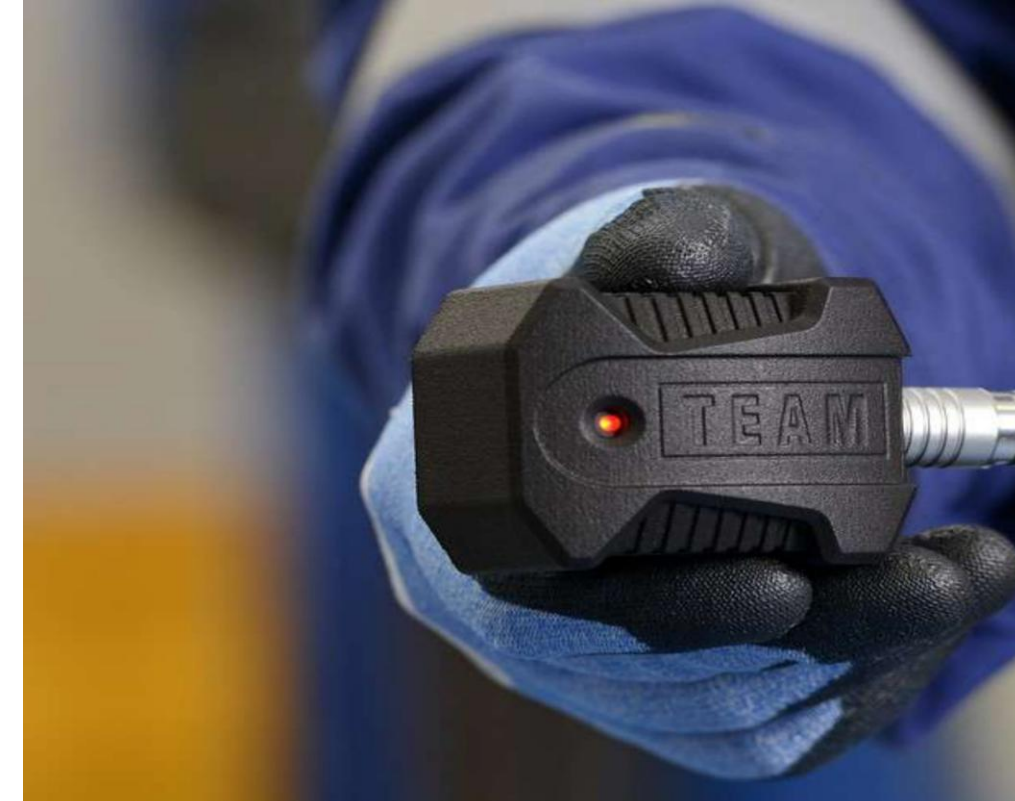
- Conventional NDT Services – Magnetic Particle Testing (MPI), Dye Penetrant Testing (DPI), Visual Testing (VT), Ultrasonic Testing (UT), Eddy Current Testing (ET), Remote Visual Inspection (RVI), Radiographic Testing
- Advanced NDT Services – Corrosion Mapping, Phased Array UT (PAUT) & Time of Flight Diffraction (TOFT), Long Range UT (LRUT), PA CAT
- Level 3 NDT & Engineering Services
- Bespoke testing procedures
- WrapAssure Inspection; **TEAM developed** volumetric examination of Composite Repair to pipework structures, tanks & vessels

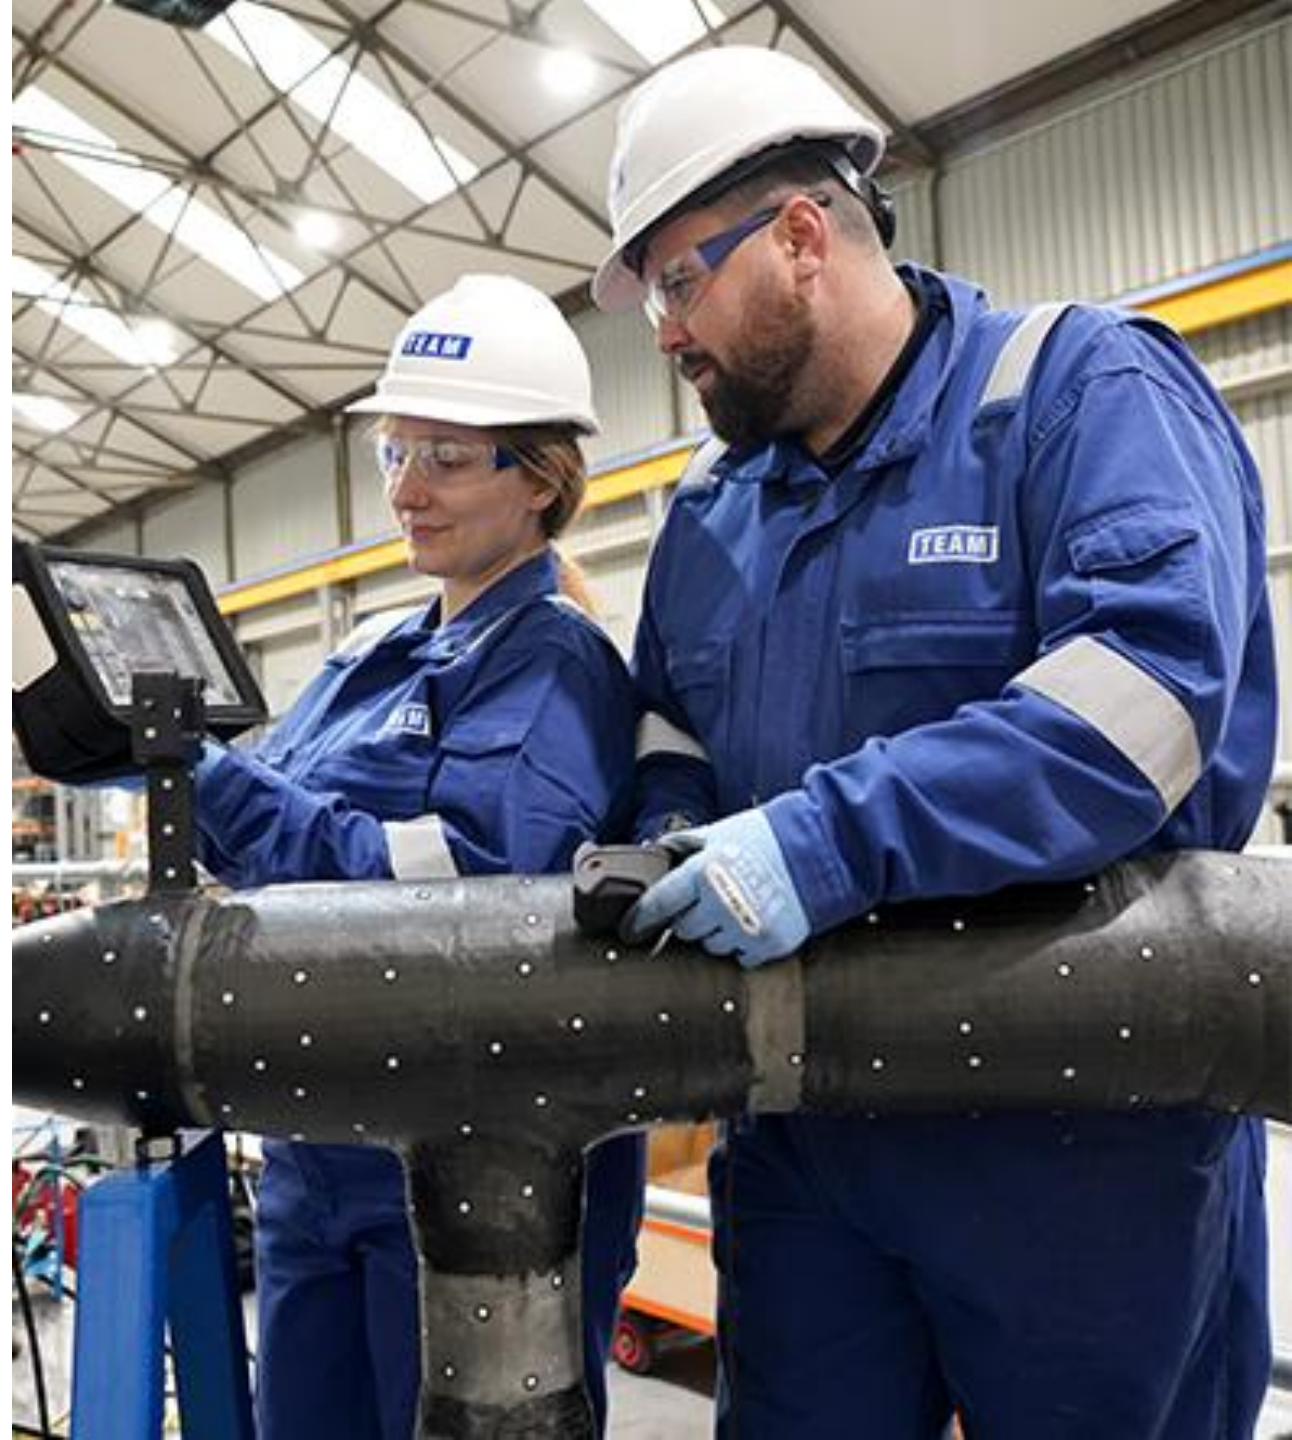
- WrapAssure is a pioneering, TEAM-developed technology that uses low frequency ultrasonics to check for disbonds between the repair and substrate and delaminations within the body of a Composite Repair.
- This information can be used to in conjunction with a detailed Visual Inspection to provide an accurate picture of the condition of the repair.
- The information can be used by TEAM's Composite Repair Engineers to support assessment of the fitness for service of the repair, including lifetime extension or remedial actions required in case of in-service damage.

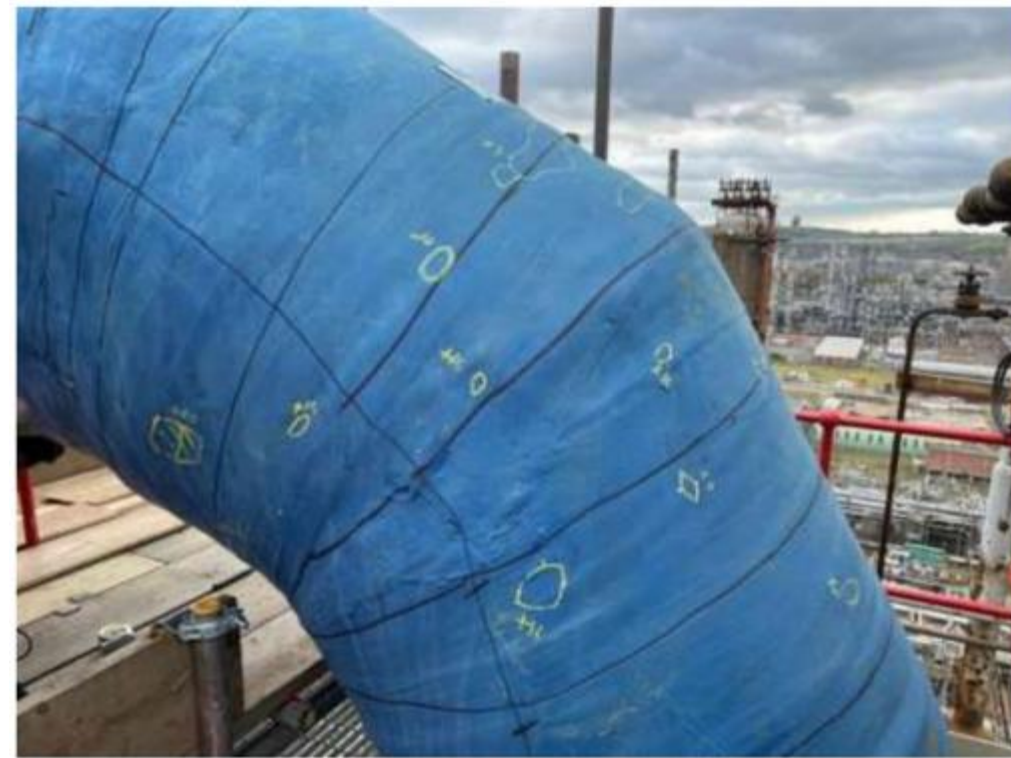
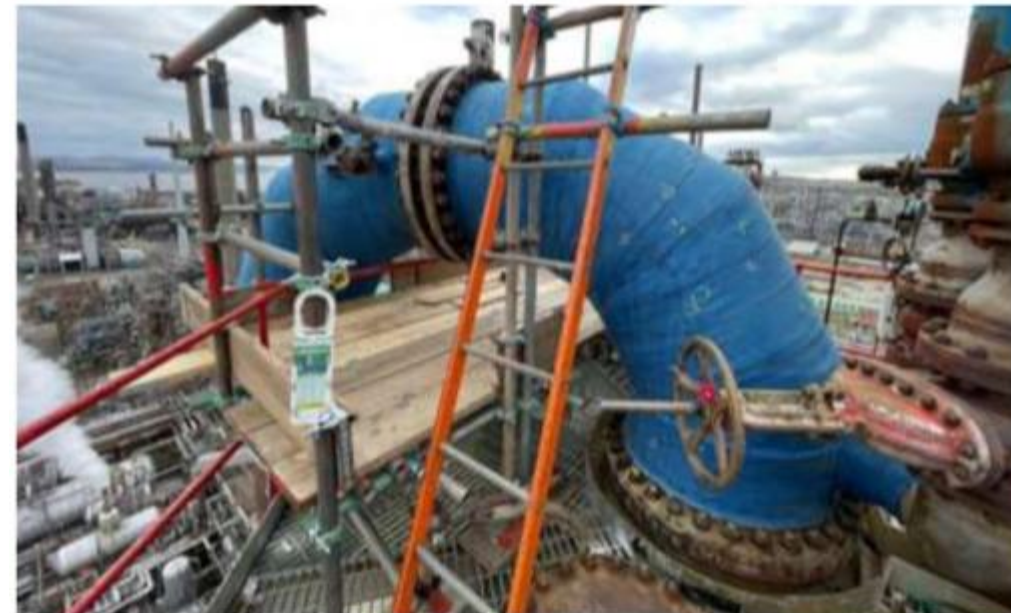
WrapAssure

- Extensive verification completed to formalize the technical procedure and confirm limitations
- Confirmed the technique remains accurate for:
 - Varying thicknesses of repairs
 - Different fabric and resin types
 - Coated and uncoated repairs
 - Disbonds (at the interface) and delaminations (within the laminate)
- In field operation is relatively quick and allows for immediate assessment
- Compact, handheld unit is ATEX certified and easy to transport, giving flexibility in terms of application.

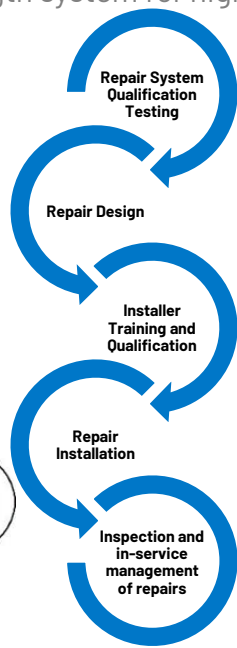
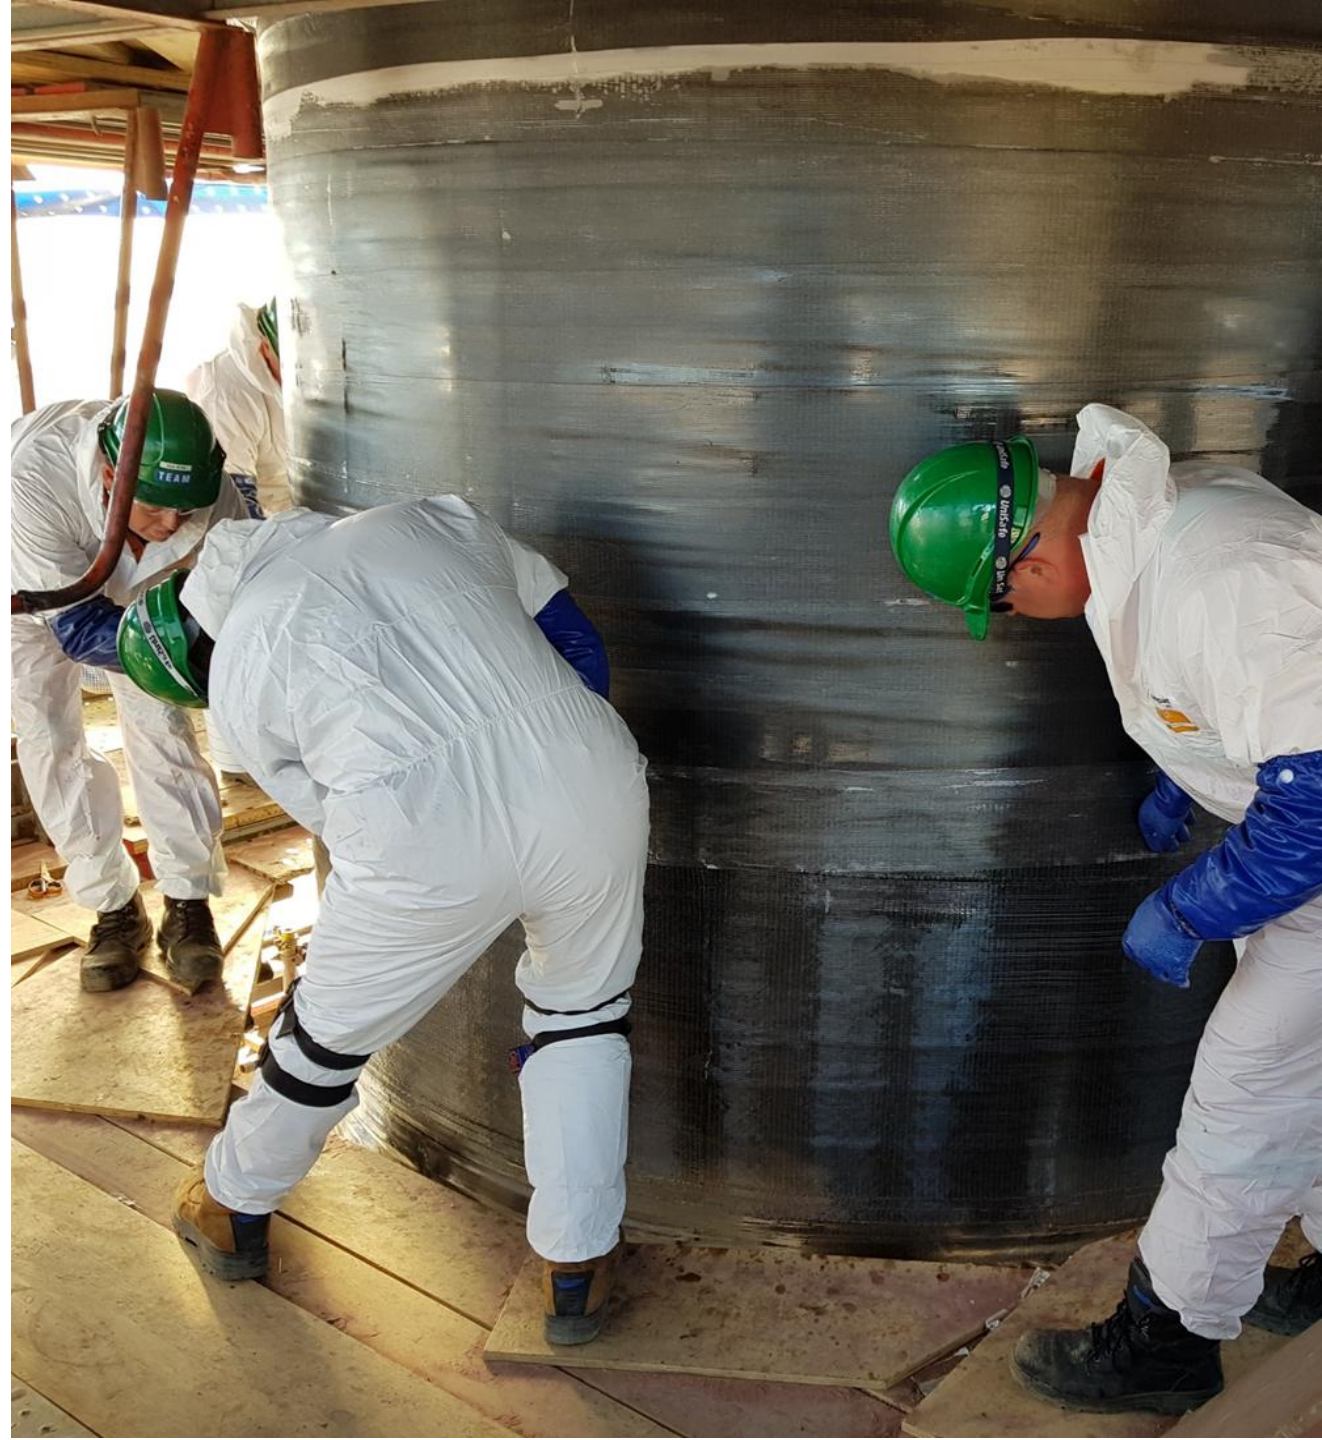
TEAM Composites

TEAM's composite repairs are designed in accordance with either [ISO 24817](#) or [ASME PCC-2 Article 401](#).

The [materials](#) typically used for TEAM's composite's repairs are:

Reinforcement: [Carbon](#) or [Glass Fibre](#)

Resin System: [Epoxy](#) (chosen for superior bond strength and chemical resistance)

Carbon Fibre Systems: [FCR-QC](#) and [FCR-BC](#) → High-strength system for higher pressures and leaking defects.

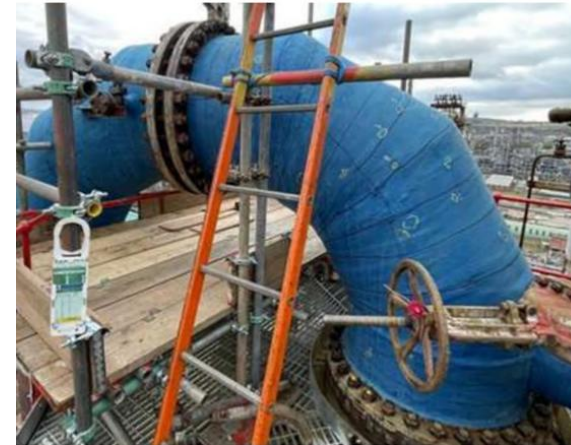
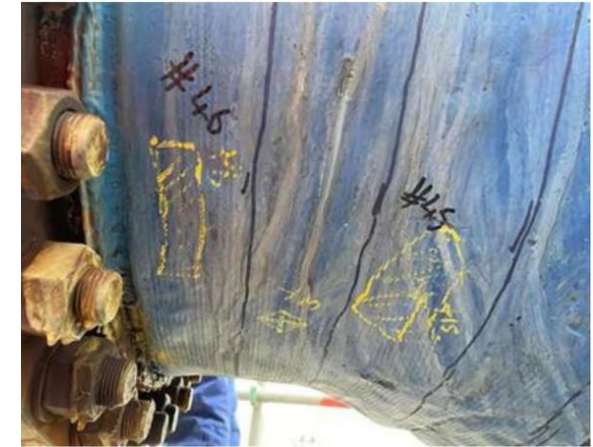
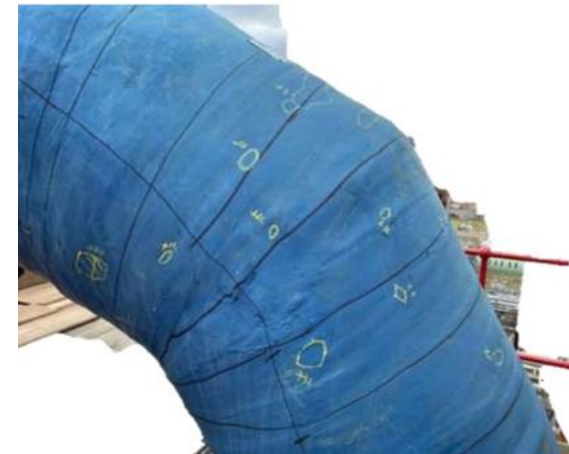
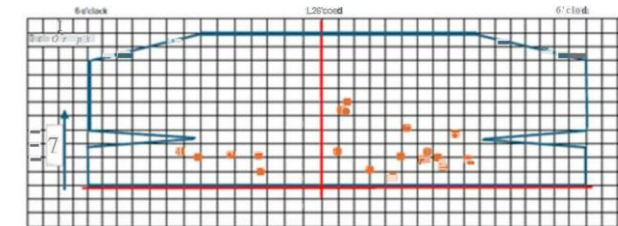
Validation of repairs used outside design conditions

- Two mitred bends had been repaired with 12 layers of TEAM's FCR QC fabric
- The repairs were subject to a spike in temp to above their design level (but within their ultimate limit) that lasted one week and there was concern this may have led to debonding of the repairs
- WrapAssure combined with visual inspection provided evidence to state with confidence that the spike had created no damage
- An engineering assessment of the data reported concluded that the repairs could remain in service

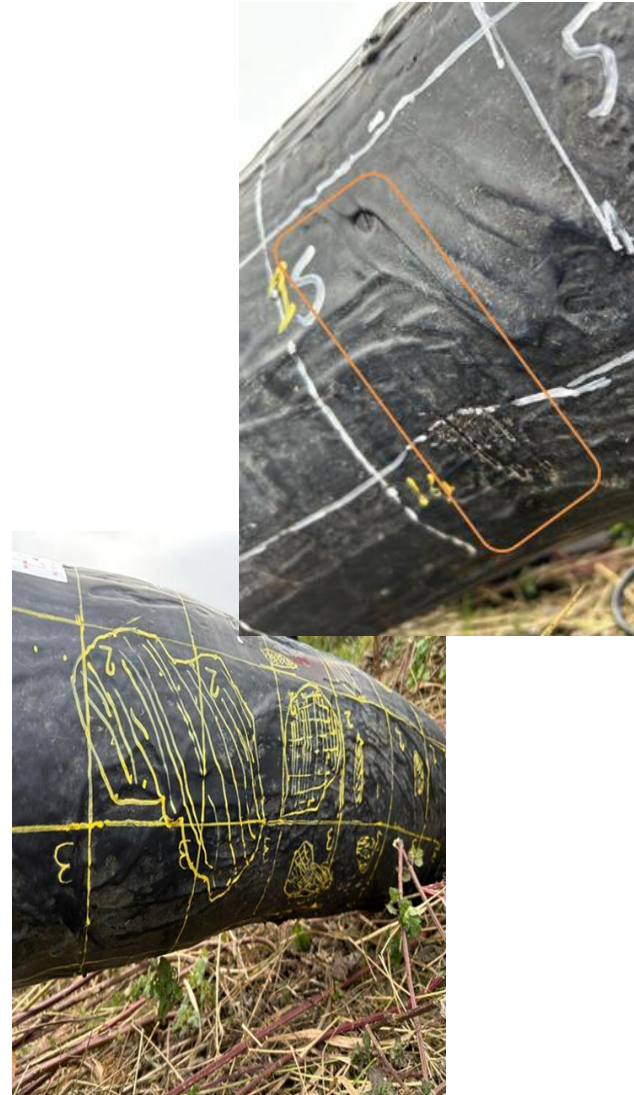
Reactive Inspection

- Mechanical damage had been reported by an engineer at a pipe bridge river crossing – where a farm implement was suspected to have damaged an existing transmission line.
- TEAM Inspection were called to assess the damage, and to ascertain what the status of the repair was beneath the (visible) surface.
- WrapAssure was able to non-destructively size all damage volumetrically around the area of concern. This was presented in tabular format and mapped out on a net from a datum on the pipe (to enable future inspections to identify any changes).
