CYBERHAWK
Aerial Inspection and Surveying Specialists

Digitising Drone Collected Data to Aid Asset Integrity & Major Projects

Phil Buchan
BEng, MSc, CEng, MIMechE, MBA
Director

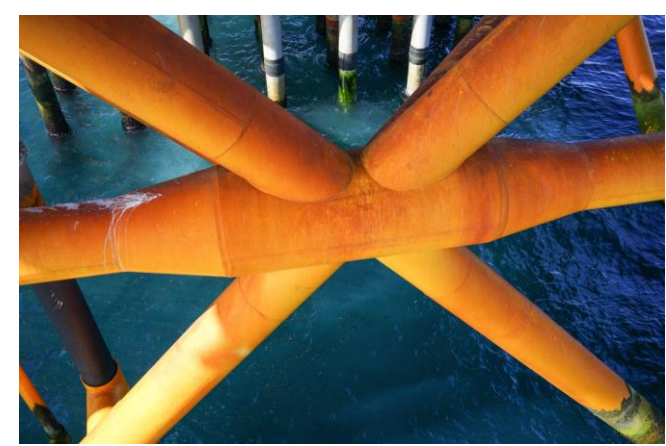
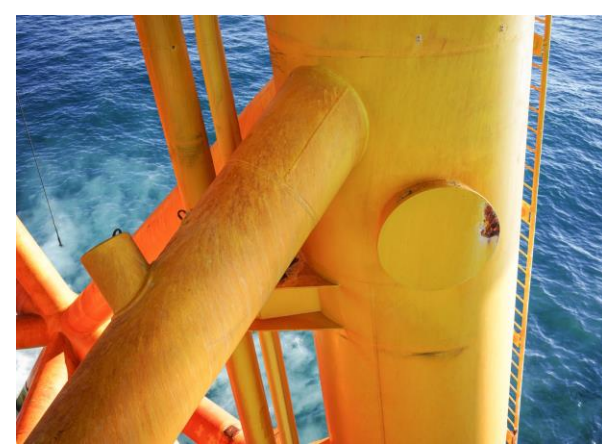
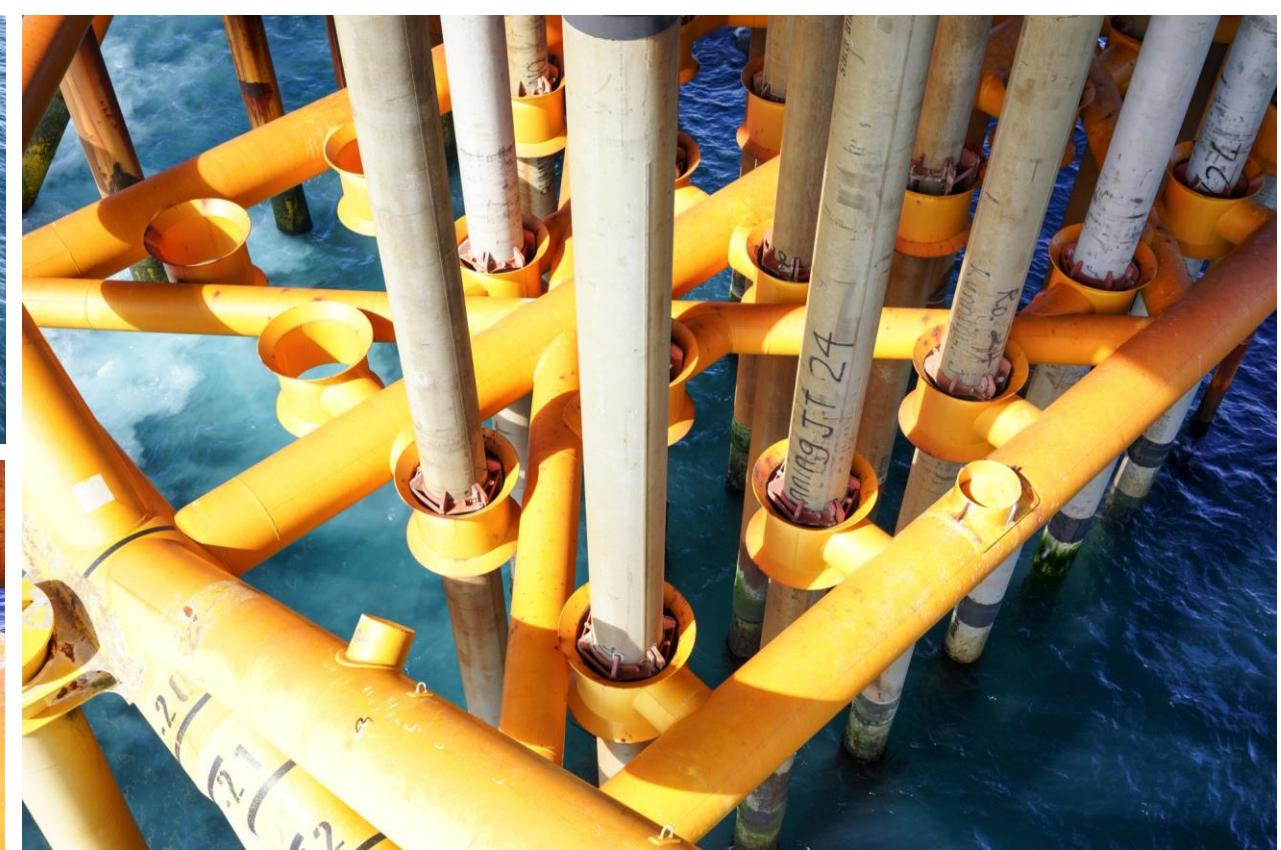
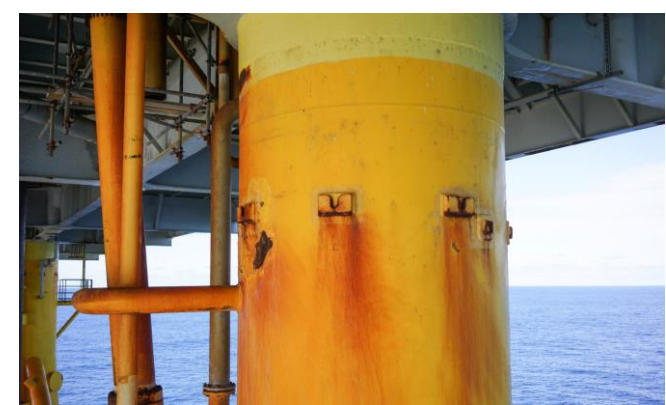
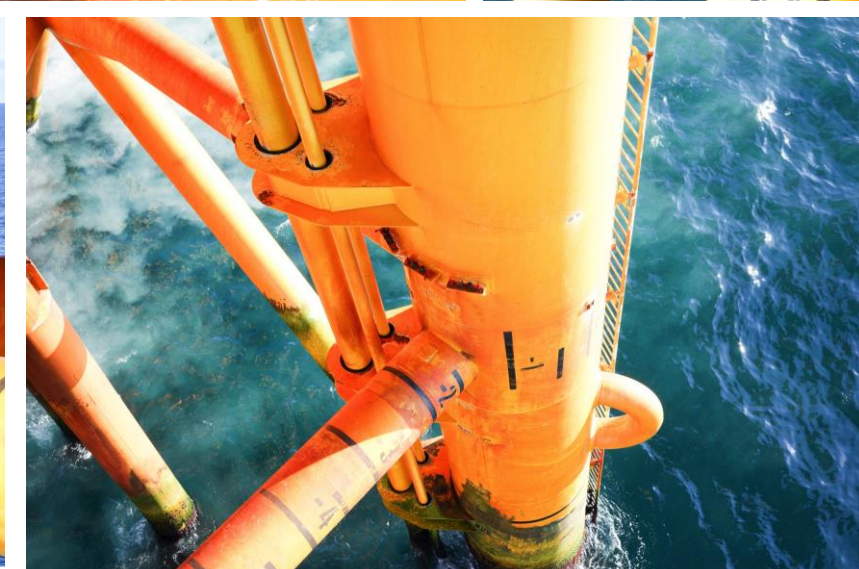
Splash Zone Inspection

A photograph of an offshore oil rig's splash zone. The image shows a complex network of dark steel pipes and structural beams extending from the rig's deck down into the blue ocean. A large, powerful jet of white water is being sprayed downwards from a pipe, creating a significant splash and mist. The rig's legs are visible, some showing signs of corrosion and greenish algae growth at the water level. The sky is clear and blue. A semi-transparent white banner is overlaid across the middle of the image, containing the text 'Splash Zone Inspection'. A large yellow diagonal graphic element is on the right side, featuring a circular logo with white curved lines.

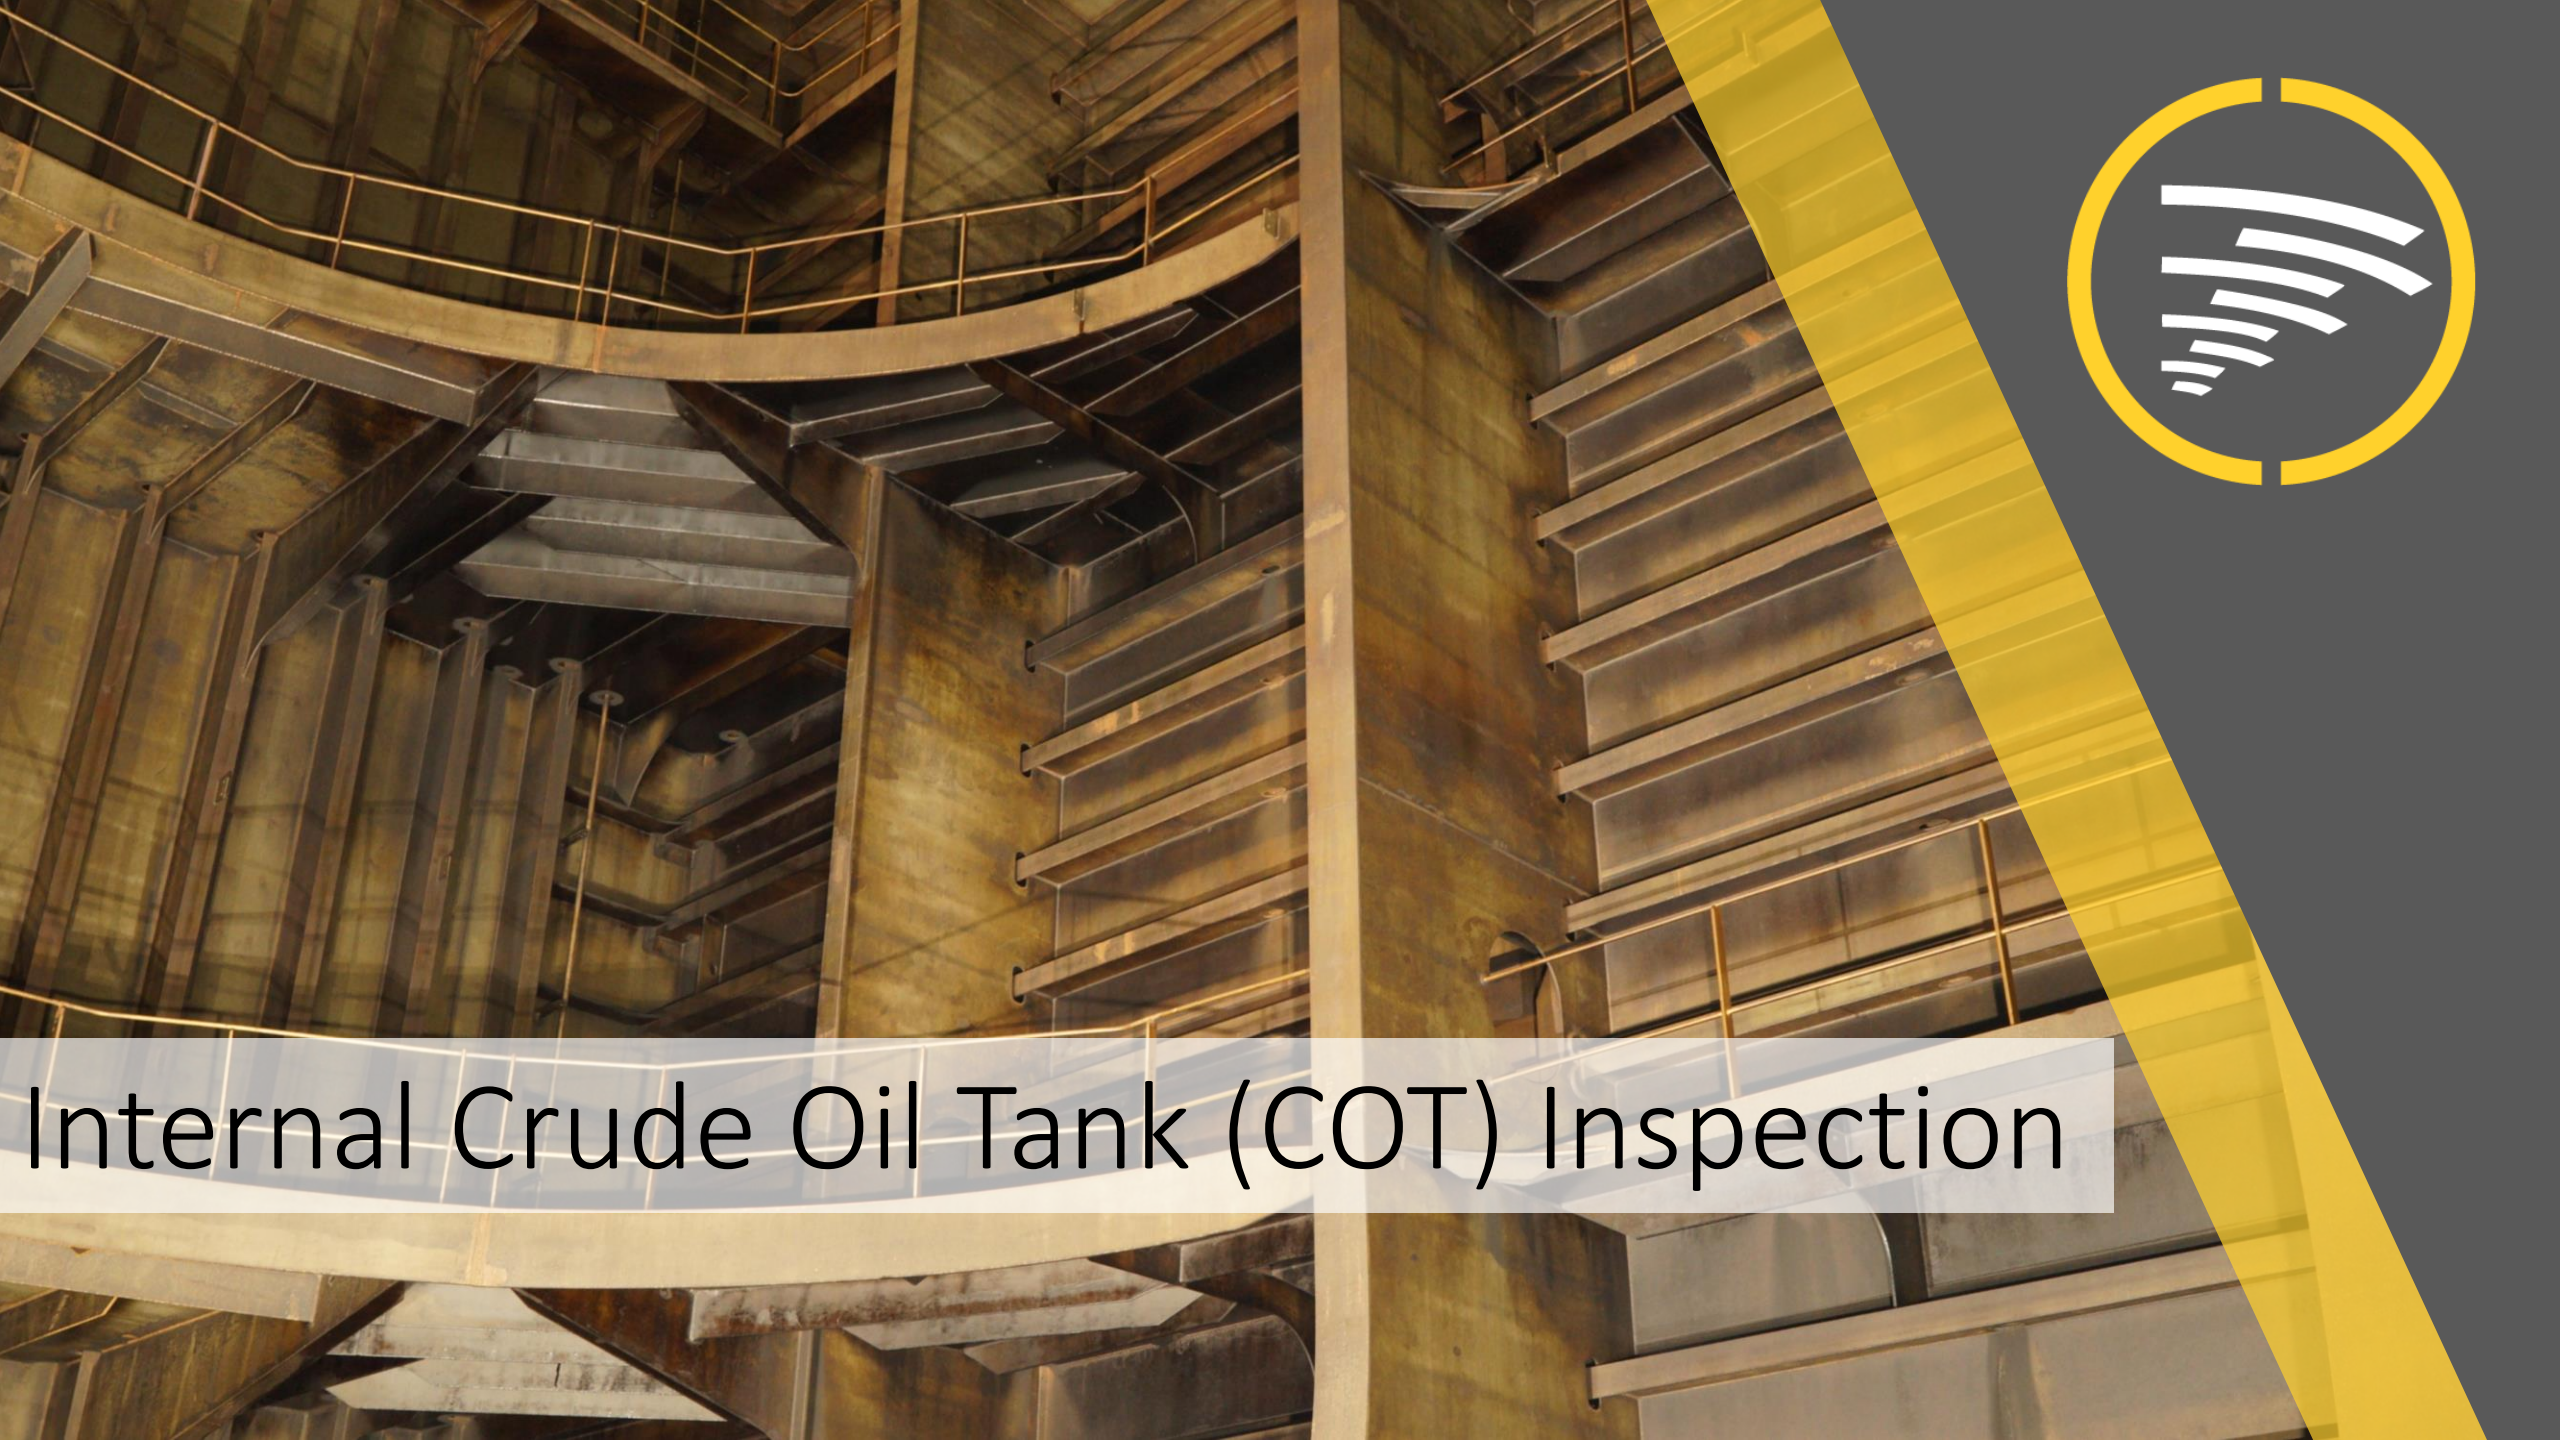
Internal Crude Oil Tank (COT) Inspection

- 14 COTs inspected in 12 days
- Inspection approved by ABS to Class code
- No scaffolding or RATs used
- Client saved \$750,000 attributed to no scaffolding costs & efficiency of the inspection allowing for quick turnaround

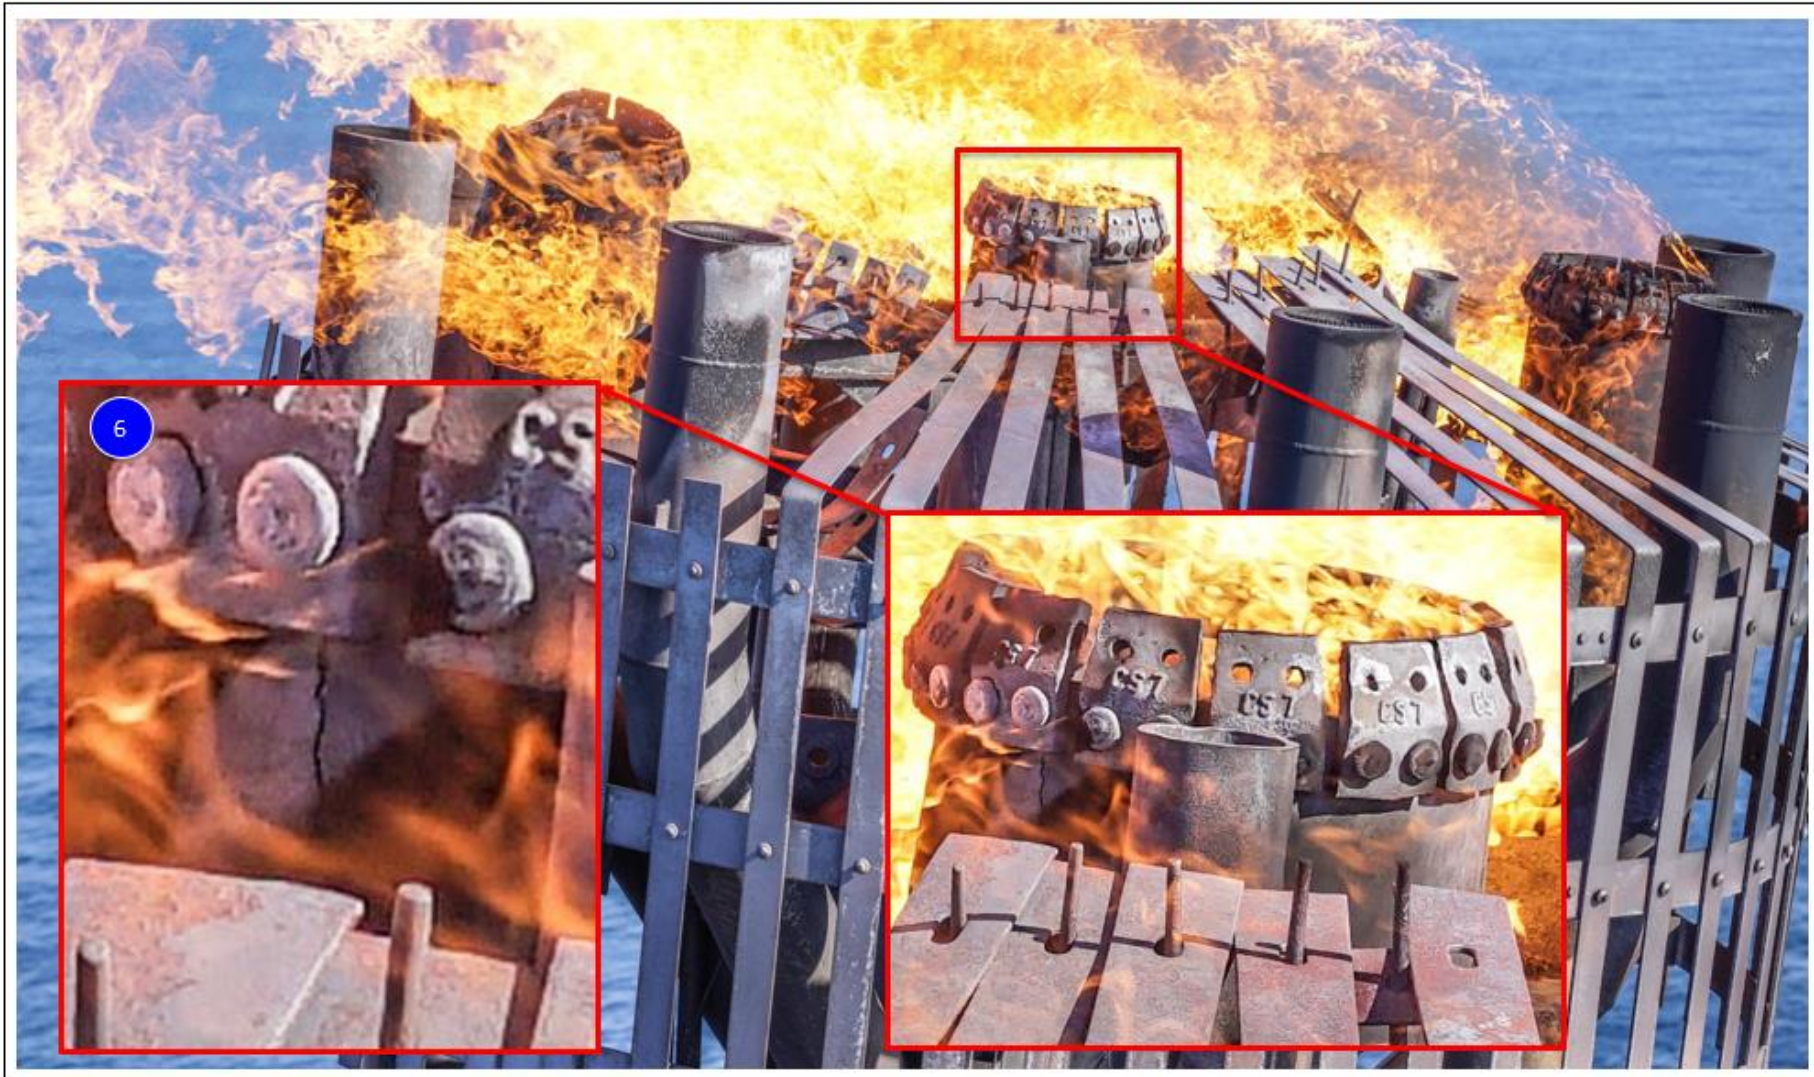
Small crack-like-indication found on HP upper shell, adjacent to the flame retention segments. Propagation likely under normal operating conditions and shutdown/start up (cooling).

The 14" HP tip was found with a possible hairline crack at the tip periphery.

The 14" HP tip was found to be in satisfactory condition with the exception of a possible hairline crack at the tip periphery, further inspection is required to confirm this. The 8" nozzles were found to be in good condition with light carbon build noted.
