# DTI - ASV

ICoTA EWIC – Annular Safety Valve Provides Sealing Integrity for use in Hydrogen Storage Wells

# ASV for Hydrogen Pilot

Bi-directional sealing safety valve technology

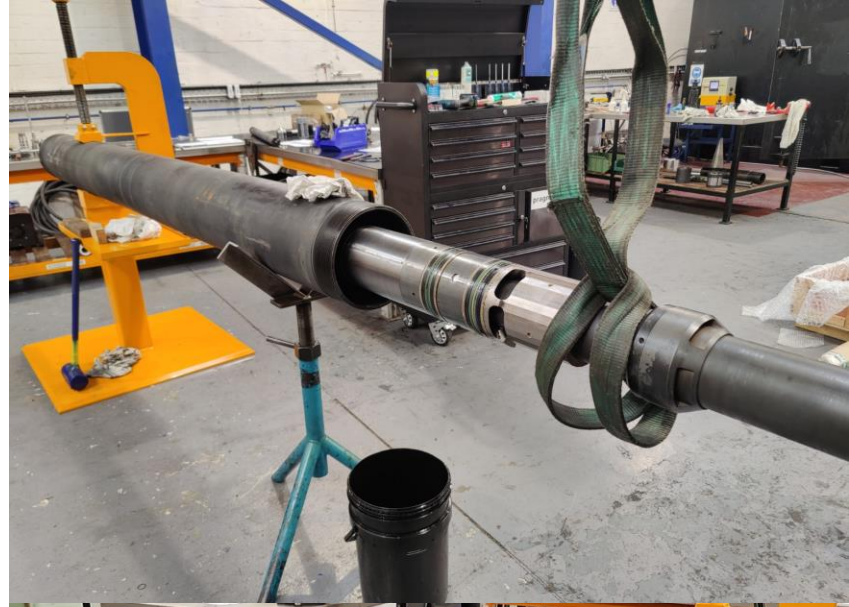
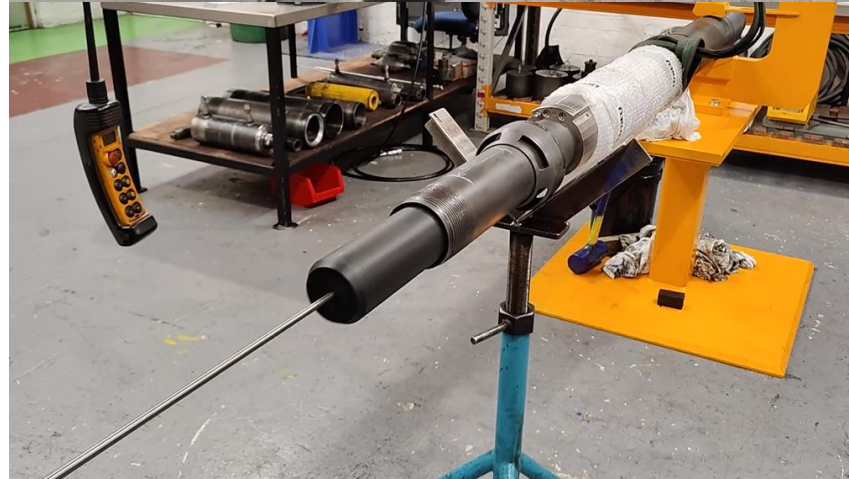
In order to mitigate risk, DTI developed test fixtures to validate key components of the design prior to undertaking the qualification test:

- Workshop testing
  - Test Nipple created.
  - Control Piston seal Test Fixture using clamshell over port. This enabled Piston seal qualification and leak rate testing in isolation of Nipple and external seals.
  - Hydraulic testing with water.
  - Gas testing with Nitrogen. Zero bubble leakage.
- DTI Nipple Testing
  - Valve was tested into the nipple and pressure testing and retrieval.
